**Date:** 2-21-2024, Wednesday  
**Time:** 1015 – 1330  
**Place:** The Dalles Dam, Lyle, WA  
**Weather:** Overcast. About 45 deg F.

**Subject:** The Dalles Dam North Fish Ladder Rockfall Observations

**Prepared by:** Alex Baumann, PE

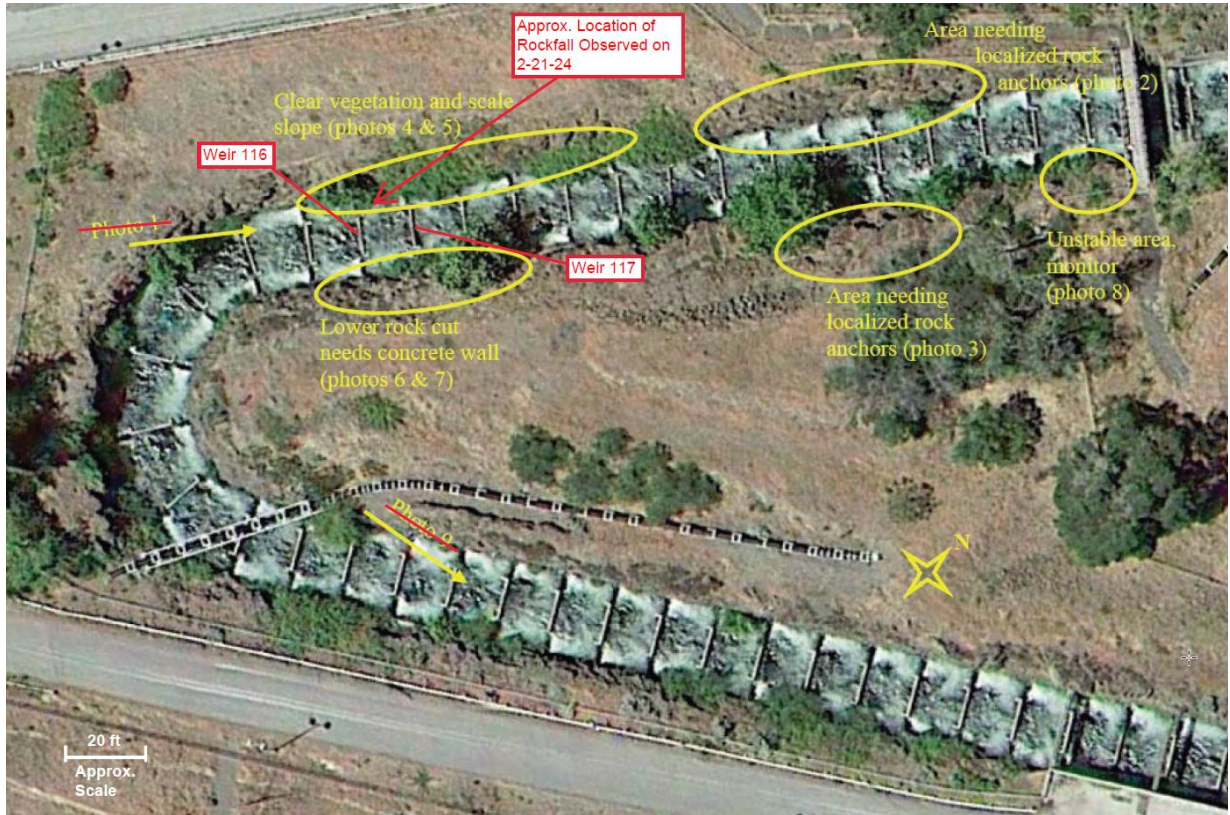
The rockfall observed today occurred approximately between Weirs 116 and 117. In Figure 2 (from the 2015 DDR), the south-facing exposed rock slope between Weirs 115 and 122 is noted as being an area recommended for remedial scaling and vegetation removal. Scaling is a process of removing loose rocks from the slope and is commonly accomplished using pry-bars, picks, or similar hand-held tools by professional rock scaling personnel skilled in scaling techniques and associated equipment/safety. As shown in Figure 2, several locations along the exposed rock walls of the north fish ladder are noted in the 2015 DDR as needing other remediation action, including a combination of rock scaling, localized rock anchors/bolts, or construction of shotcrete walls with mesh, rebar, and rock anchor support.

Figure 2: Figure from 2015 DDR showing DDR recommendations for rockfall mitigation, and the February 21, 2024 field observation location.

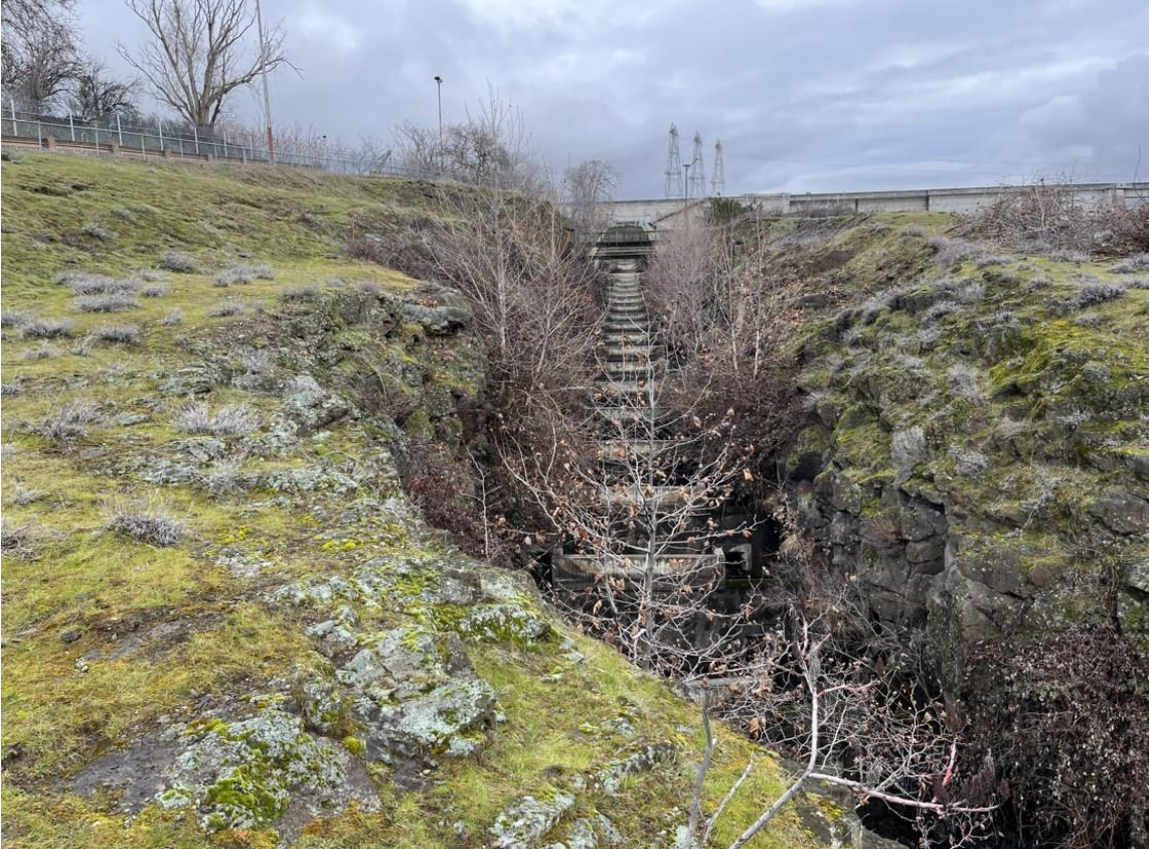
Photo 1: Looking northeast from west bend of north fish ladder, looking at north half of the ladder.

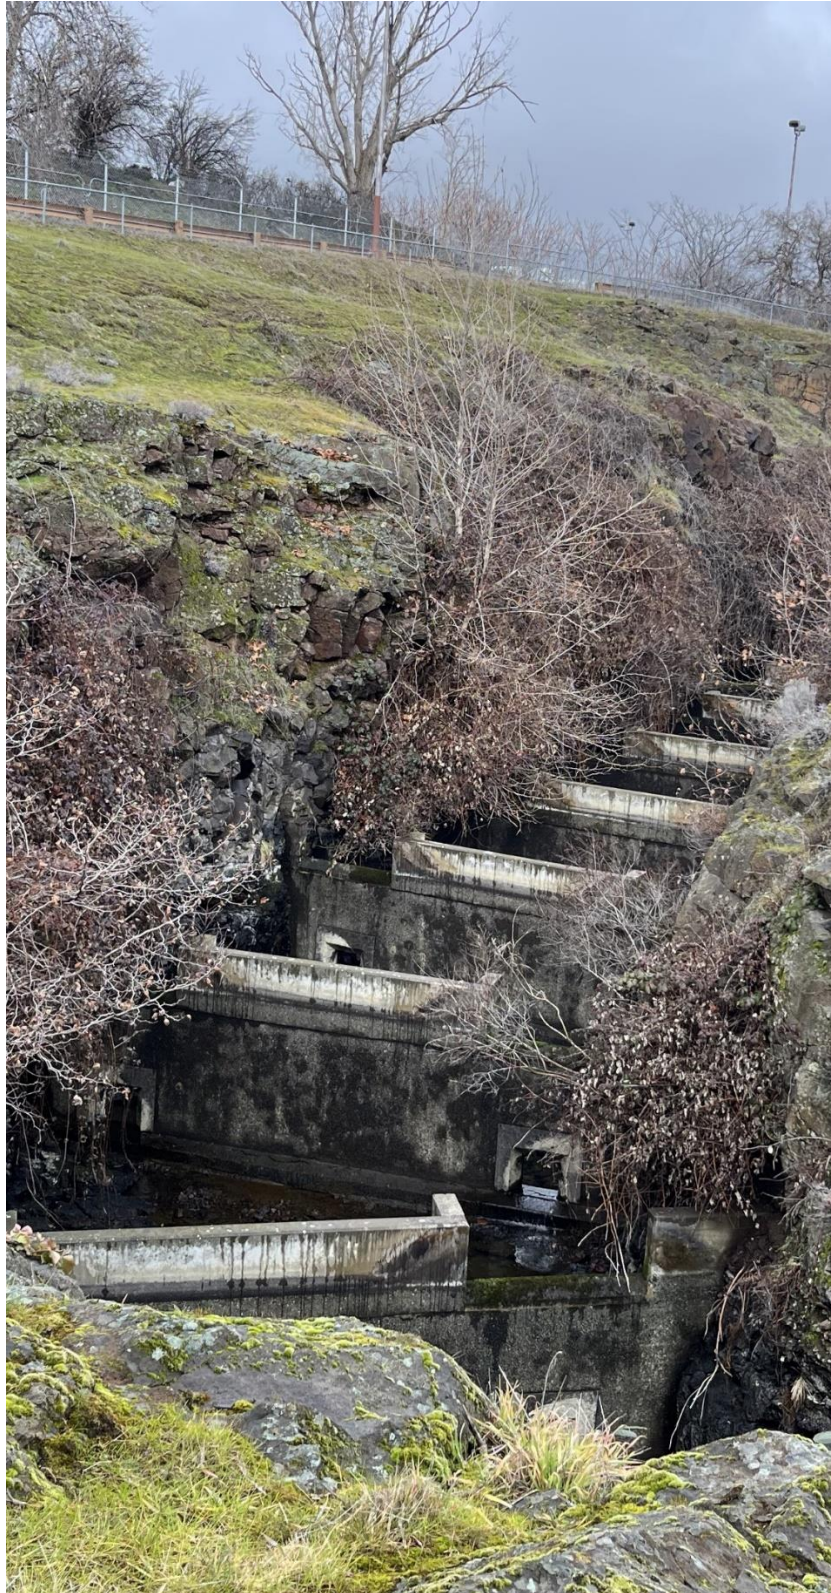
Photo 2 shows the south-facing exposed rock slope, which contains several areas of potential rockfall hazard. Photos 6 through 8 show the rockfall observed today and overhanging rock mass above the rockfall pocket. The pile of rock below the rockfall pocket is estimated to be on the order of 2 cubic yards and includes rock sizes ranging from about 6 inches to 3 feet in diameter, which are blocking a weir opening. Each weir opening has dimensions of about 2 ft by 2 ft. The largest rock pieces that are piled from the rockfall in this location are estimated to weigh between 1,500 and 2,500 lbs. The height of the piled rock pieces from the rockfall is about 6 to 8 feet. Photo 8 also shows significant vegetation (primarily a tree about 4-in. in diameter with a root system penetrating the rock wall) along the slope in the location of the rockfall.

Photo 2: Looking north from west bend of north fish ladder, looking at weirs 113 through 118 (from closest to farthest)

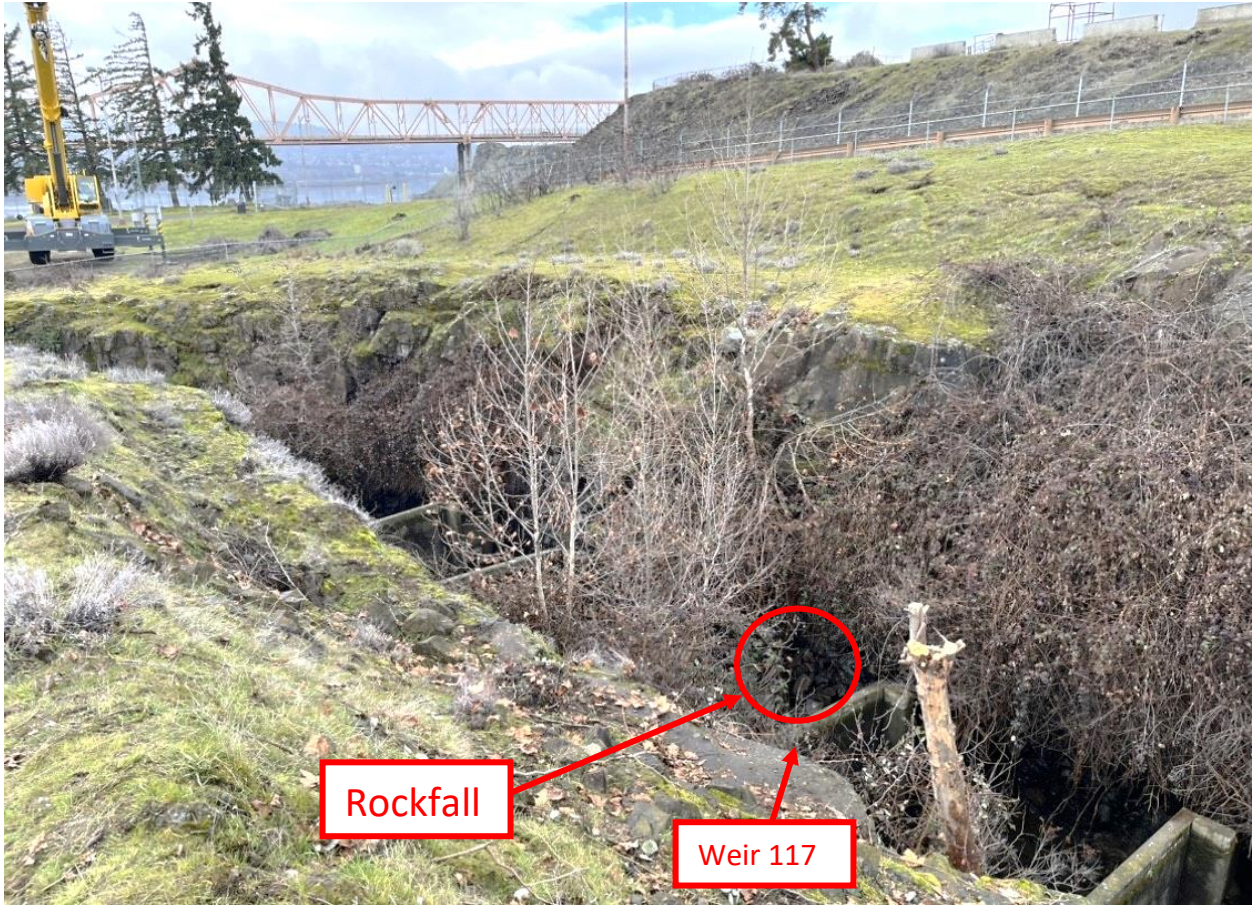
Photo 3: Looking west from top of rock cut (looking toward south-facing wall) at north fish ladder, looking toward weirs 114 through 118 (from left to right, weir 116 is not visible in this photo).

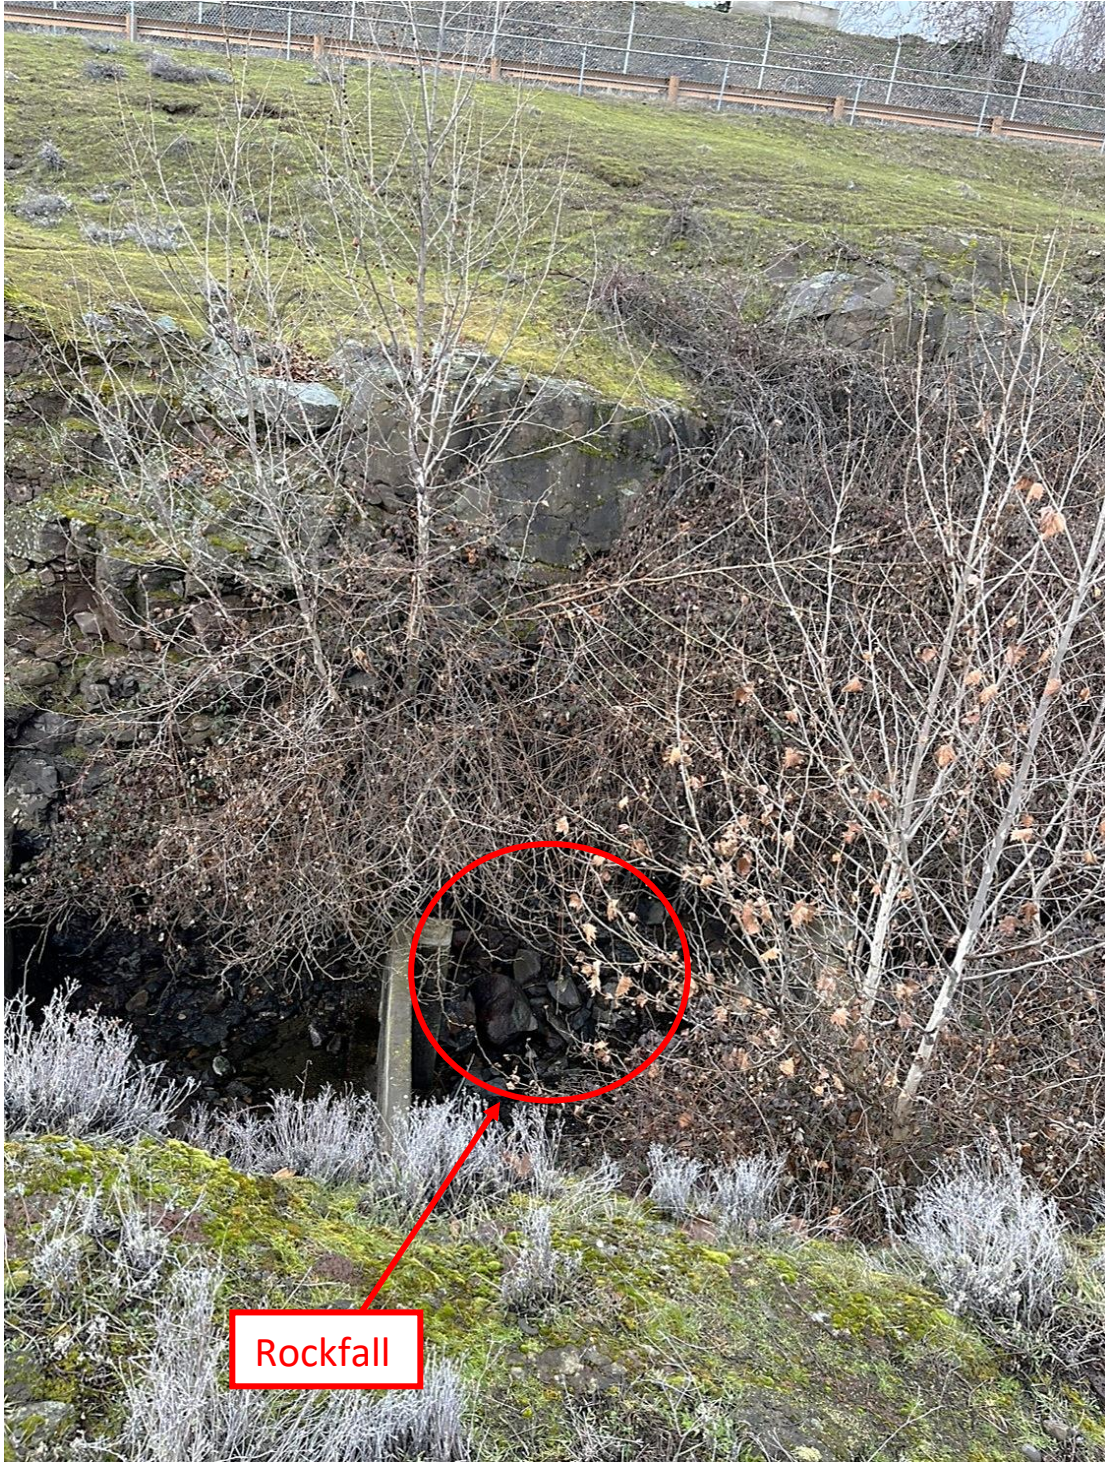
Photo 4: North half of north fish ladder, looking north and down into fish ladder at Weir 116 and adjacent rockfall

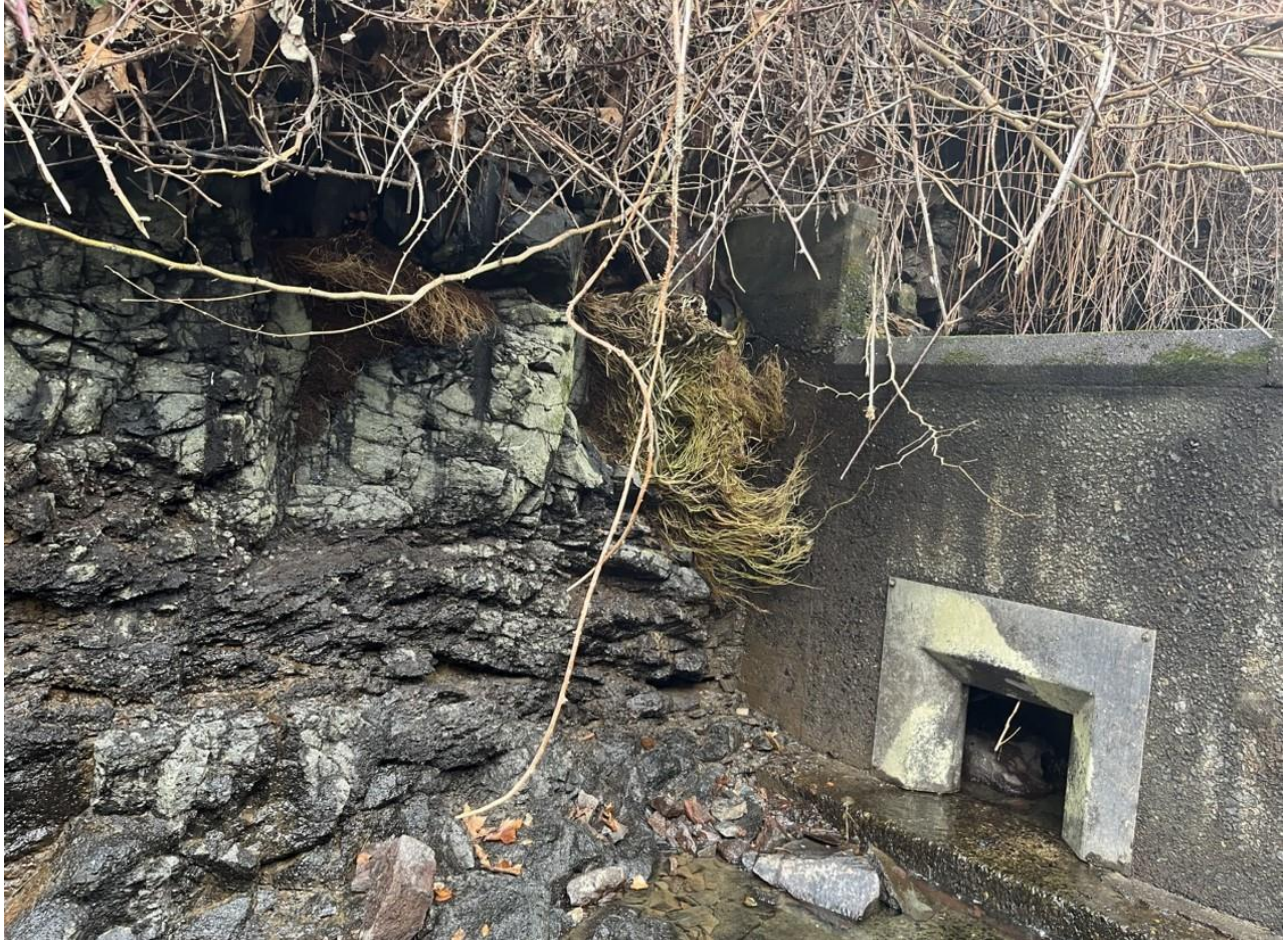
Photo 5: Interior of north fish ladder, looking at north end and west side of Weir 116, south-facing wall. Weir opening shown is opposite side of rockfall blockage. Rockfall boulder visible through opening.

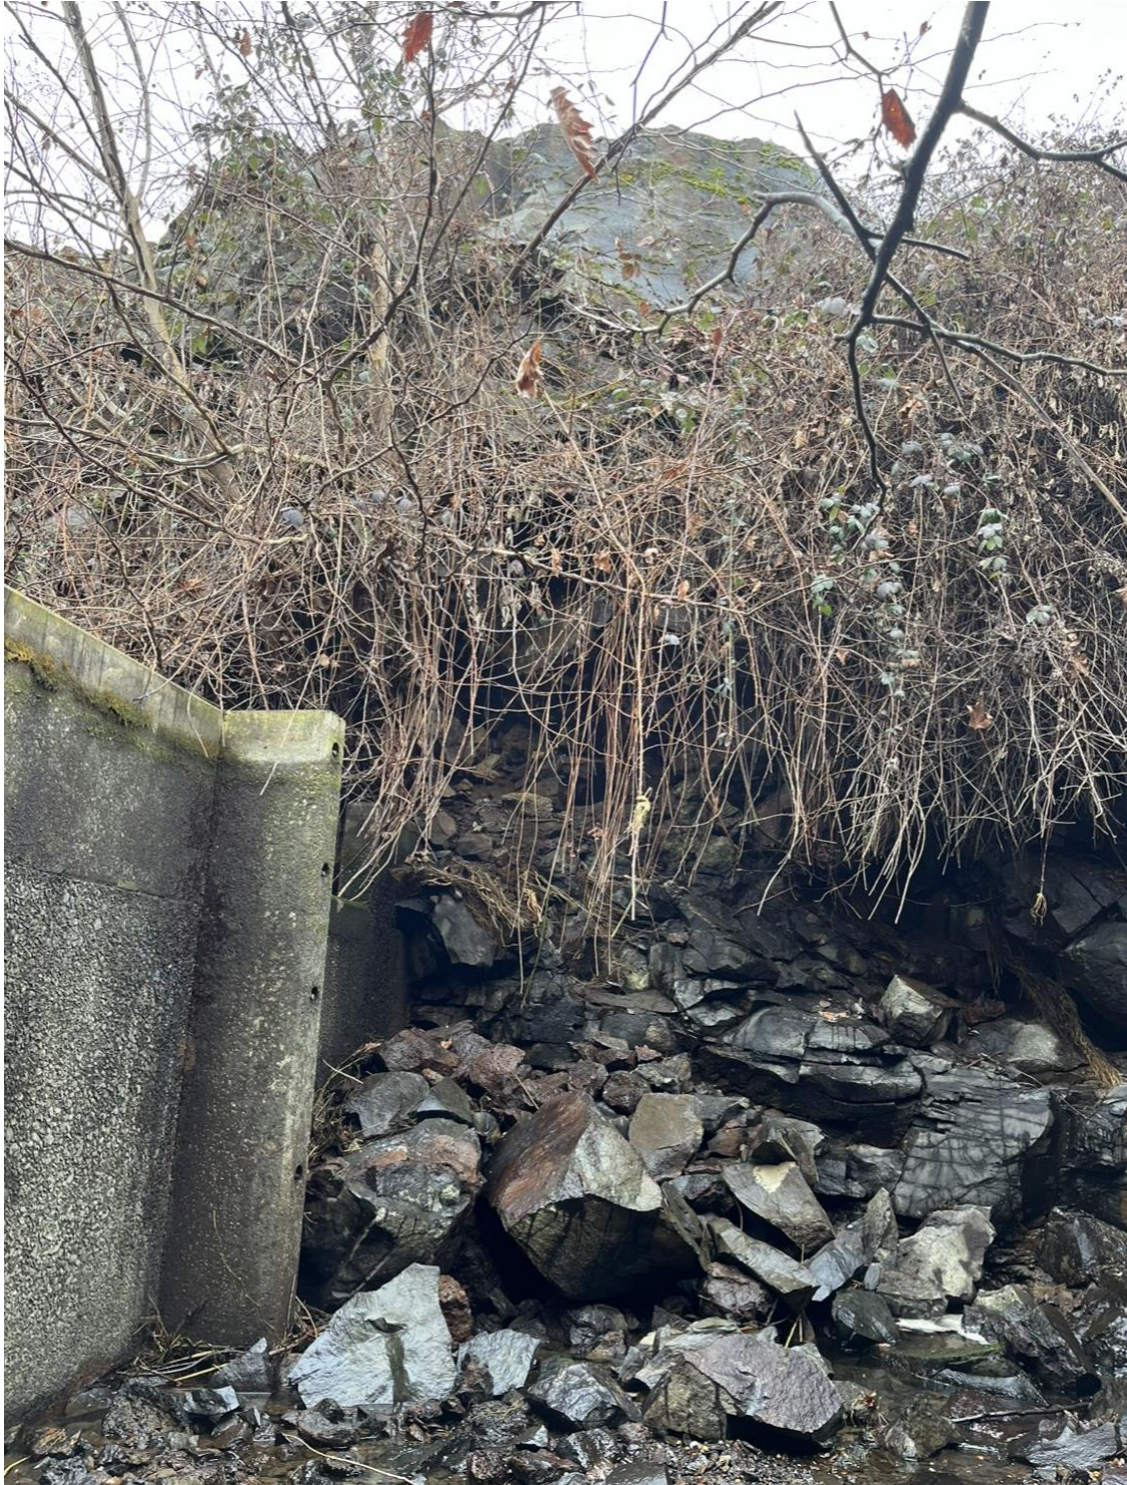
The large overhanging rock mass immediately overlying the rockfall pocket and tree at Weir 116 is generally heavily vegetated, and thus could not be thoroughly evaluated today, but the slope surface immediately west of this vegetation (approximately between Weirs 115 and 116) appears to consist of several highly fractured/jointed surficial rocks up to 2 feet in diameter. In the area of the rockfall observed today, as well as several other areas noted in the north fish ladder as part of the 2015 DDR, rockfall is a significant risk to the safety of personnel in the in the fish ladder and is a potential impact to fish passage.

Due to the size of the rocks blocking the weir opening (estimated to weigh up to 1,500 to 2,500 lbs each), removal of these rocks by hand may be extremely difficult or impossible. Additionally, due to the height of the rock pile, removal of the large rocks blocking the weir opening may cause further sloughing of rocks and pose as a significant safety risk to personnel, or cause further blockage to the weir opening.

Photo 6: Rockfall adjacent (east side and north end, south-facing wall) to Weir 116. Larger rock pieces blocking weir opening (opening is not visible due to blockage). Heavy vegetation and overhanging rock mass shown at top of photo.

Considering the ongoing rockfall hazard and potential for further sloughing, the Portland District does not recommend the rocks blocking the weir opening be removed by hand. The Portland District also recommends that no personnel enter the fish ladder, especially in areas containing higher risk of rockfall, without adequate slope support or rockfall protection measures until remedial action occurs. The north fish ladder should be further evaluated for weathering and rockfall hazard that has progressed since the 2015 DDR. The 2015 DDR recommendations should be reevaluated for the current condition of rockfall hazards, especially for areas where only scaling and vegetation removal were recommended, as scaling alone can cause further undermining in a raveling slope. Mitigation applicable from the 2015 DDR, as well as any additional or alternative mitigation recommended upon further evaluation of current conditions, should be completed for the north fish ladder to reduce safety hazards to personnel and to reduce potential impacts to fish passage. Figures from the 2015 DDR and photos from today's observations are provided below.

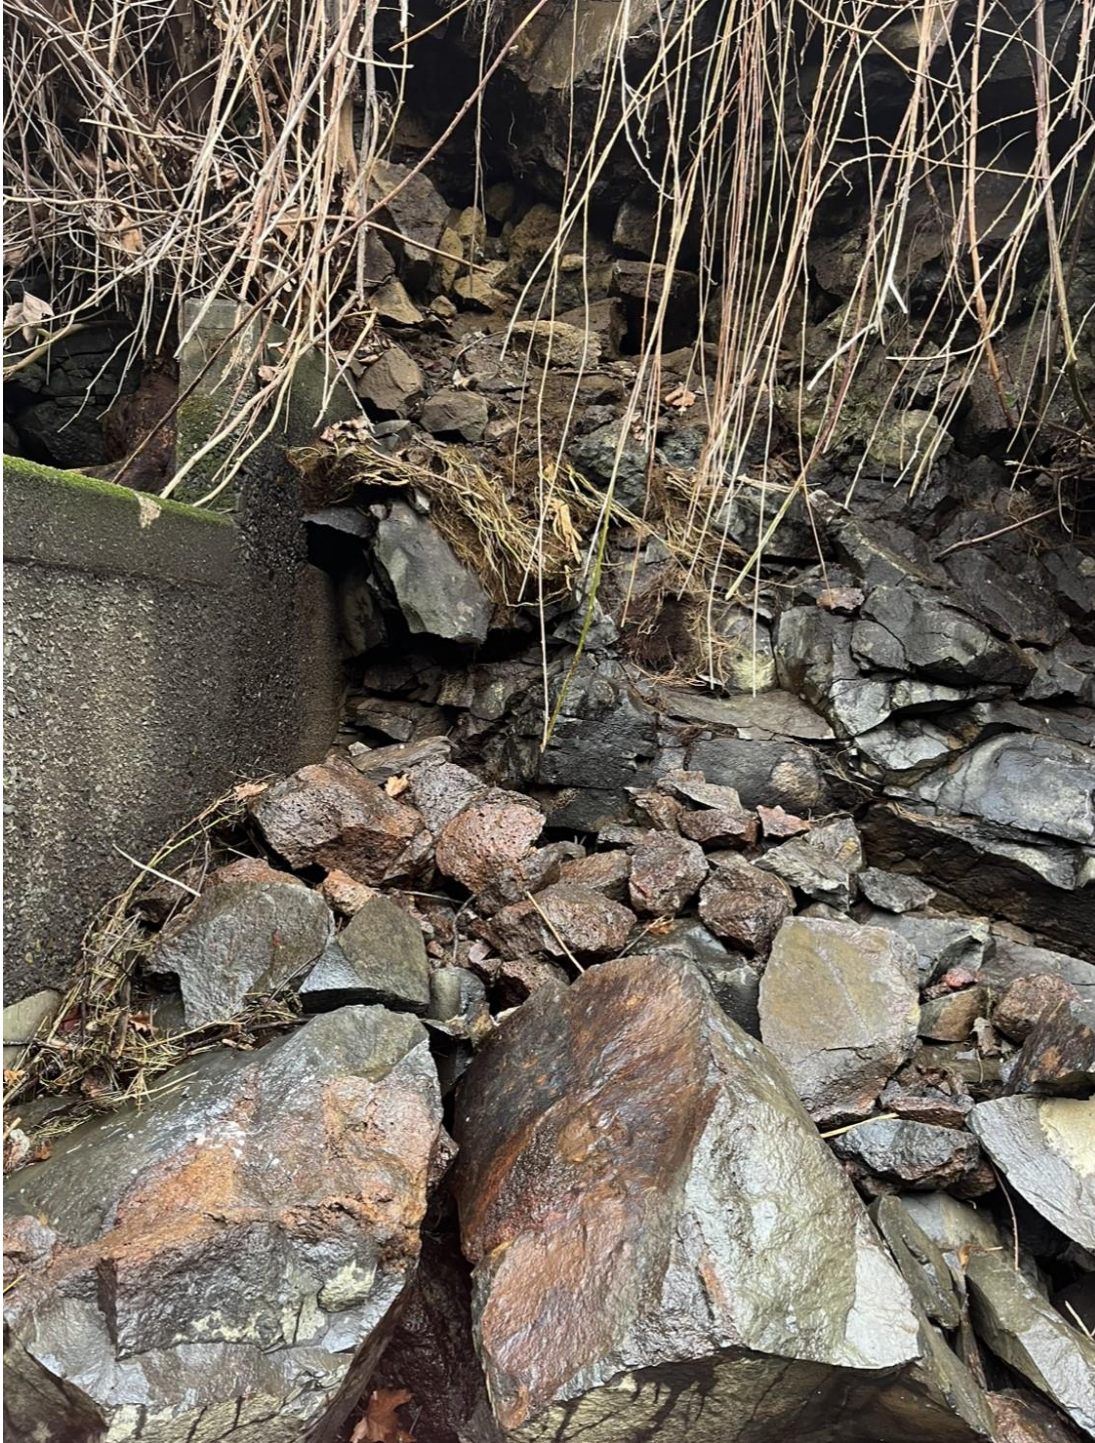
Photo 7: Close-up view of rockfall pile, north fish ladder, south-facing wall, east side/north end of Weir 116.

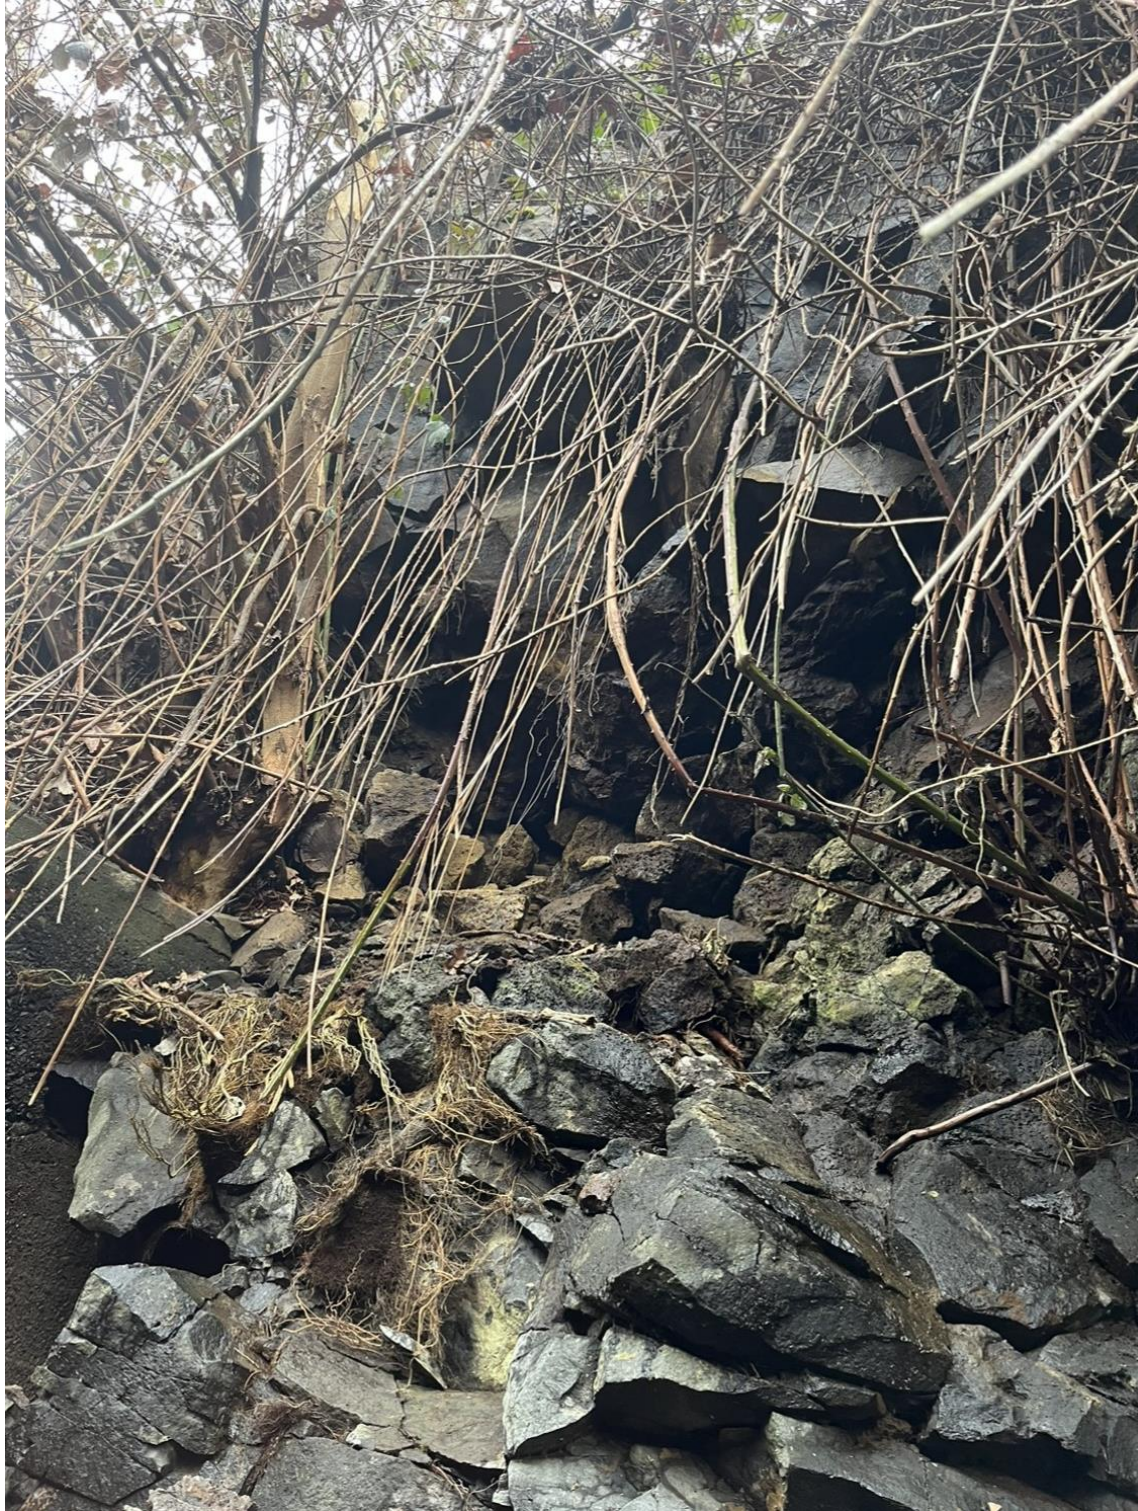
Based on the PDT's observations of the rock slope and rockfall near Weir 116, the recent rockfall was likely caused by the original fracture pattern in the slope and the rapid weathering within the joints from the tree/vegetation roots slowly expanding the joints, allowing moisture to penetrate the rock and accelerate the weathering process. The presence of vegetation on the rock slope will continue to worsen the condition of the rock surface and accelerate weathering. In areas that are not currently vegetated, heavily jointed rock blocks/pieces are also likely to become more loose over time due to the weathering process of the rock structure in these areas.

Photo 8: Close-up of pocket left from rockfall, overhanging rock mass, and tree root system near top and north end of Weir 116, north fish ladder.
