Bonneville Spillway and Rocks

Laurie Ebner
05 December 2018

Bonneville Spillway

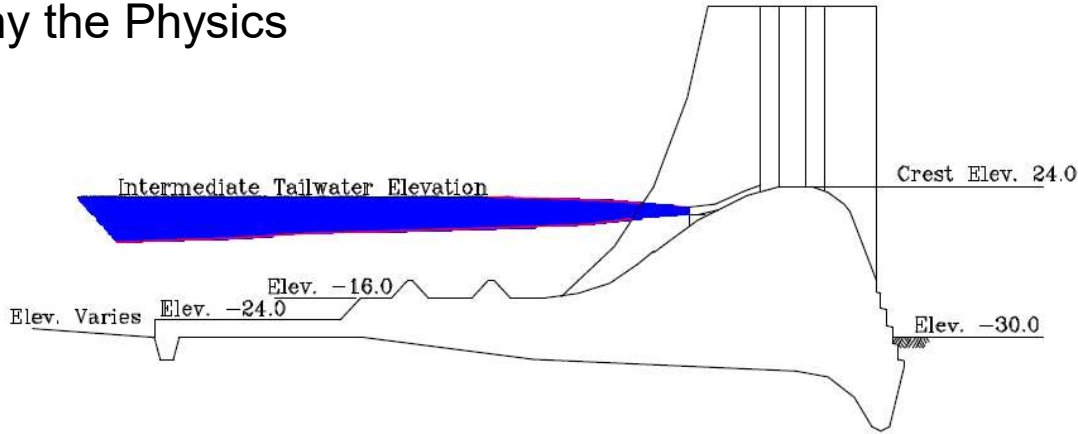
Figure 4. Cross-section of Skimming Flow

Flow Deflectors Cause Flow to Move Upstream

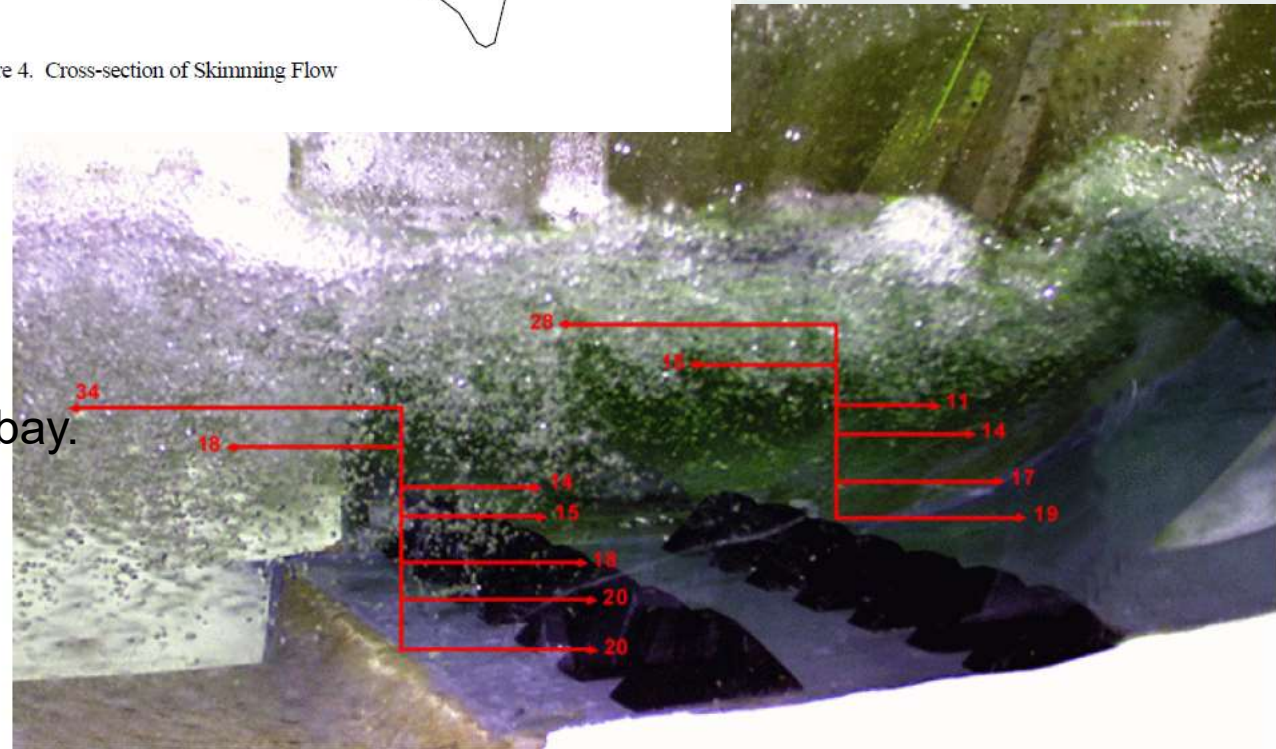
Figure 15. Skimming Surface Jet, Modified Bonneville Deflector, 6,700 cfs/bay, 1-1/2 bays, TW el -21.0, HW - 74.0

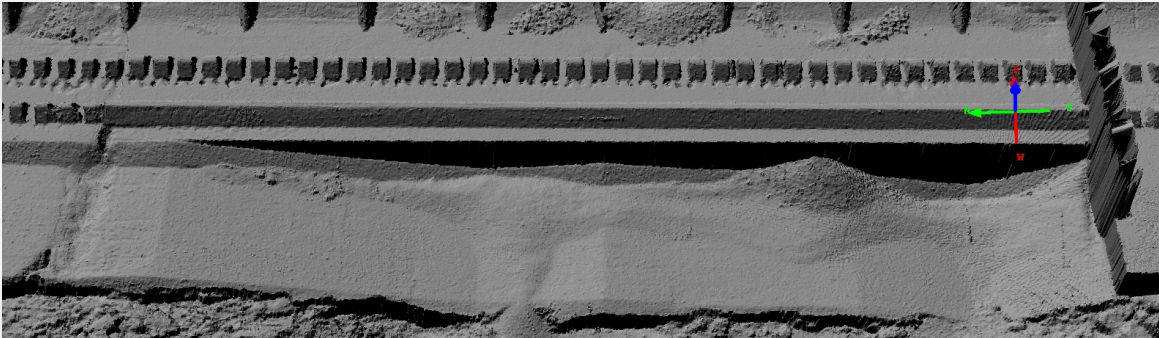
Flushing Spill

Before

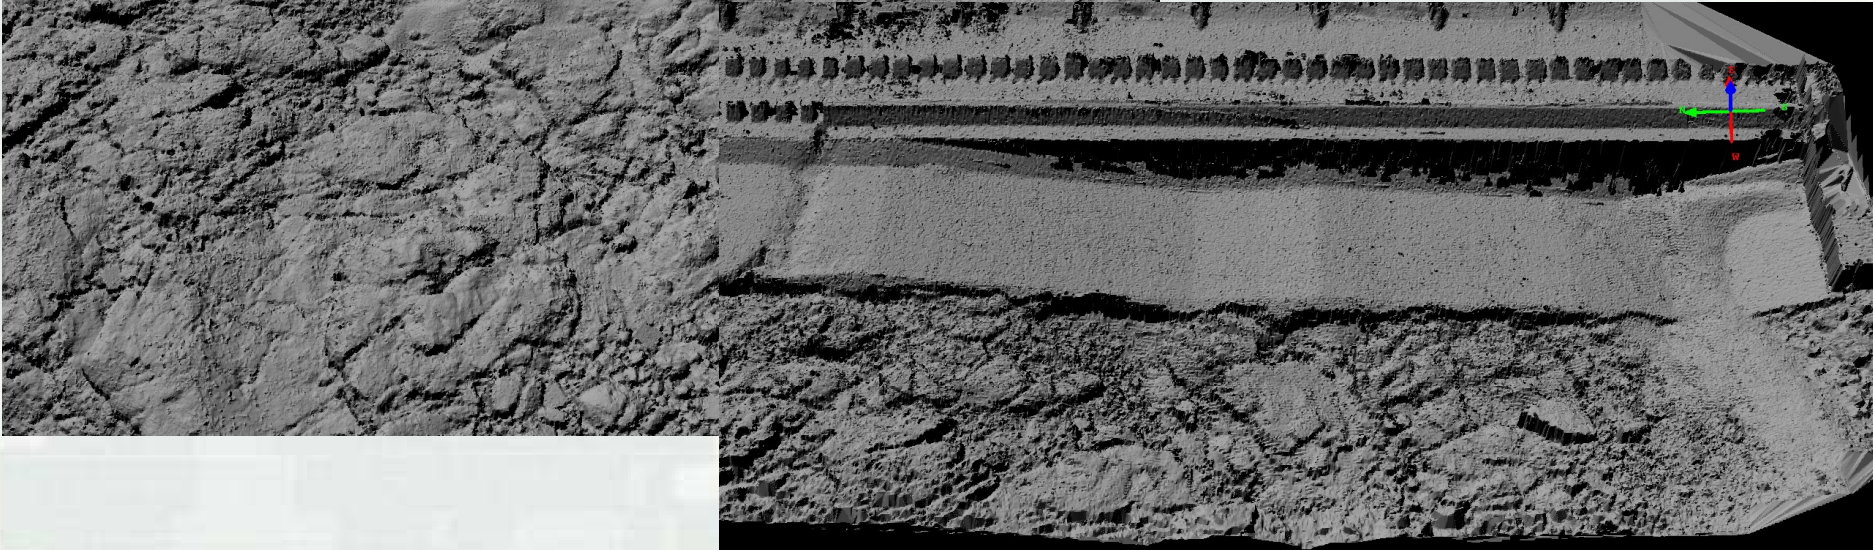
After

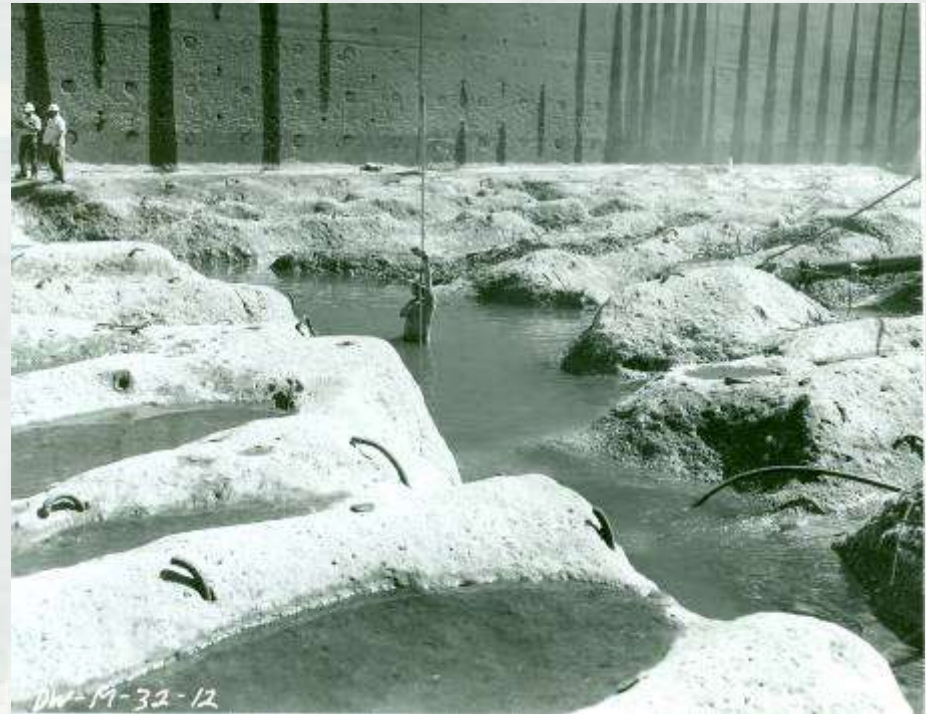
Stilling Basin Erosion

- Dworkshak Dam – picture taken in 1974

- ▶ Ball milling occurs when foreign debris enters a stilling basin and continually “churns up” the concrete as it sees flow
- ▶ Major problem at many dams although not likely to cause a failure unless damage remains unchecked
- ▶ Importance of routine inspections

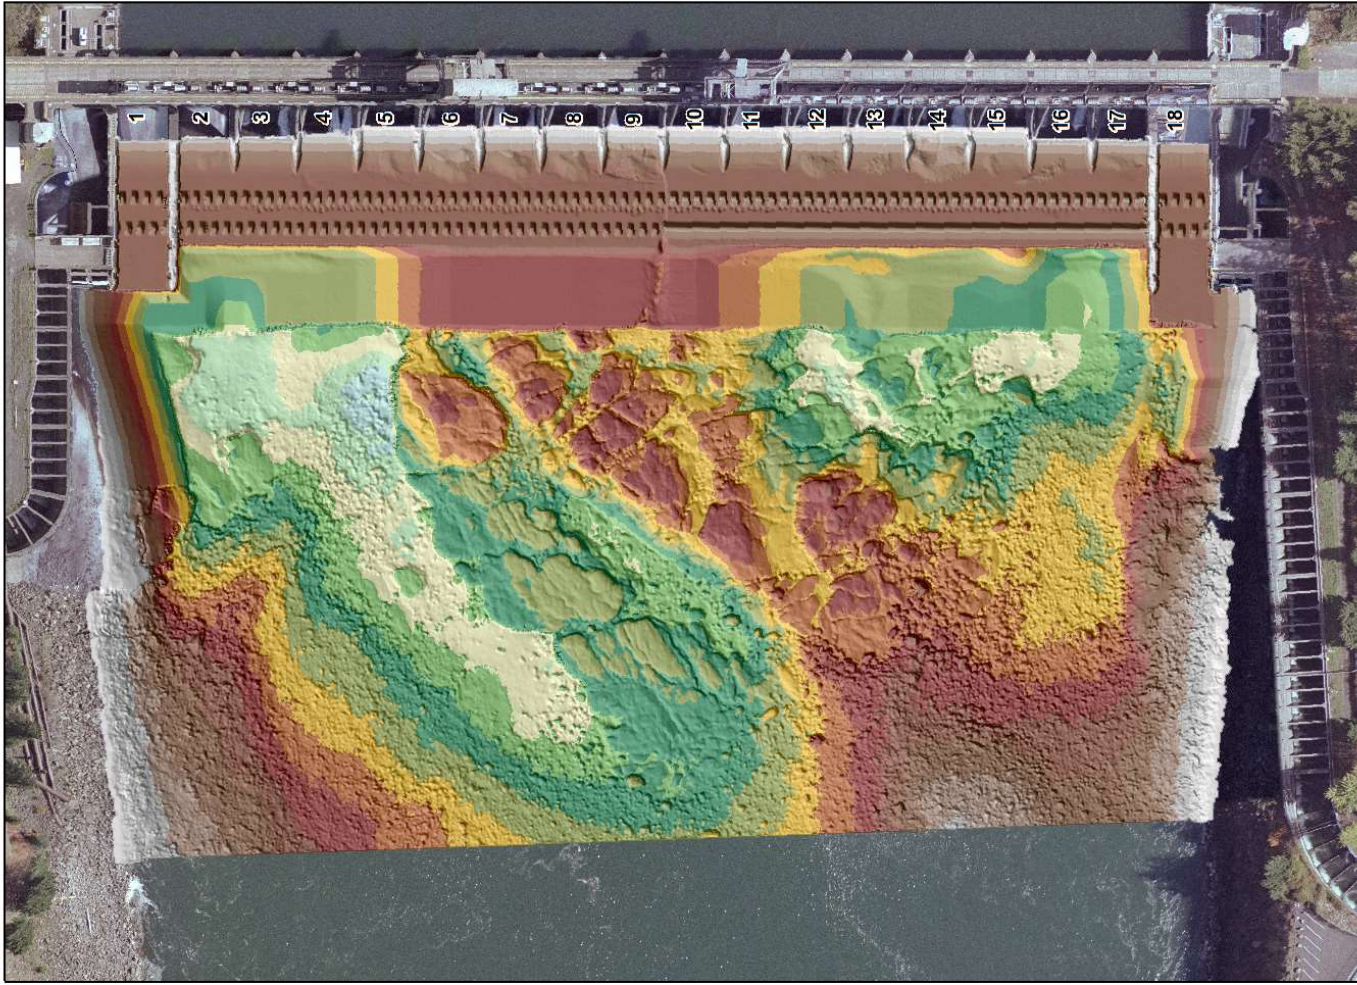
Bonneville Dam Spillway Stilling Basin

Elevation
(Feet, NGVD29)

Survey results suggest about 3000 cubic yards of loose material on either side that could continue to move upstream (we have removed approximately 1000 cubic yards so far)
