# **Evaluation of an Electric Barrier as a Seal Deterrent on the Puntledge River**

Pacific Salmon Commission  
Southern Boundary Restoration & Enhancement Fund Committee  
600 – 1155 Robson Street  
Vancouver, B.C., Canada  
V6E 1B5

December 2008

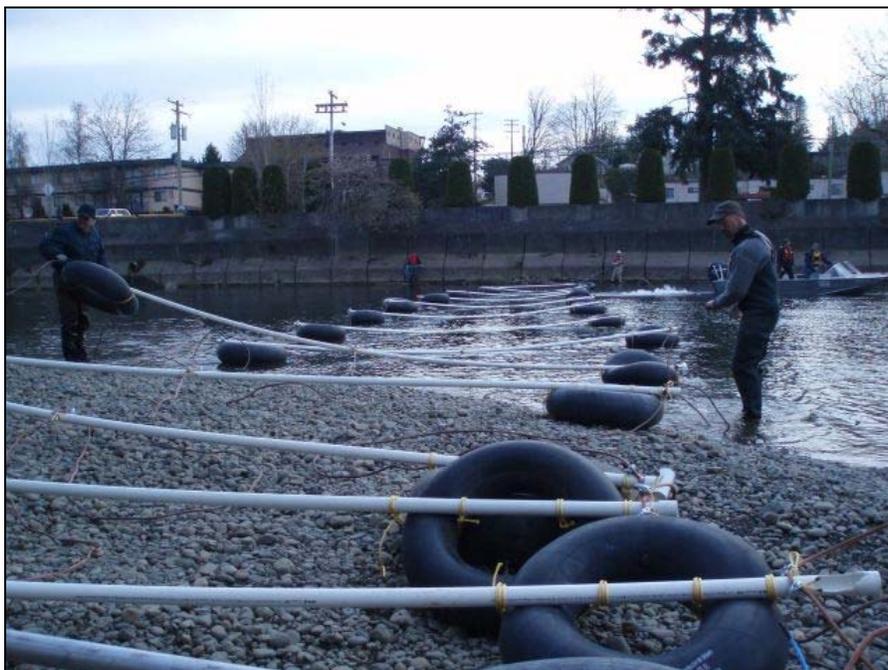
**Photo 1.** Assembling and installing the 3-cable array, April 2008. Photo looking from east to west shore (river left to river right) at low tide.

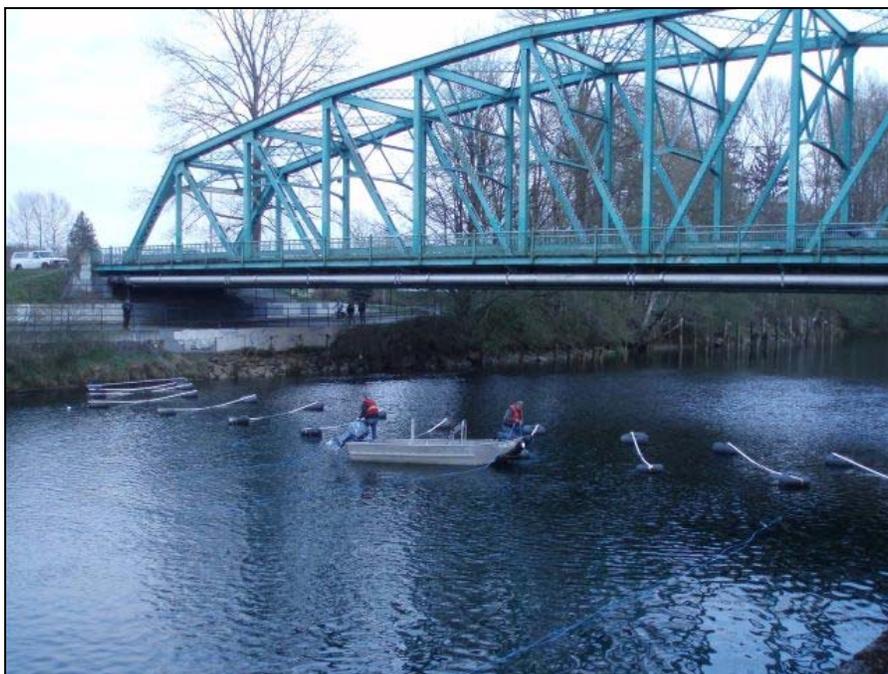
**Photo 2.** Placement of the 3-cable array upstream of the 5<sup>th</sup> Street bridge prior to anchoring, April 2008. Photo looking downstream from west to east shore (river right to river left).

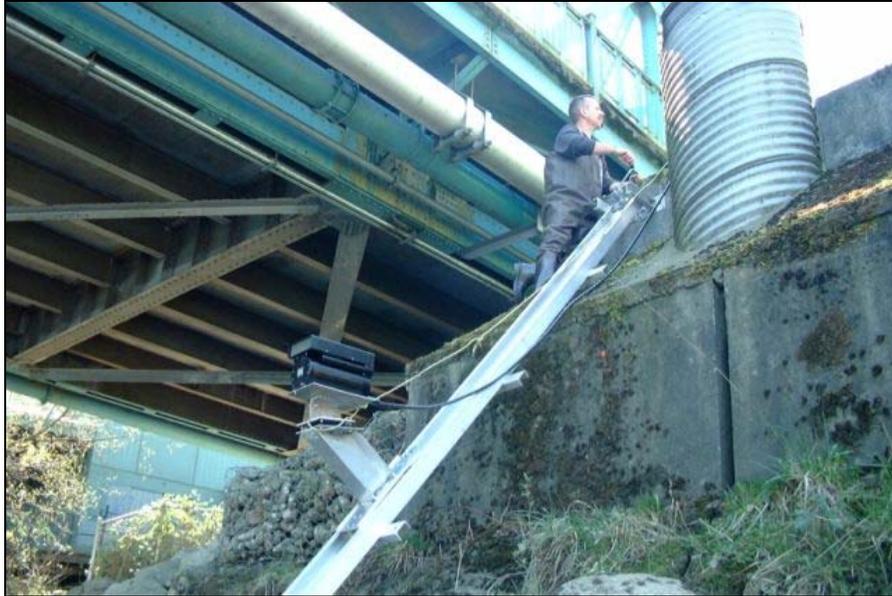
**Photo 3.** Placement of one of two DIDSON sonars and ramp upstream of the 5<sup>th</sup> Street bridge

Two DIDSON (Dual-frequency IDentification SONar) acoustic cameras, a Short-range (30 m) and a Long-range (80 m), were used to record behaviour of seals and fish in the area of the active electrical array. Two ramps were constructed on the west shoreline to guide and position the DIDSON acoustic cameras in the water (Appendix C - Photo 3). This additionally allowed easy installation and removal, as the DIDSONs could not be left permanently in position due to security concerns. One was located downstream of the lower array and the other was located upstream of the upper array (Appendix A). The positioning of these ramps was not changed throughout the testing. The Long-range DIDSON initially was placed at the downstream ramp with the Short-range DIDSON at the upstream ramp, however the downstream ramp was located in water too shallow to allow continual operation of the DIDSON throughout the tidal cycle. As the Long-range DIDSON provided the best coverage of the interactions between seals and the electric array, it was moved to the upstream ramp after a few days. DIDSON imagery was collected during each evening the electric array was operated with the exception of the initial trial period of the 3-cable array.

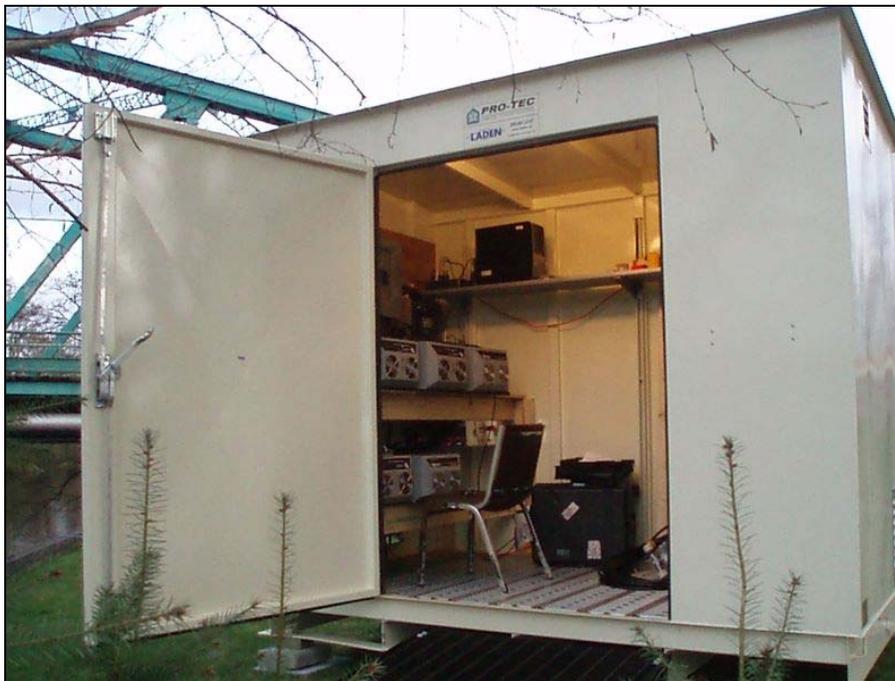
**Photo 4.** Secure metal building temporarily installed on the west side of the river to house all electronic and computer components necessary for the project.

DFO provided a secure metal building on the west side of the river to house all electronic and computer components necessary for the project (Appendix C - Photo 4). This included Smith-Root BP-1.5 Programmable Output Waveform (POW) pulsators, computer components needed to produce and control electrical output to the arrays, and computers to record DIDSON images. The 1.5 POW barrier pulsators were powered by 220V, 30 Amp circuit obtained from a neighbouring apartment building. Heavy gauge wires encased in conduit transmitted power to the array cables at the water’s edge. The arrays laid flat on the river bottom and, when energized at a frequency of 2.25 Hz, filled the volume of water directly over the cables with an electric field of no more than 0.32 V/cm at the surface (Appendix B). The electric field bowed out 2-3 meters above and below the array, but quickly decreased to undetectable levels several meters upstream and downstream of the array. Field strength measurements were taken for all three arrays using the Smith-Root, Inc. EFP-2 Electric Field Probe. This consisted of taking voltage gradient measurements at the water surface from a boat. These measurements were used to assess whether the array was functioning properly and within operational parameters. Water conductivity varied from 28 – 37 microSiemens/cm between April 27<sup>th</sup> and May 1<sup>st</sup>, 2008. Conductivity measurements taken at high tide underneath the 5th St. bridge on the river bottom on June 4, verified the lack of saltwater intrusion.

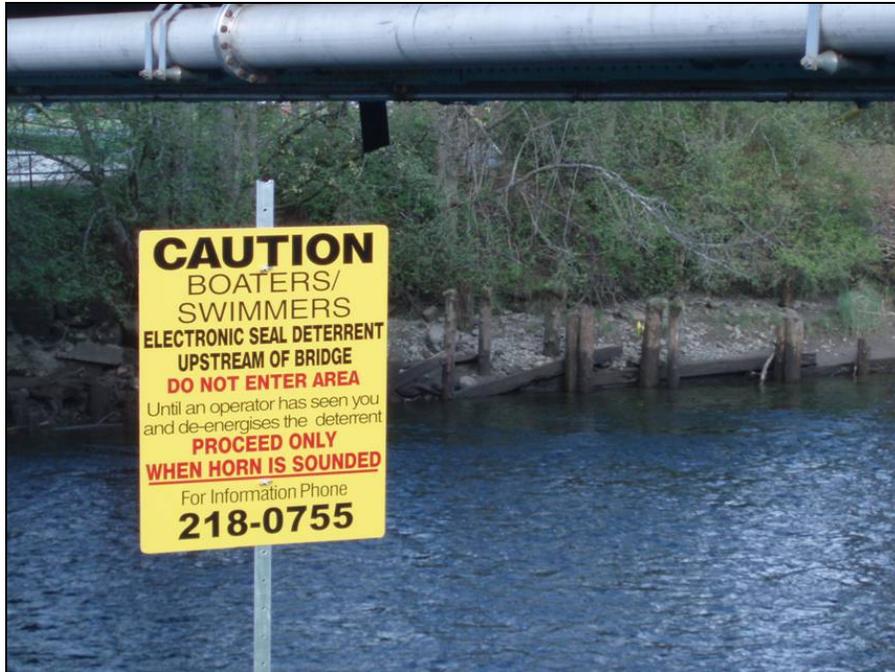
**Photo 5.** Example of signage posted upstream, downstream and within the testing area of the electric deterrent in the Courtenay River from April – June 2008.
