Report No.: 2022 Willamette RST Bi-Weekly Report 07/01 to 07/15 by EAS

**Re: WILLAMETTE VALLEY FISH PASSAGE MONITORING VIA ROTARY SCREW TRAPS**

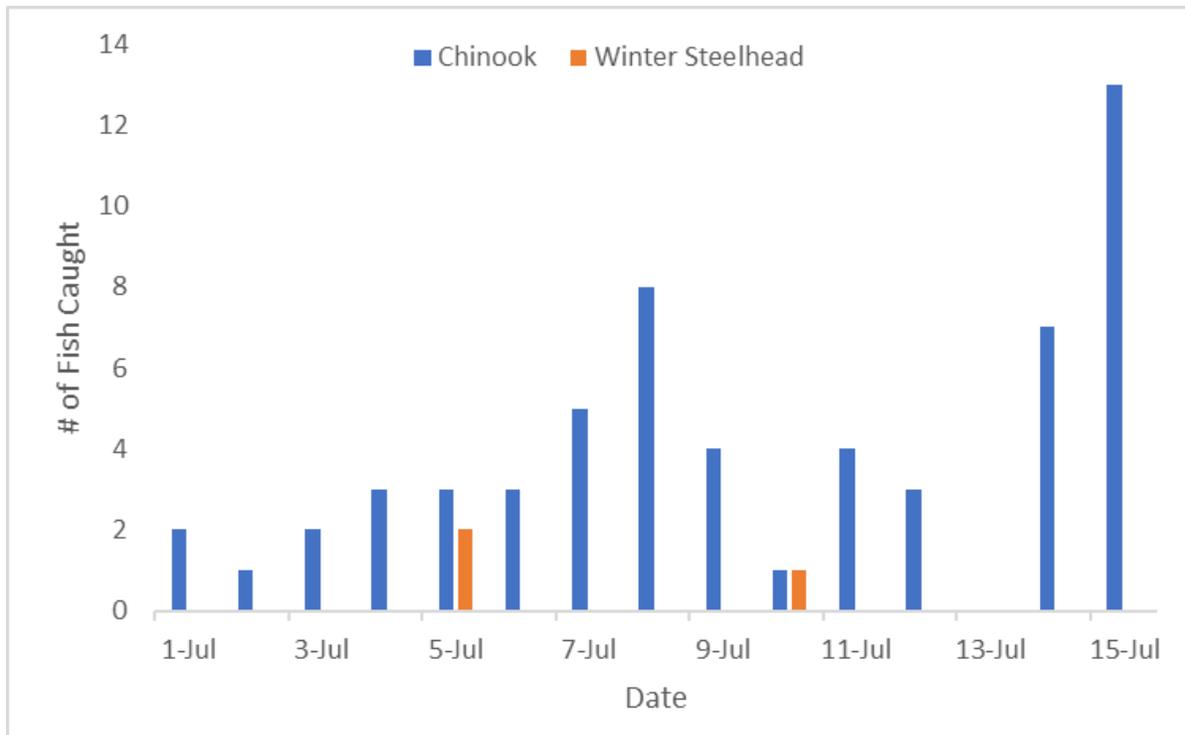
**Figure 7. Chinook and Winter Steelhead Captured per day 07/01/2022 to 07/15/2022 (Big Cliff)**

This reporting period began on July 1 and ended on July 15. There were a total of 59 Chinook salmon (CHS) and 3 Winter Steelhead (STW) captured during the 15-day sampling period (Figure 7). Sampling duration was 100% for the RST. Table 4 provides life stage, length, and weight data for all Chinook salmon and Winter Steelhead that have been caught at the Big Cliff Dam site to-date and for the reporting period. Figure 8 shows length frequency data to-date.

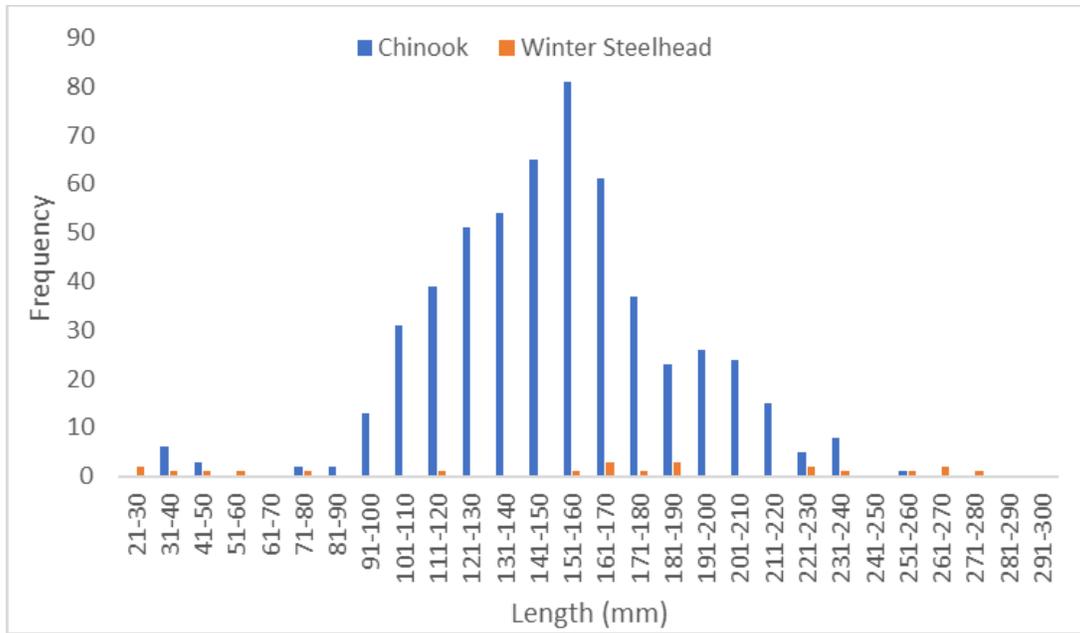
**Figure 8. Length Frequency of Juvenile Chinook and Winter Steelhead Sampled Season To-Date (Big Cliff)**

\*Figure does not include fish without heads (10)

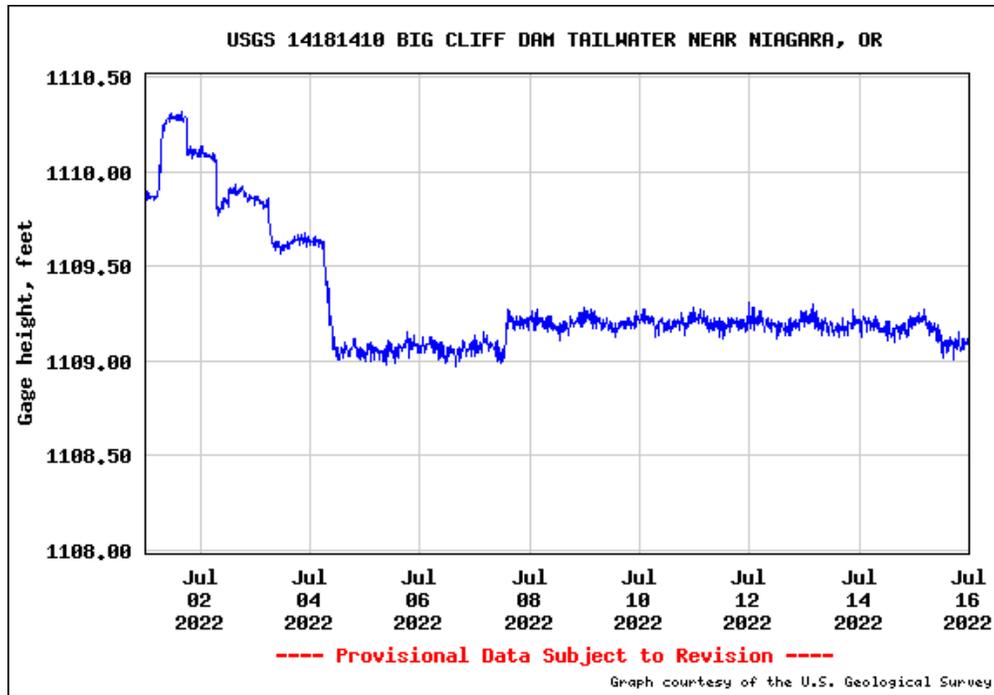
**Figure 9. Gage height (ft); below Big Cliff Dam**

Basic stream statistics at the Big Cliff Dam site were calculated from data downloaded from U.S. Geological Survey stream gage numbers 14181410 and 14181500. Gage height (feet) is the only metric provided at gage 14181410. Total dissolved gas (TDG) saturation data was received from gage 14181500, 1 rkm downstream of the trap. During the reporting period, daily maximum values for instantaneous gage height ranged from 1,109.1 feet to 1,110.3 feet (mean: 1,109.5 feet). Figure 9 shows instantaneous gage height.

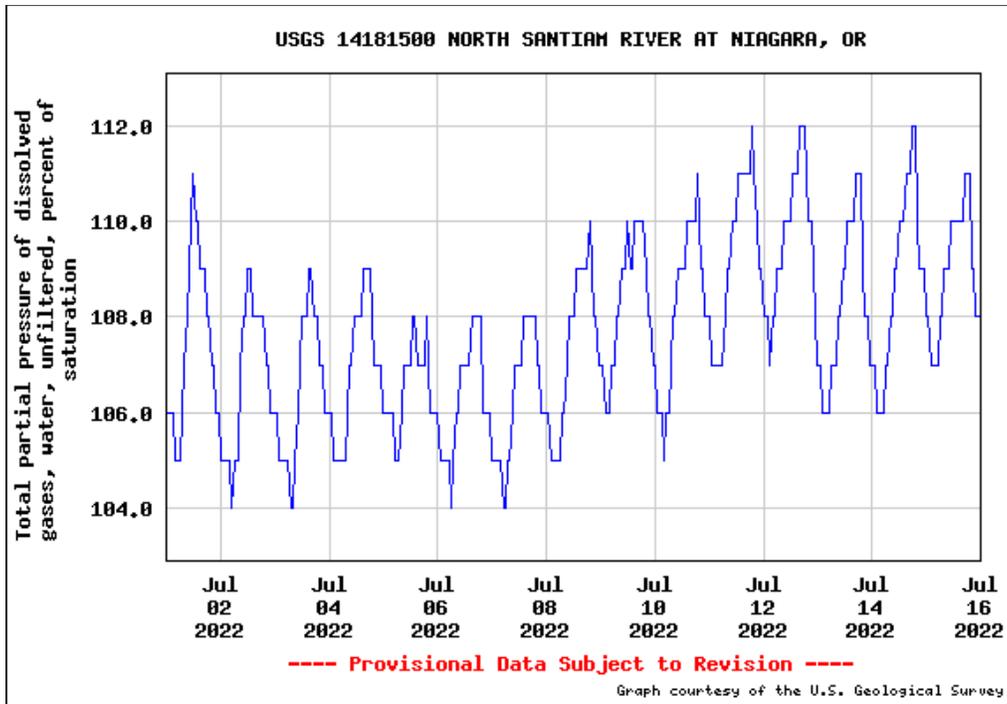
**Figure 10. Total Dissolved Gas Saturation (%); below Big Cliff Dam**

Total dissolved gas saturation ranged from 104 to 112% during the reporting period (mean: 107.7%). Figure 10 shows total dissolved gas saturation.

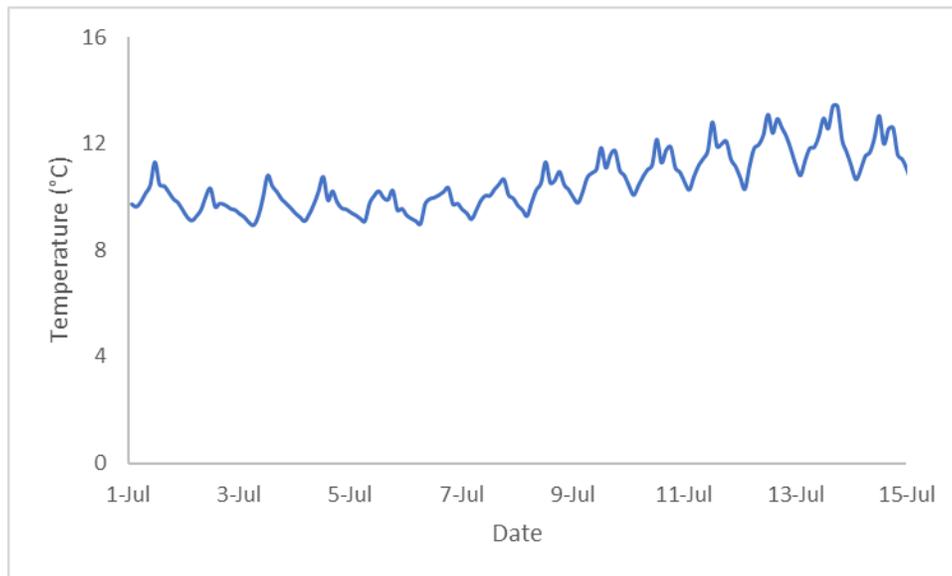
**Figure 11. Temperature at RST (Big Cliff Dam)**

Stream temperatures were recorded every 2 hours for the length of the report period at the RST (Figure 11). Temperature probes operated normally throughout this reporting period.

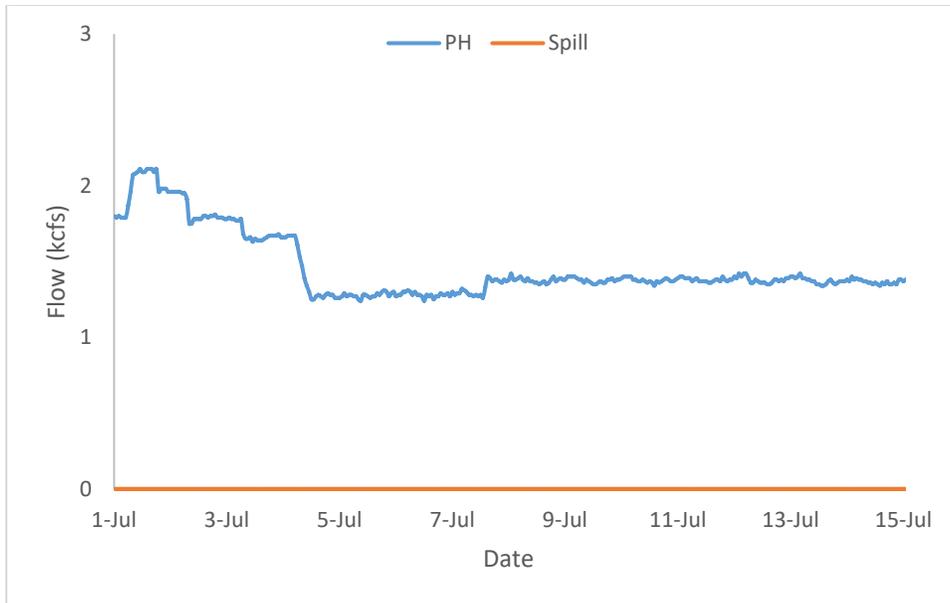
**Figure 12. Hourly Flows PWR vs. RO (Big Cliff Dam)**

Flows through the Powerhouse and Spill during the reporting period averaged 1,451 and 0 cubic feet per second (cfs), respectively (Figure 12). Catch per unit of effort (CPUE) data are summarized in Table 7.

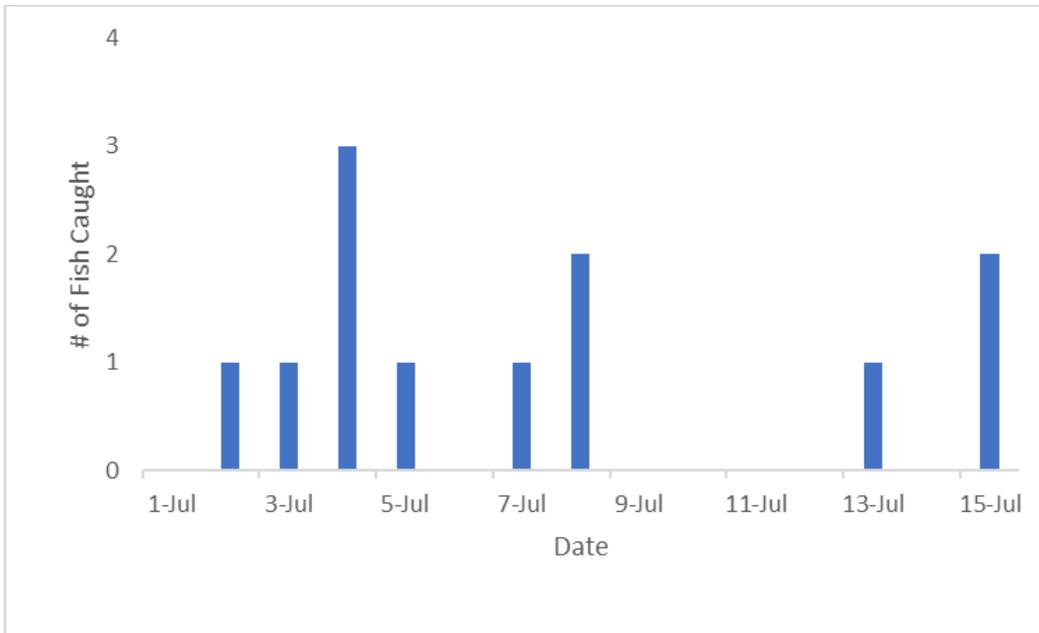
**Figure 13. Chinook Captured Per Day 07/01/2022 to 07/15/2022 (Cougar Dam)**

This reporting period began on July 1 and ended on July 15. There was a total of 12 Chinook Salmon (CHS) captured during the 15-day sampling period (Figure 13). Sampling duration was 100% for both Powerhouse RST and RO RSTs. Table 16 provides life stage, length, and weight data for all Chinook salmon that have been caught at the Cougar Dam site to-date and for the reporting period. Figure 14 shows the daily capture numbers for chinook and Figure 28 shows length frequency data to-date.

\*Recaptured fish for trapping efficiency trials not included.

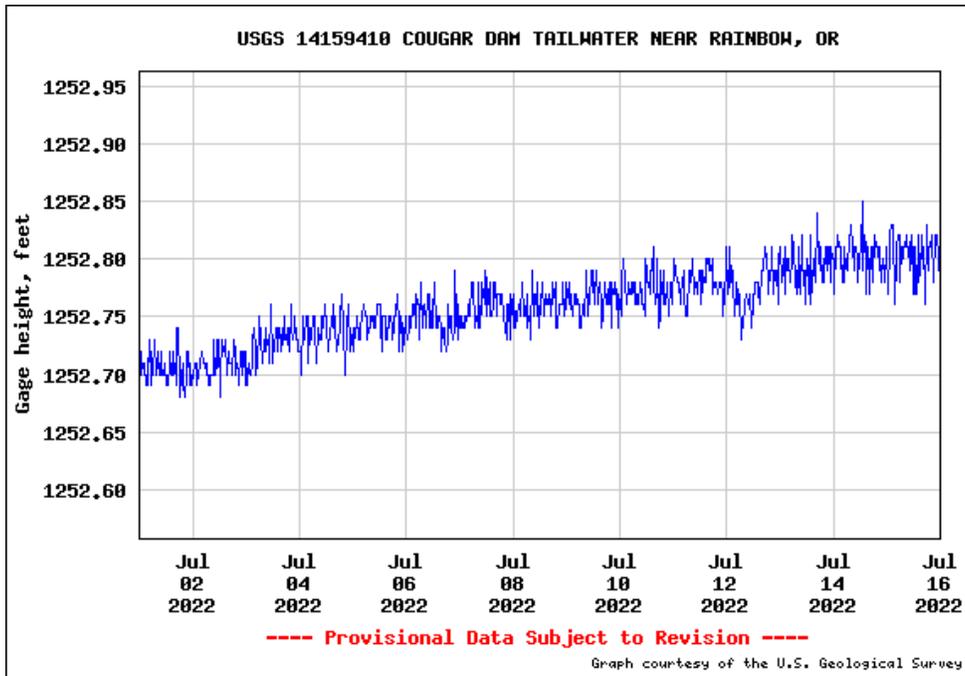
**Figure 15. Gage Height (feet); below Cougar Dam, South Fork McKenzie River**

gage height ranged from 1,252.7 feet to 1,252.9 feet (mean: 1,252.8 feet). Figure 15 shows instantaneous gage height.

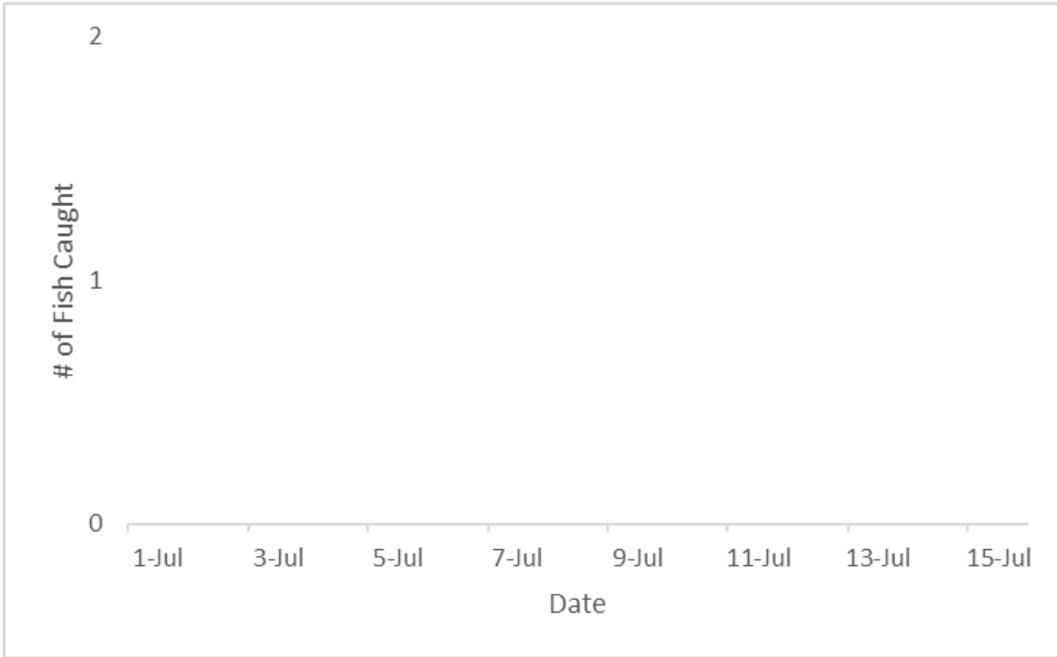
**Figure 20. Chinook Captured Per Day 07/01/2022 to 07/15/2022 (Fall Creek Dam Tailrace)**

The reporting period began July 1 and ended July 15. No Chinook salmon were captured during the 15-day sampling period (Figure 20). The trap was operated 100% of the reporting period. Table 24 provides life stage, length, and weight data for all Chinook salmon that have been caught at the Fall Creek Dam Tailrace site to-date and Figure 21 shows length frequency data to-date.

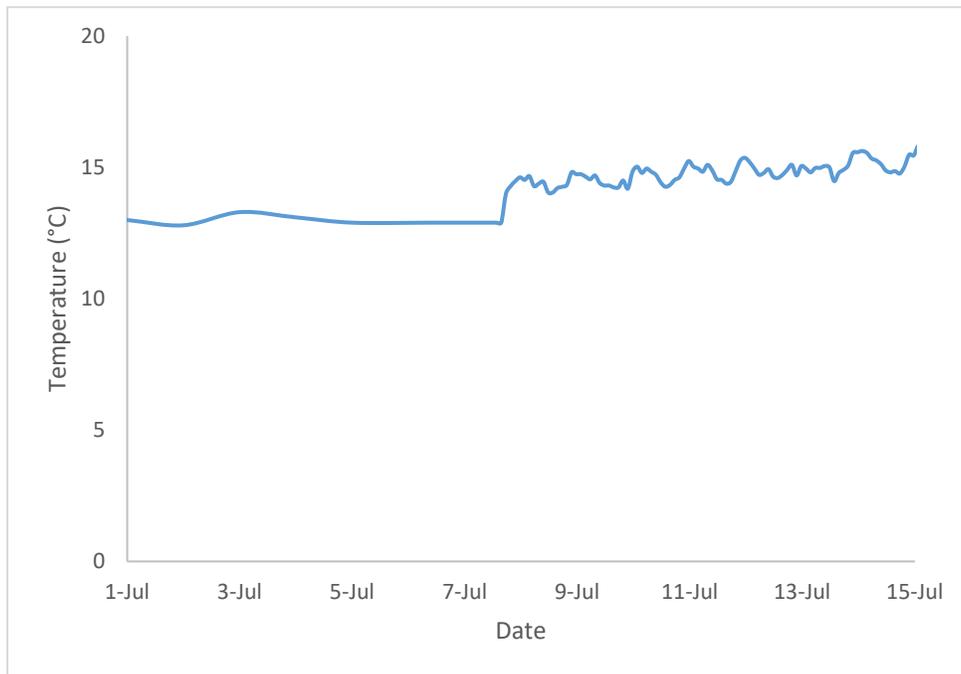
**Figure 24. Temperature at RST (Fall Creek Dam Tailrace)**

Note: Hobo logger was ripped off trap prior to the reporting period. Temperature began recording with a new logger on July 7th, 2022. Data supplemented with daily trap check temperatures from July 1<sup>st</sup>, 2022 to time of logger deployment.

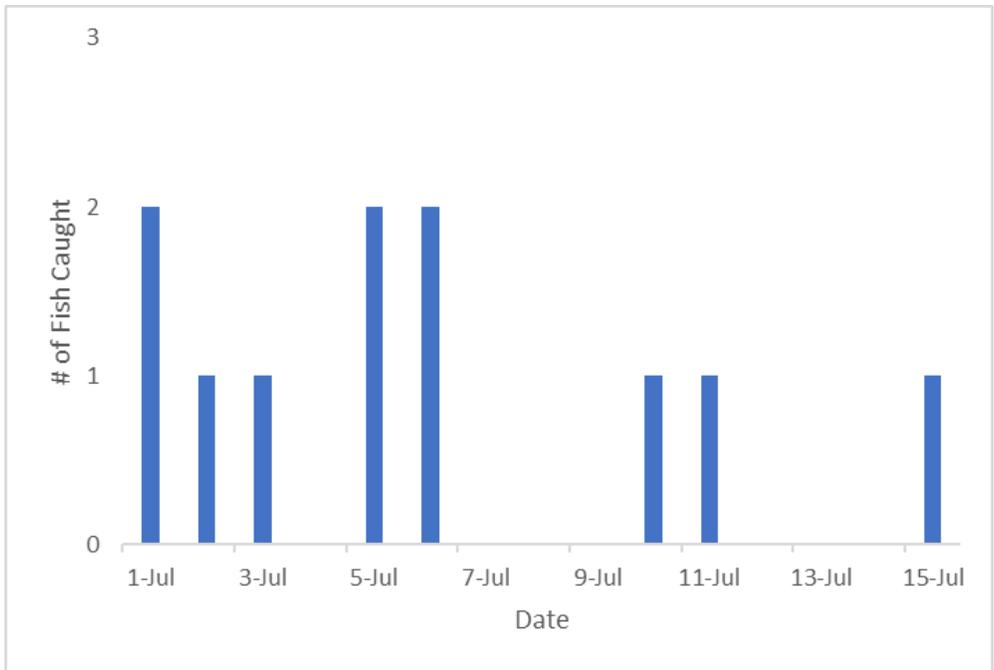
**Figure 26. Chinook Captured Per Day 07/01/2022 to 07/15/2022 (Dexter Dam)**

This reporting period began on July 1 and ended on July 15. There were 11 Chinook salmon (CHS) captured during the 15-day sampling period (Figure 26). Sampling duration was 100% for the 5 ft RST. Table 32 provides life stage, length, and weight data for all Chinook salmon that have been caught at the Dexter Dam site to-date and for the reporting period. Figure 26 shows the daily capture numbers for Chinook and Figure 27 shows length frequency data to-date.

\*Recaptured fish for trapping efficiency trials not included.

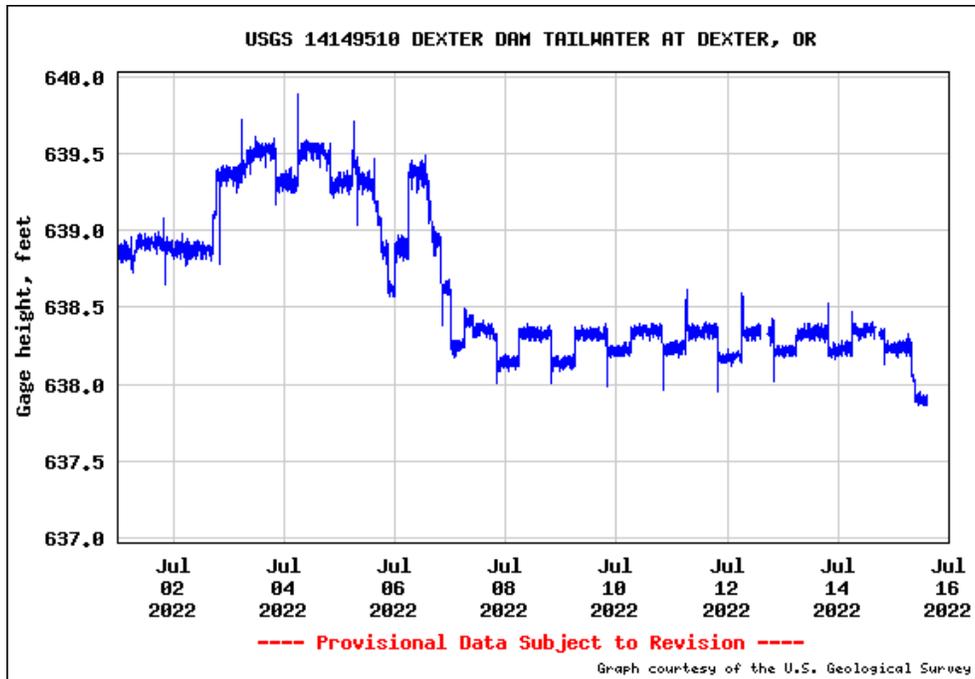
**Figure 28. Gage Height (feet); below Dexter Dam, Middle Fork Willamette**

Basic stream statistics at the Dexter Dam site were calculated from data downloaded from the U.S. Geological Survey stream gage numbers 14149510 and 14150000. Gage height (feet) is the only metric provided at gage 14149510. Total dissolved gas saturation data was received from gage 14150000, 4.75 rkms downstream of the trap. During the reporting period, daily maximum values for instantaneous gage height ranged from 638.3 feet to 639.9 feet (mean: 638.9 feet). Figure 28 shows instantaneous gage height.

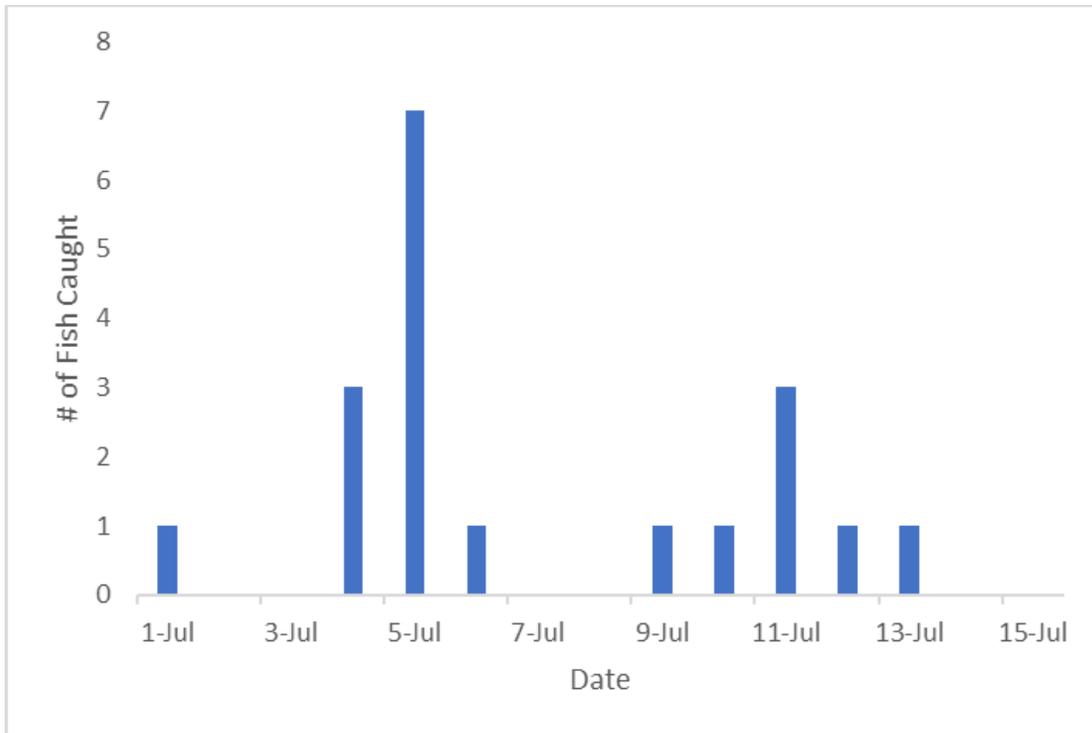
**Figure 32. Chinook Captured Per Day 07/01/2022 to 07/15/2022 (Lookout Point Dam Tailrace)**

The reporting period began July 1 and ended July 15. 19 Chinook salmon were captured during the 15-day sampling period (Figure 32). The traps were operated 100% of the reporting period. Table 36 provides life stage, length, and weight data for all Chinook salmon that have been caught at the Lookout Point Dam Tailrace site to-date and Figure 33 shows length frequency data to-date.

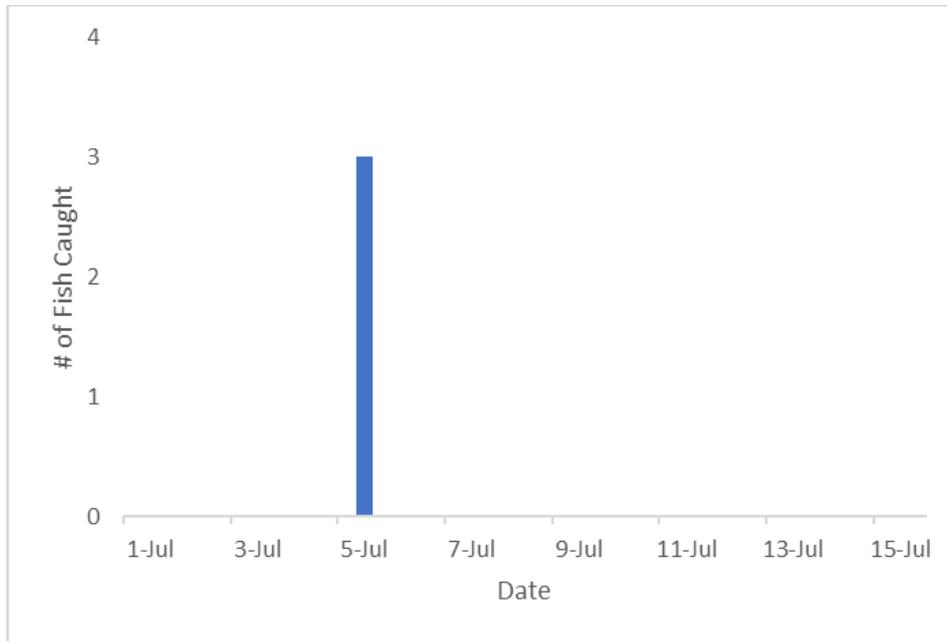
**Figure 38. Chinook Captured Per Day 07/01/2022 to 07/15/2022 (Lookout Point Head of Reservoir)**

The reporting period began July 1 and ended July 15. 3 Chinook salmon were captured during the 15-day sampling period (Figure 38). The trap was operated 100% of the reporting period. Table 40 provides life stage, length, and weight data for all Chinook salmon that have been caught at the Middle Fork Willamette - Lookout Point Head of Reservoir site to-date and Figure 39 shows length frequency data to-date.

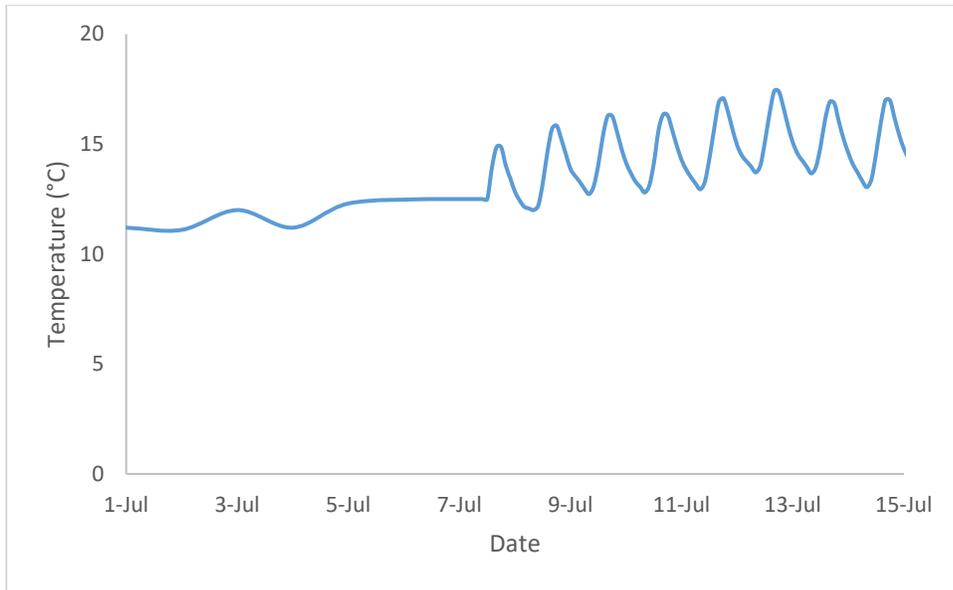
**Figure 41. Temperature at RST (Lookout Point Head of Reservoir)**

Note: Hobo logger was ripped off trap prior to the reporting period. Temperature began recording with a new logger on July 7th, 2022. Data supplemented with daily trap check temperatures from July 1<sup>st</sup>, 2022 to time of logger deployment.
