BONNEVILLE SECOND POWERHOUSE FISH GUIDANCE EFFICIENCY (B2FGE) OVERVIEW FOR B2 STS REHAB PHASE 1A

Based on a presentation originally prepared by Max Wilson-Fey (ENC-HD) August 2025 and modified to inform B2 STS rehab pre-design work.

Presented at FFDRWG on 2/5/2026 by Kyle Sautter and Jake Macdonald

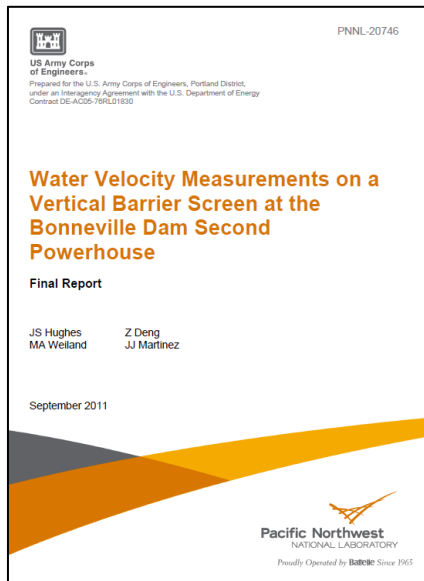
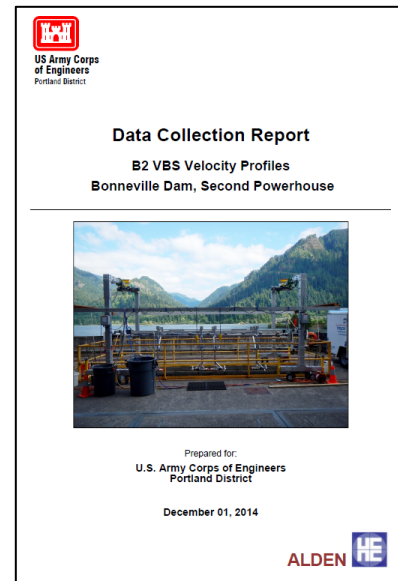
2001-2002

- Gatewell improvements at B2 have been developed, constructed, and evaluated over the last 15 years...

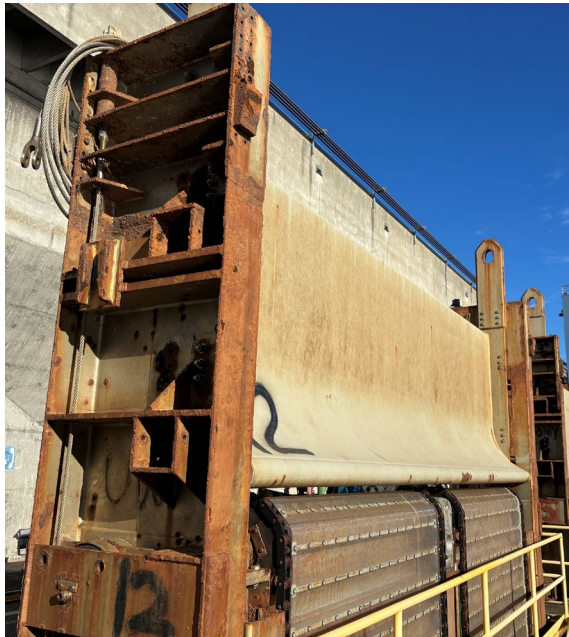
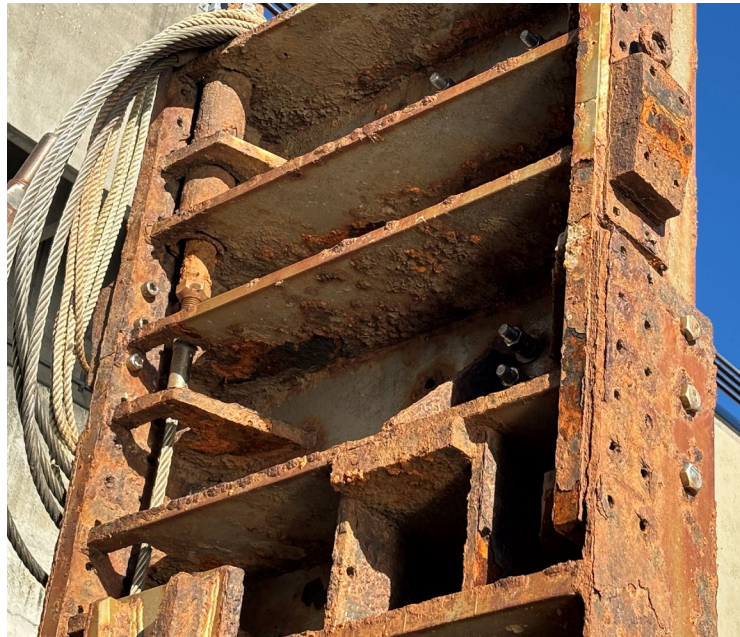
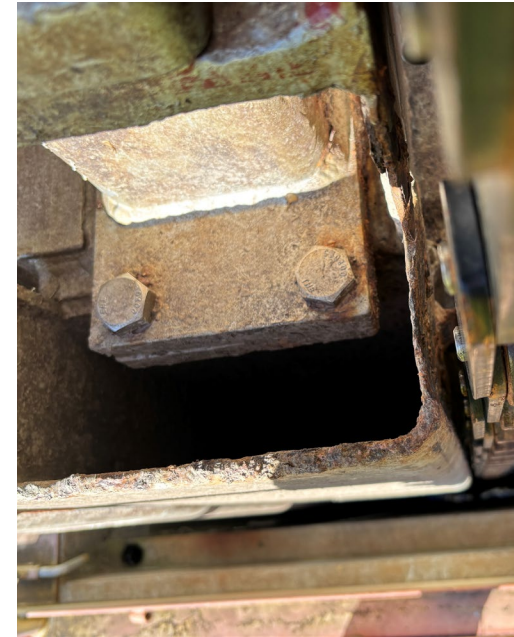
BAD FRAMES

About half (12) of the B2 STS frames are considered in poor condition.

- Material loss in key structural components
- Loss of protective coating accelerating material loss
- Reasonably expected to fail within next 10+ years without major overhaul

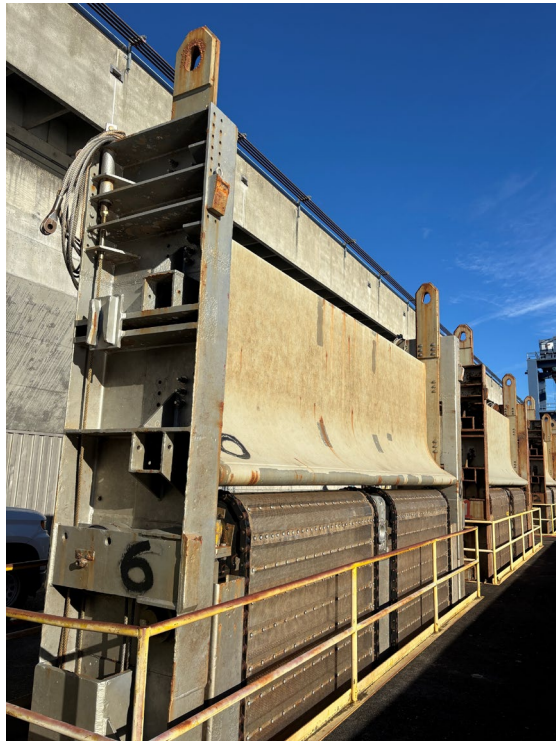
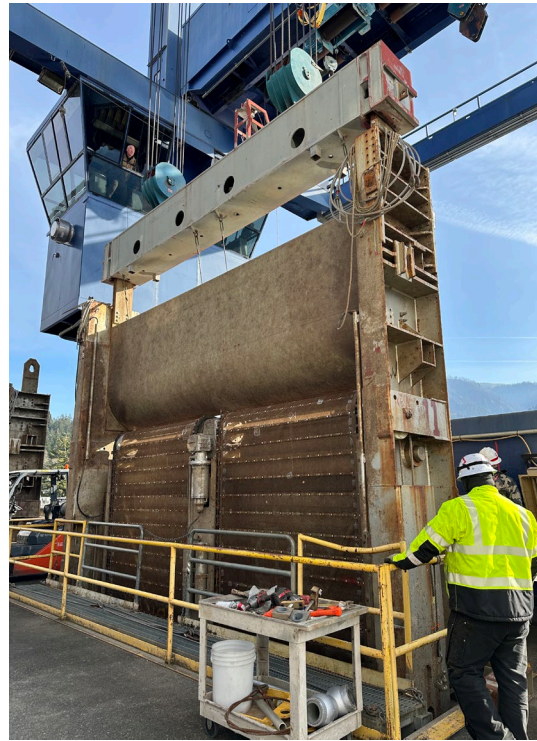
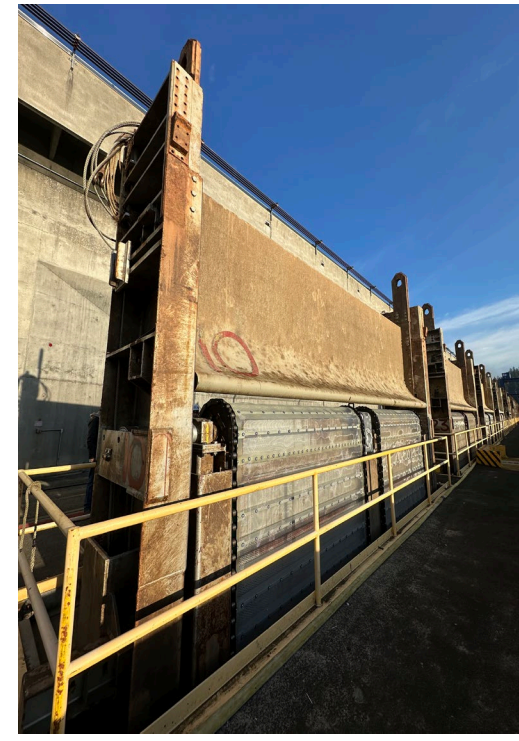
GOOD FRAMES

About half (12) of the B2 STS frames are in serviceable condition.

- Little to no material loss in key structural components
- Intact protective coating inhibiting material loss
- Reasonably expected to last for decades with routine maintenance before needing complete overhaul.
