| <b>DESIGN DOCUMENTATION REPORT</b><br>The Dalles Dam, Columbia River<br>North Fish Ladder Rock Wall Stabilization | |

**Design Documentation Report**

**THE DALLES DAM  
COLUMBIA RIVER**

**NORTH FISH LADDER ROCK WALL STABILIZATION**

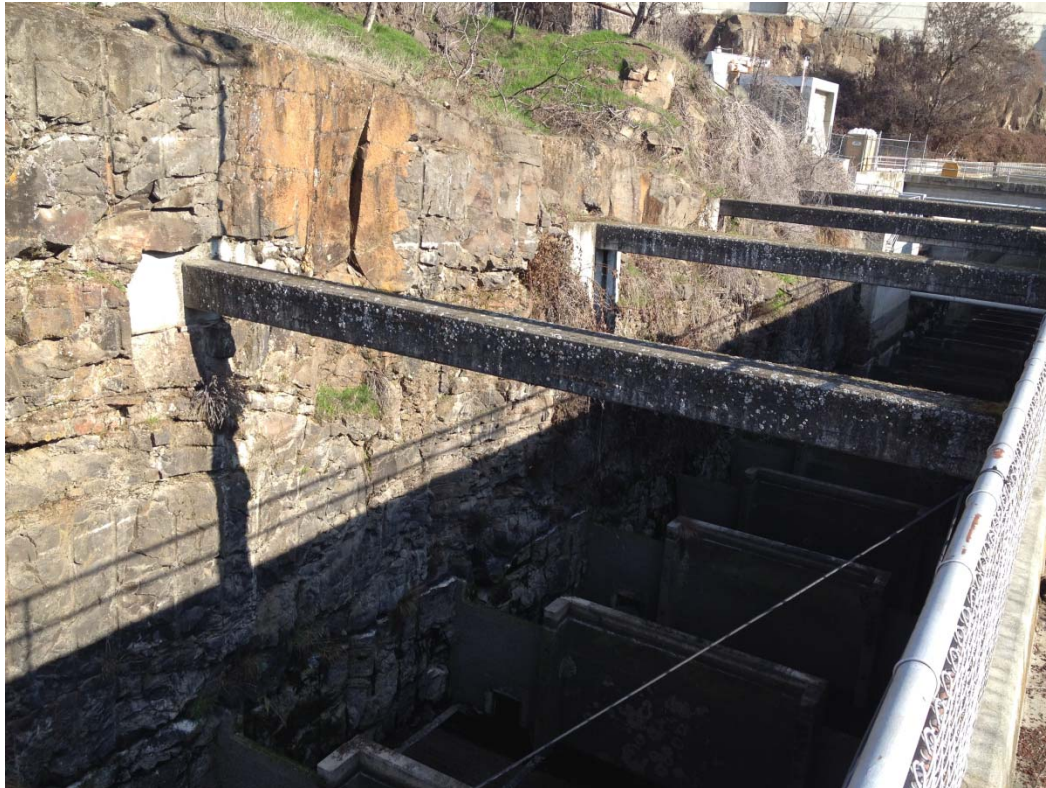
***Figure 4 – Photograph looking north-northeast towards section of fish ladder between weirs No. 77 and 92. Note concrete struts supporting wall to the right of the photo.***

The Dalles Dam North Fish Ladder, between weirs No. 77 and 132, is comprised of vertical to near vertical rock cuts to form the fish ladder side walls (Figures 3 through 5). Mechanical weathering over the last 50+ years has caused areas of the steep rock cuts to become unstable creating project life safety and operability concerns. In addition, the open rock joints along the rock faces have allowed brush and trees to establish causing acceleration of the destabilization of these rock cuts.

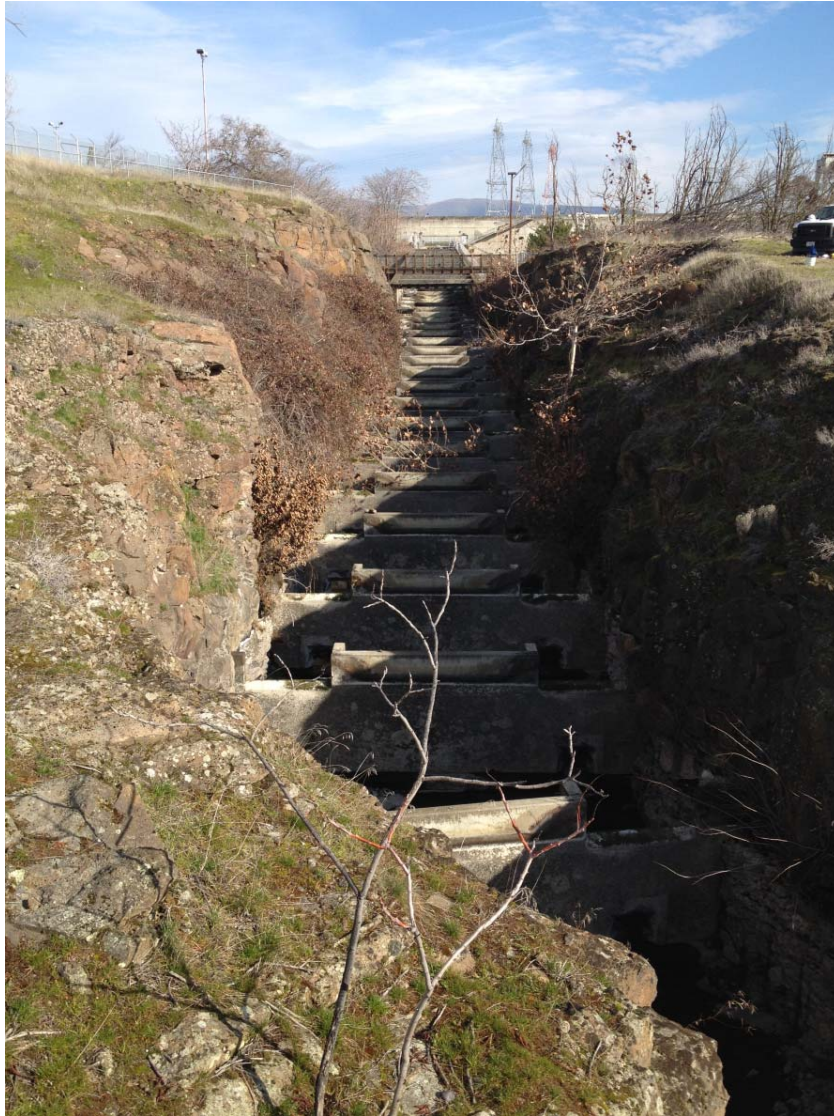
**Figure 5 – Photograph looking northwest towards the northern section of fish ladder.**

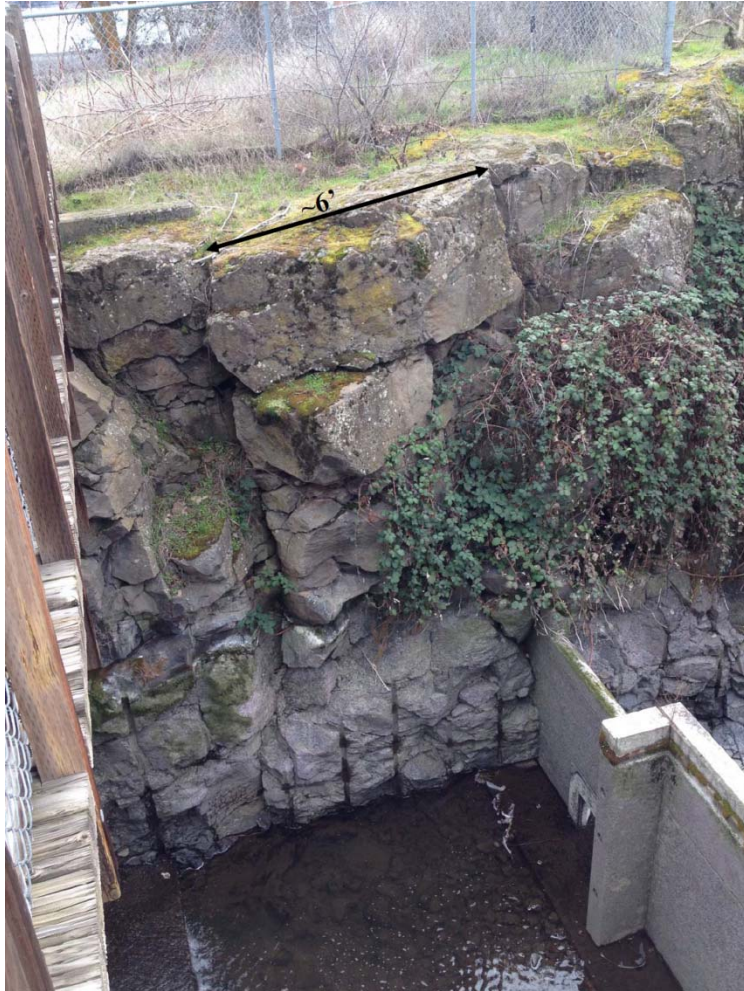
***Figure 11 – Photograph looking south towards the southern fish ladder rock cut near weir 130. Rock blocks up to 6 feet in diameter have weathered out of the cut face in this area.***

Fracturing in the basalt rock exposed in the north fish ladder and AWS channel generally consist of widely spaced primary fractures (cooling joints) and close to moderately spaced secondary fracture which bisect the blocks formed by the primary fractures. The fractures are tight to slightly open and often curve away from the vertical toward the bottom of a flows. Based on mapping completed in the AWS channel, fracture surfaces are generally smooth, and are typically stained with iron oxide or coated with an altered secondary mineral. Average fracture spacing ranged from 0.7 feet to 1.6 feet with an overall average spacing of about 1 foot. However, intact blocks or boulders which have weathered from the exposed rock cut faces in the fish ladder are commonly greater than 2 feet diameter, and can be up to 6 feet in diameter (Figure 11).

Based on site observations of the north fish ladder slopes, the primary block failure types are wedge to planar-wedge (Figure 13). Both types of failures are primarily controlled by the orientation and the spacing of the discontinuities with respect to the slope face. There are also indications of the occurrence of toppling type failures in some locations, where columns of rock, formed by steeply dipping discontinuities in the rock, rotates about a fixed point causing rock fall. In general, the fragments and blocks that fail are a few inches to a few feet diameter. However, large failures are possible, which can mobilize blocks up to 6 feet diameter (Figure 11).

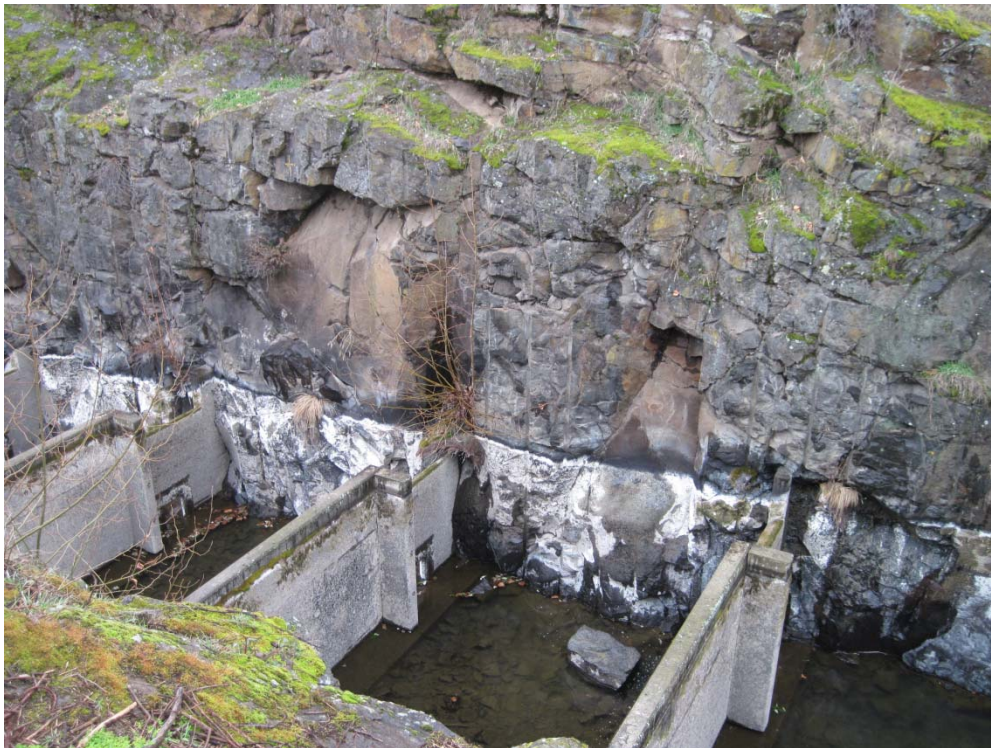
**Figure 13 – Photograph looking west towards the northern part of the fish ladder, showing recent rock fall.**

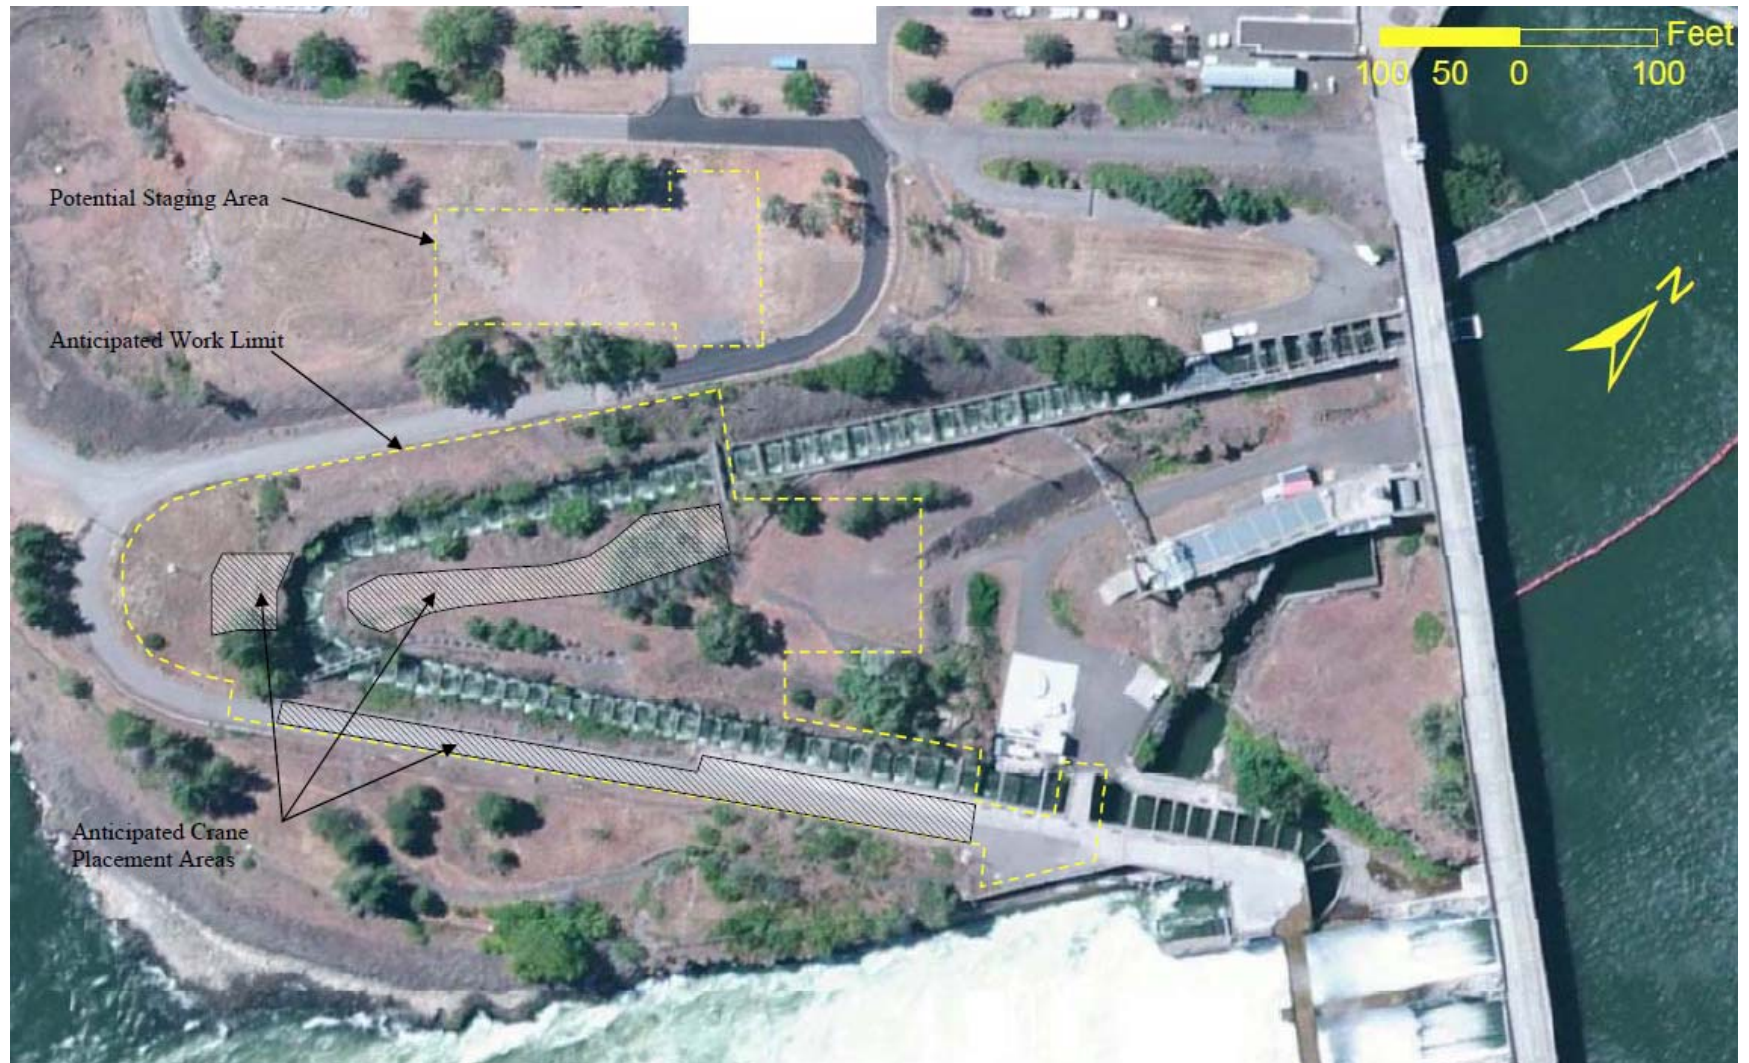
*Figure 17 - Site plan showing anticipated work limits, staging areas and crane placement areas.*

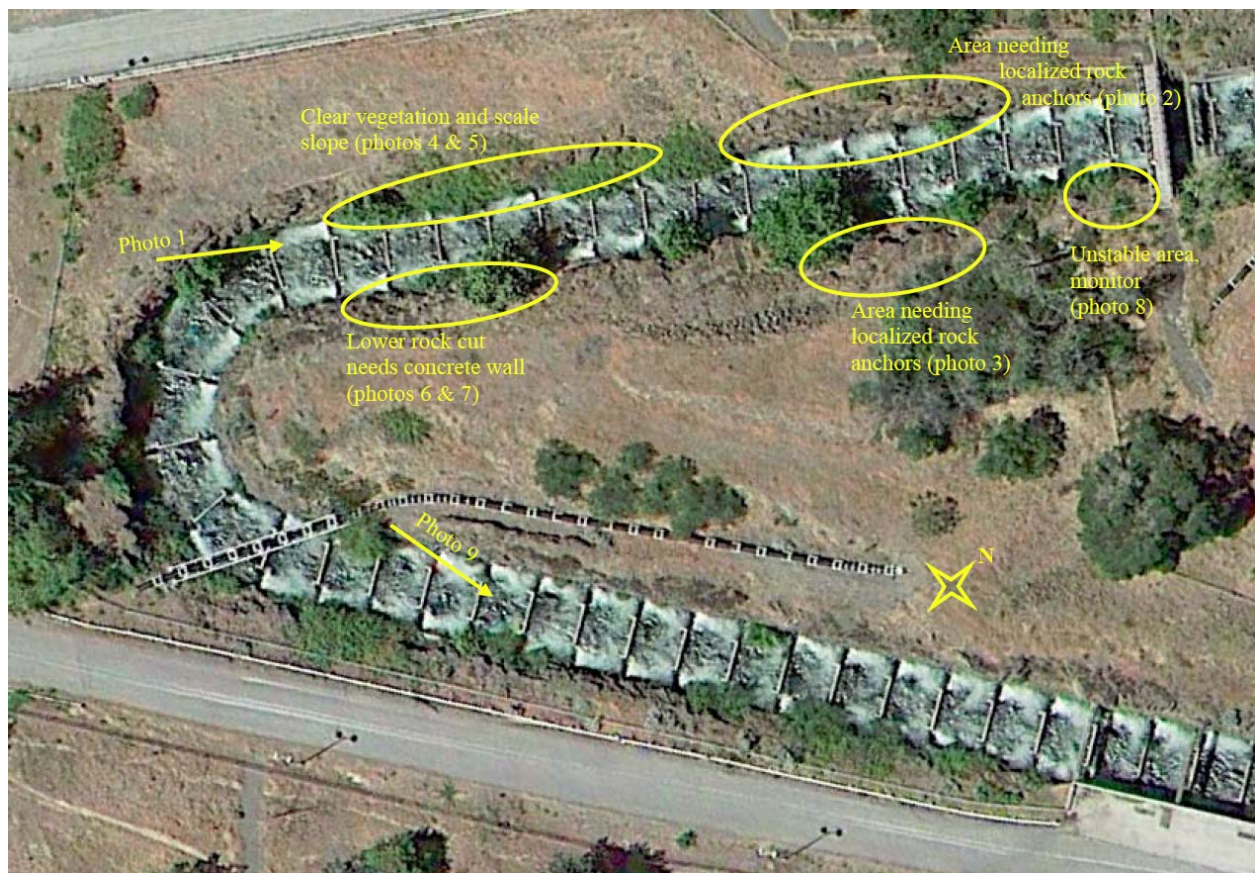
Figure 1 - Aerial photo showing north fish ladder and areas of interest.

There is an area of the ladder, near the footbridge, that has unstable rock, including large unstable rock blocks (Figure 1 and photo 8). Unfortunately, it is likely that any scaling or rock anchor activity completed in this area could cause rock fall that could damage the fish ladder. Therefore, this area of the fish ladder could simply monitored, with special precautions given to personnel who work in this area of the ladder.

Figure 1 and photo 2 shows an area of the fish ladder that has experienced rock block fall as the result of jointing in the rock that slope steeply down towards the fish ladder. In this area of the site scaling alone may not fully eliminate the risk of future rock fall. Therefore, localized rock anchors will likely be required to hold larger, unstable rock blocks in place.

There is one section of the ladder where water flow has caused erosion of the lower rock cut, essentially undercutting the slope (See Figure 1 and photos 6 & 7). Continued erosion can result in larger rock fall that could damage the ladder. In this area of the ladder some kind of concrete wall will likely be required to protect the cut from on-going erosive forces. The wall could be supported by rock anchors.

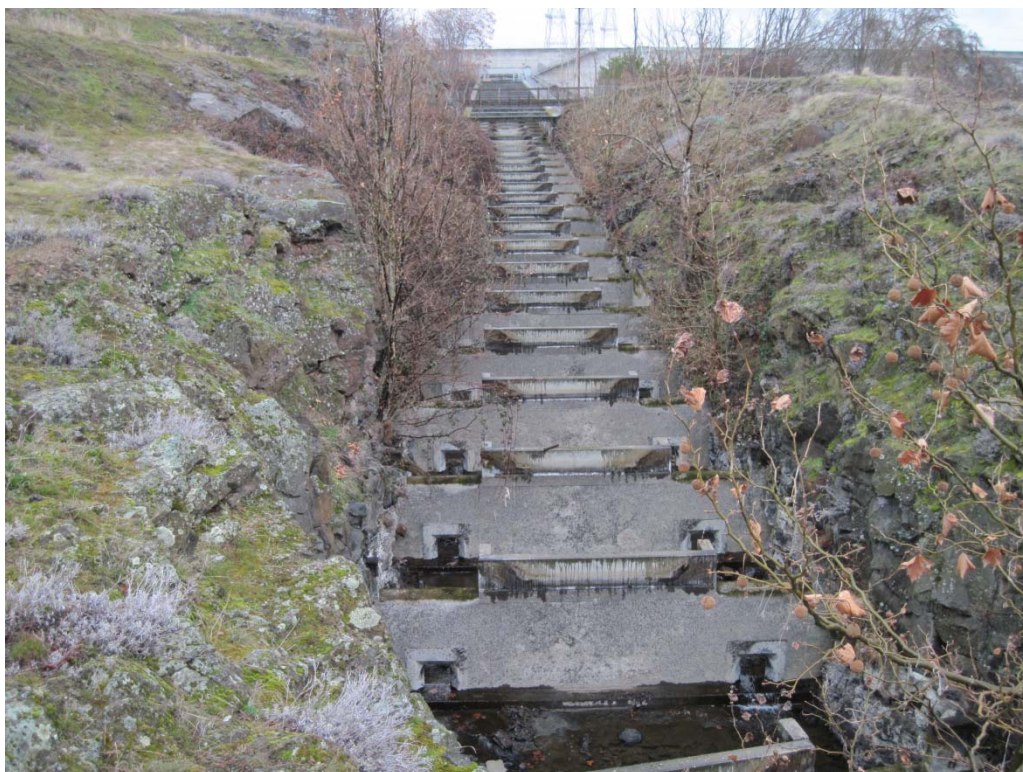
Photo 1 - looking north up fish ladder.

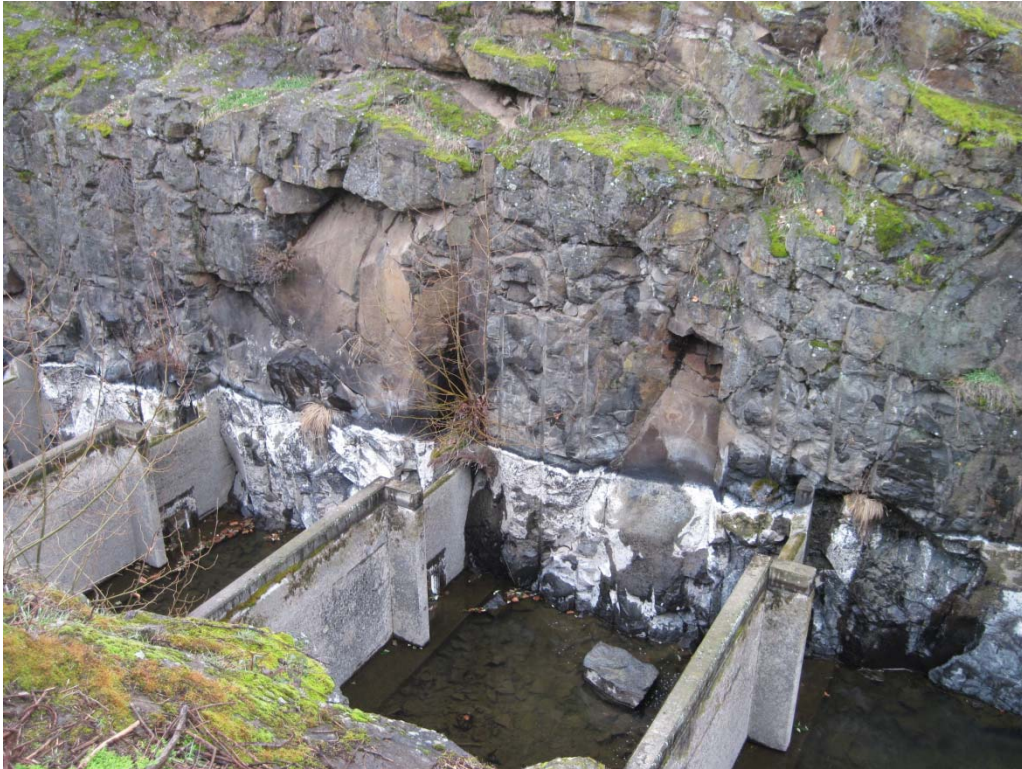
Photo 2 - Showing areas of recent rock block fall. Localized rock anchors are required.

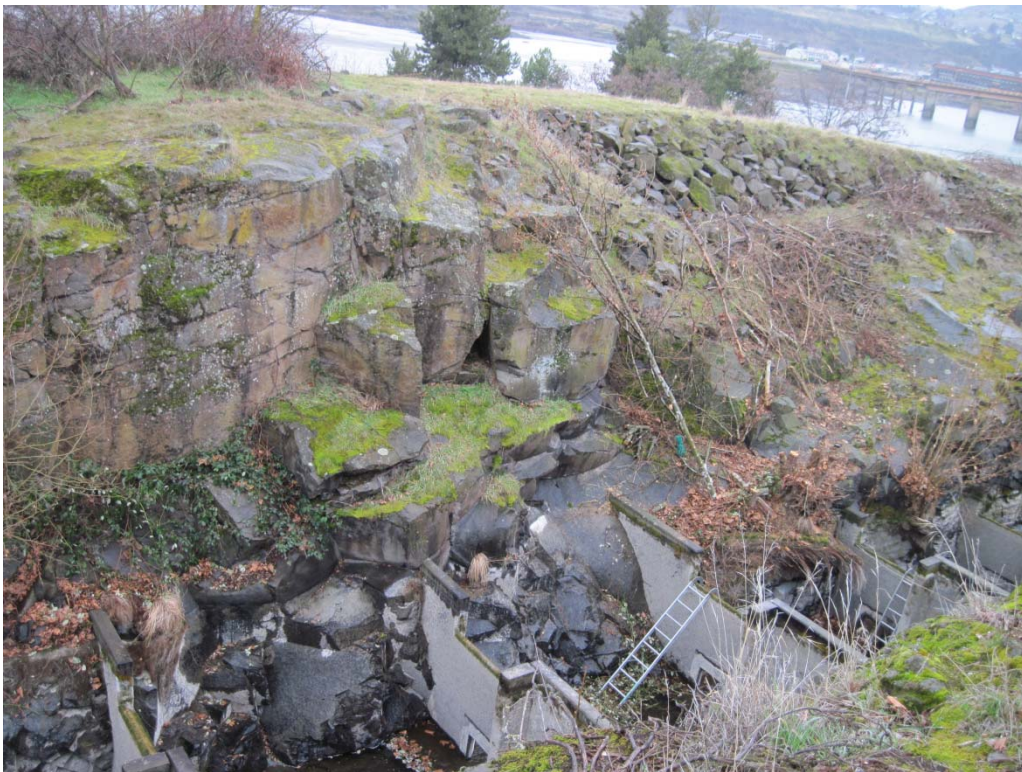
Photo 3 – Showing large rock blocks that may be at risk of toppling. Localized rock anchors may be required.

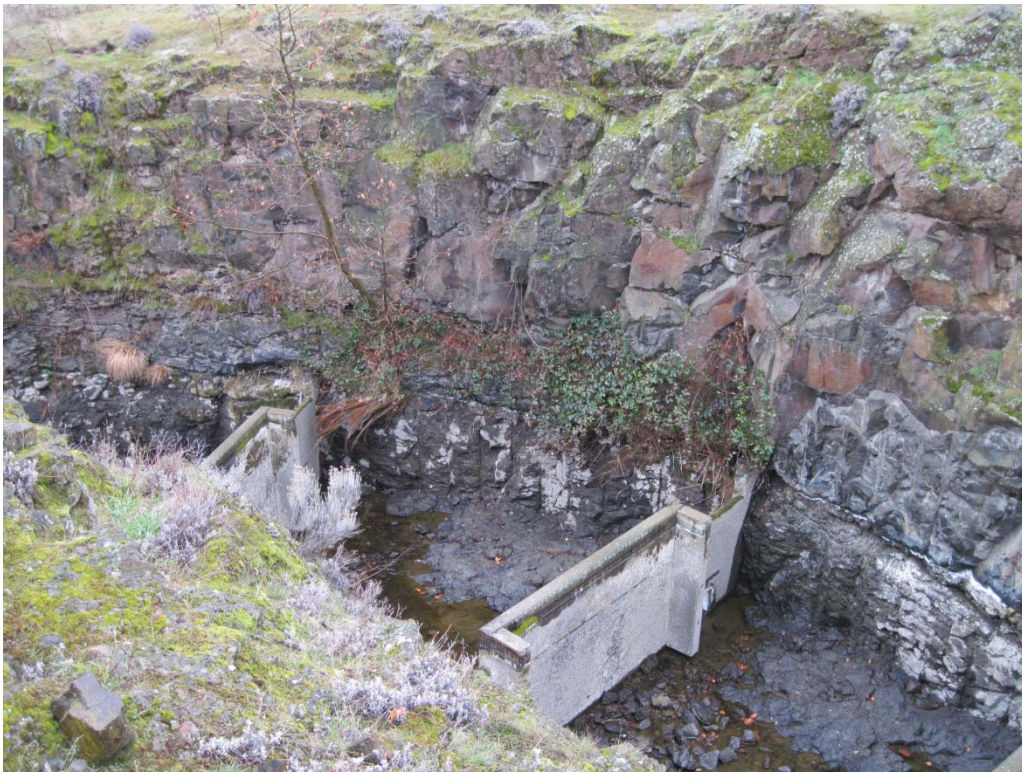
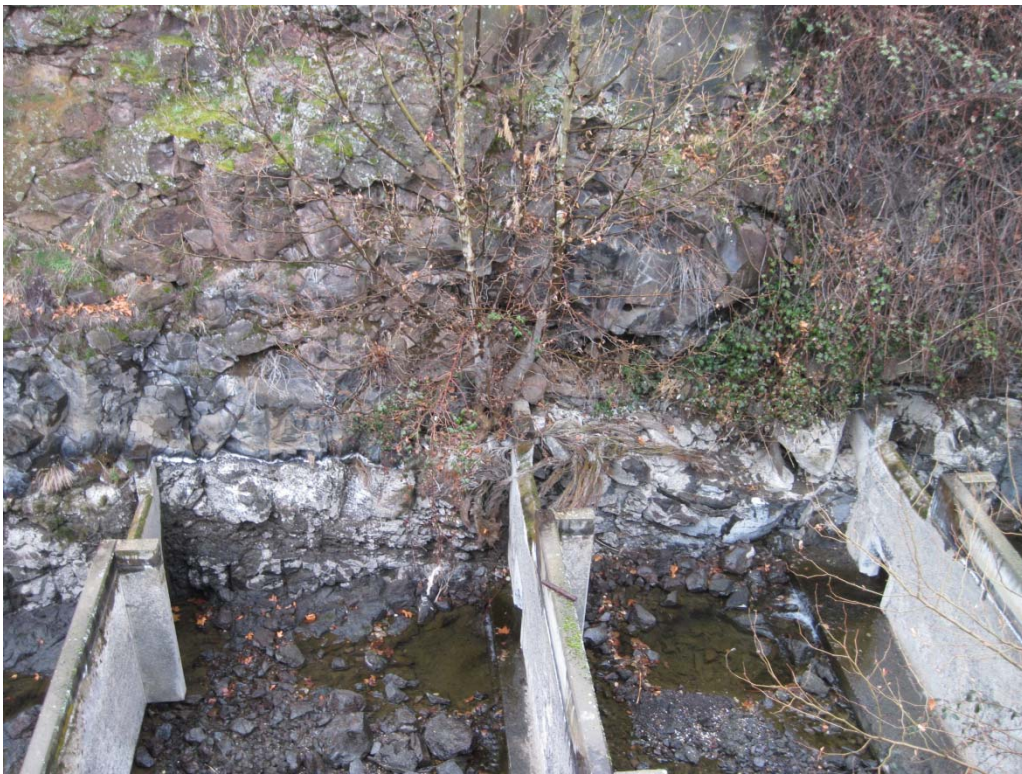
Photos 4 & 5 – Sections of rock cut needing vegetation removal and scaling.

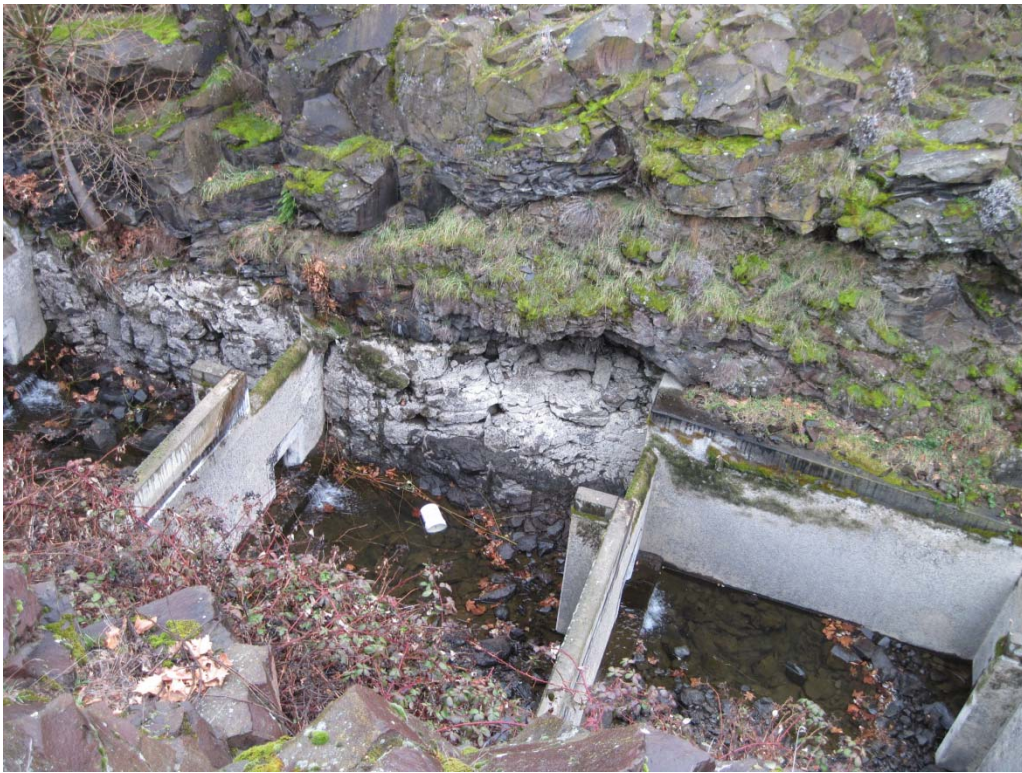
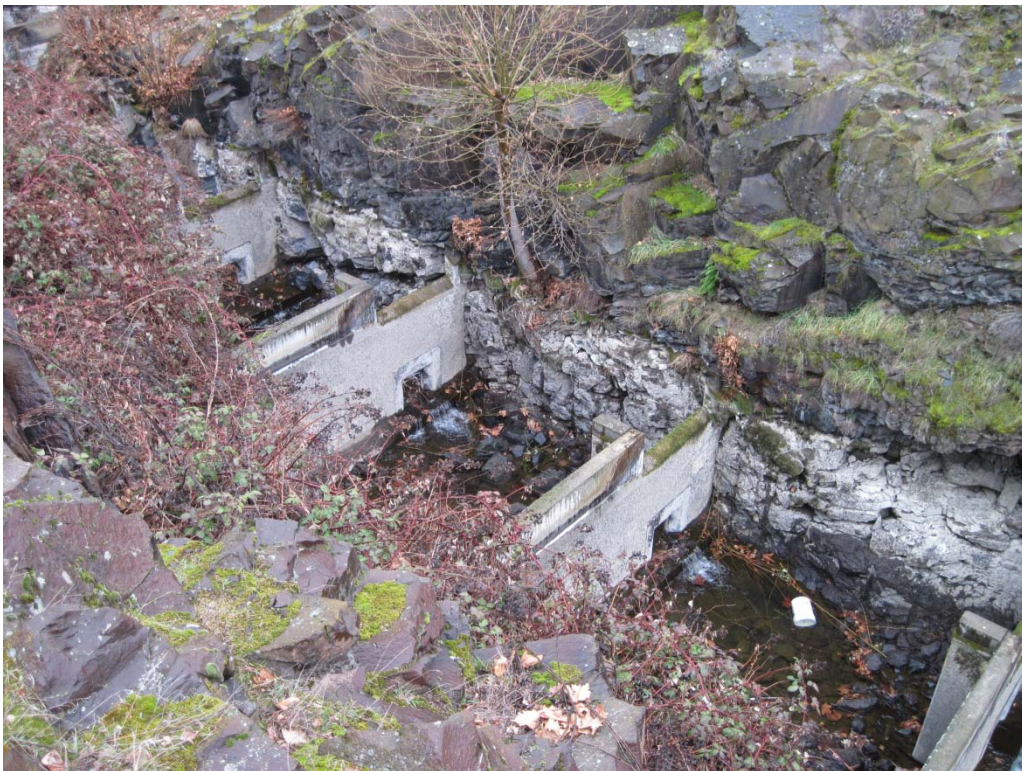
**Photos 6 & 7 – Area of lower rock cut being eroded and undermined by water flow. This area of cut may require construction of a concrete wall structure to protect lower rock cut for further erosion.**

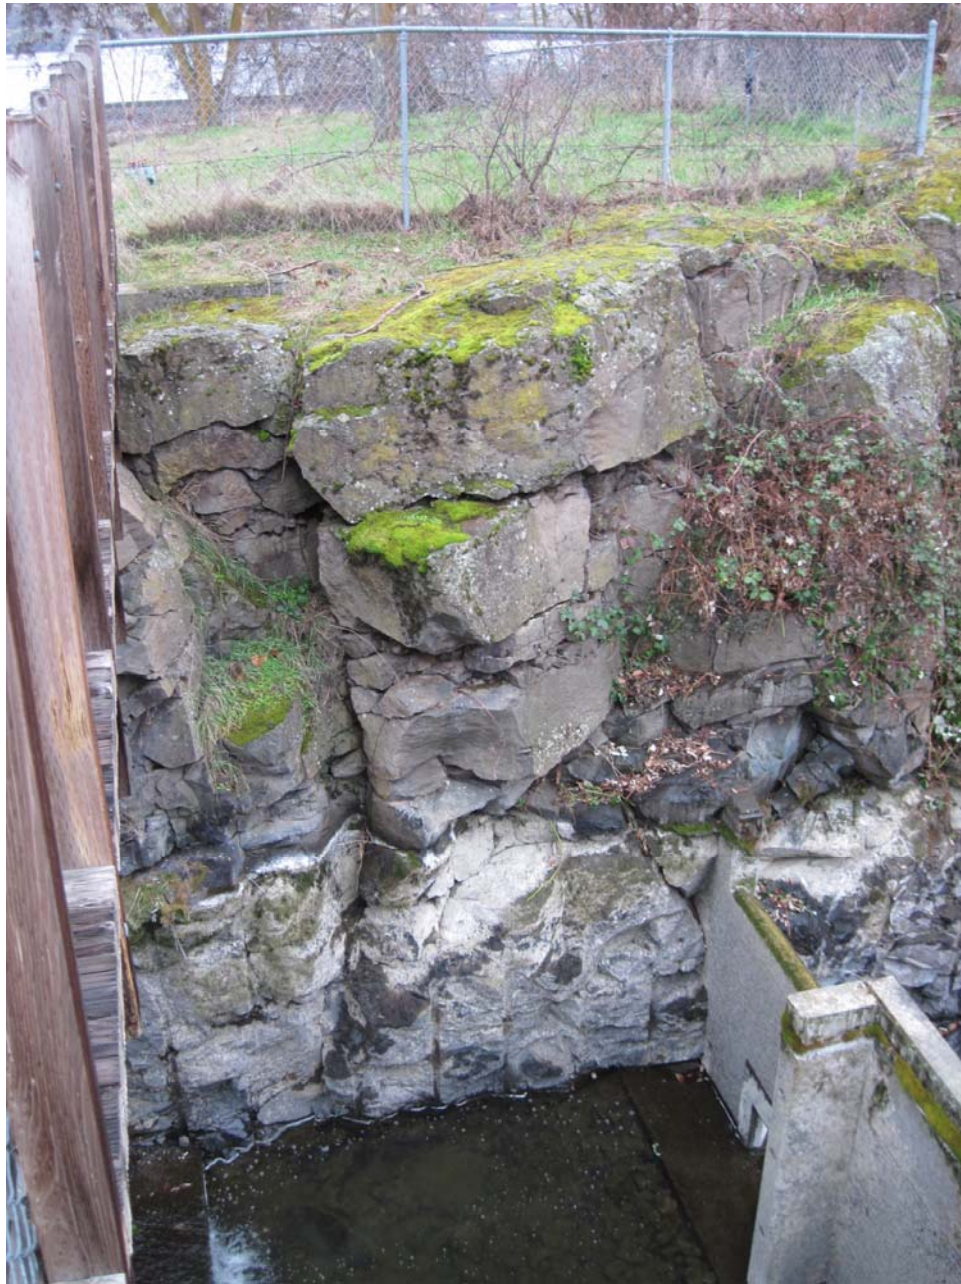
**Photo 8 – Area of unstable rock blocks, near footbridge. Although these blocks appear unstable, it would be difficult to anchor or scale this area without threatening damage to the fish ladder. This area should be monitored, and any work in the area should be done to limit impacts to the slope. Workers access to this area should be limited.**

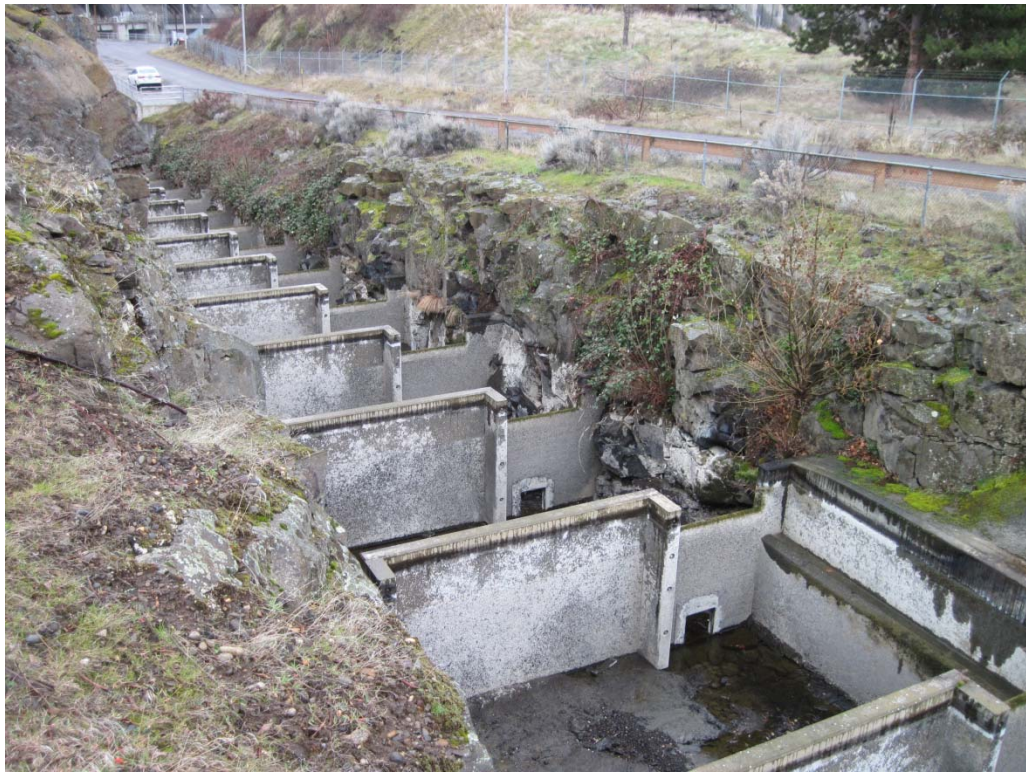
Photo 9 – Looking towards the southern section of the fish ladder.
