Appendix A

2019 Total Dissolved Gas Fixed Monitoring Stations

Updated November 2019

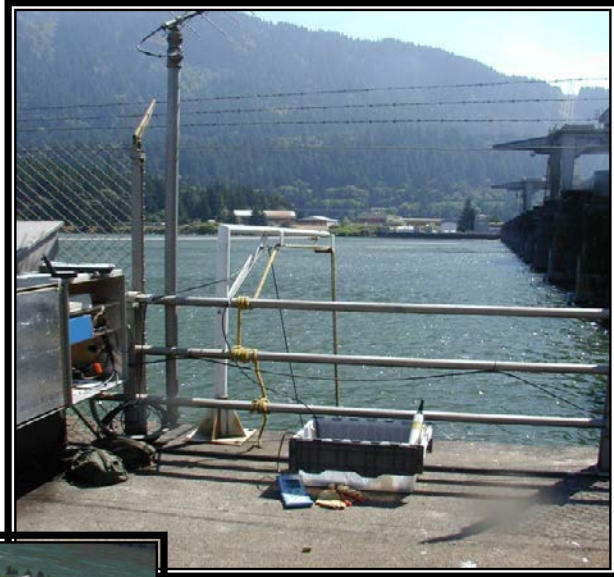
4. Bonneville Forebay TDG Monitoring Station (BON)

Gage Elevation: Fixed
Latitude: 45° 38' 44.42147" N
Longitude: 121° 56' 24.29279" W
Distance from Dam: On face of dam
Datum: NAD83
River: Columbia
River Mile: 146.1
USGS-ID: 453845121562000
Owner: U.S. Army Corps of Engineers-NWP
Gauge Type: Hydrosonde
Data Transmission: GOES Satellite
Dates of Operation: April 1 – August 31*
Years of Operation: 1986 – Present
Water Conditions: Mixed
Location: On the northern side of the spillway channel on Cascade Island just upstream of Spillbay #1.
This gage replaced: N/A
Reason for replacement: N/A
Comments: *The seasonal gauges may go in several days before April 1 and remain in operation several days after August 31.

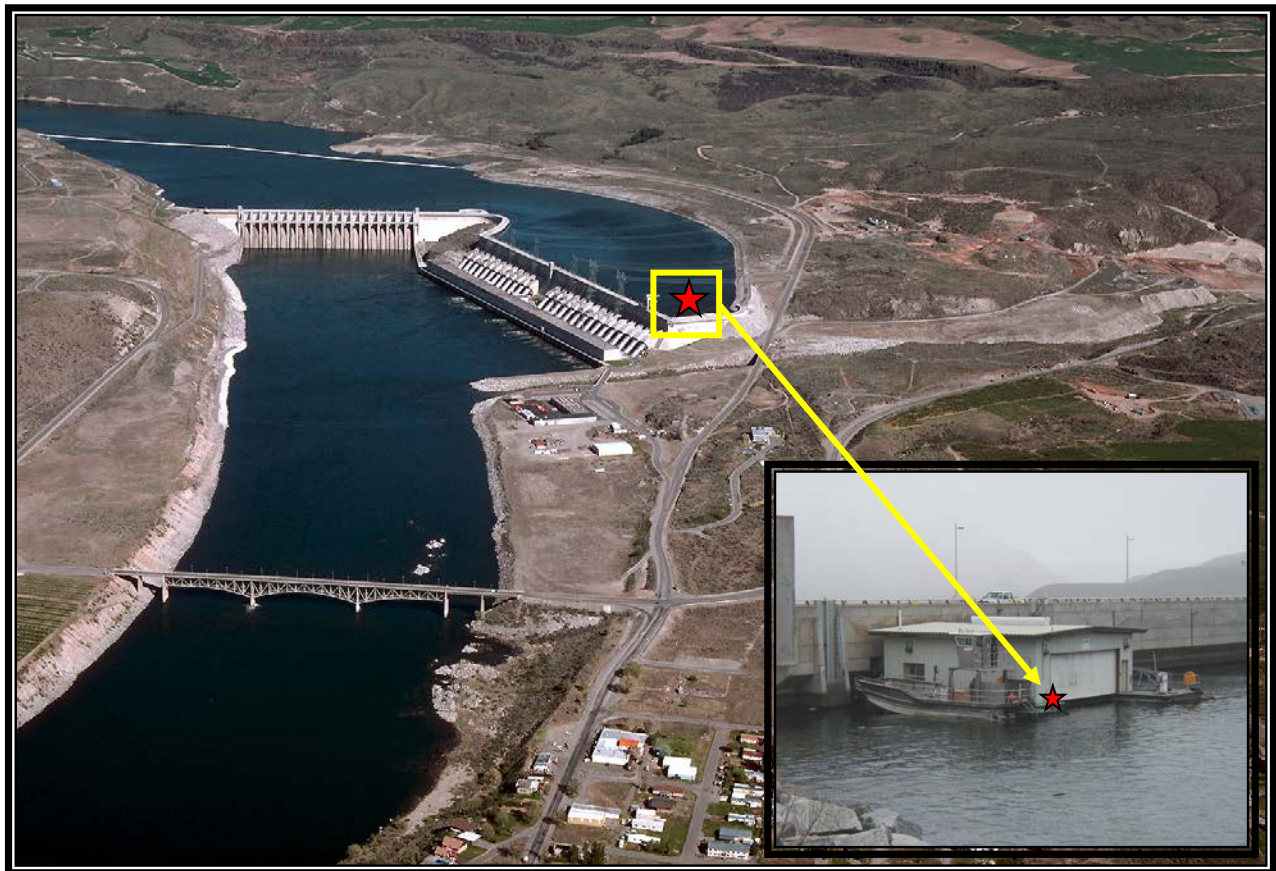
7. Chief Joseph Forebay TDG Monitoring Station (CHJ)

Location: Along the southern edge of Lake Rufus Woods
(inside the boat house).

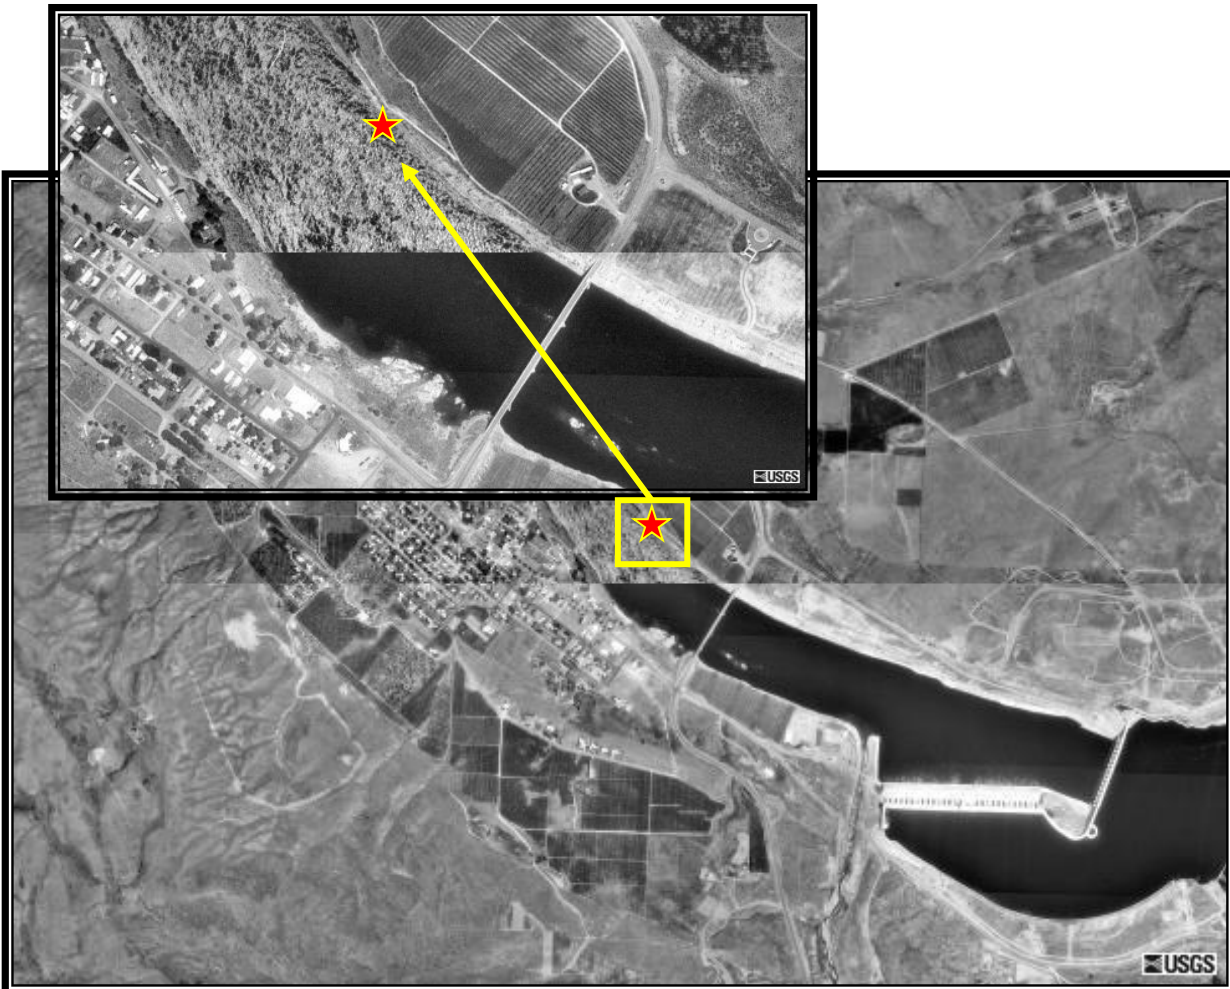
8. Chief Joseph Tailwater TDG Monitoring Station (CHQW)

Gage Elevation: Fixed
Latitude: 48° 00' 17.2" N
Longitude: 119° 39' 30.3" W
Distance from Dam: 1 mile
Datum: NAD83
River: Columbia
River Mile: 543.8
USGS-ID: --
Owner: U.S. Army Corps of Engineers-NWS
Gauge Type: Hydrosonde
Data Transmission: GOES Satellite
Dates of Operation: April 1 – Aug 31*
Years of Operation: 1985 – Present
Water Conditions: Spillway
Location: North bank of the river, just downstream of the Highway 17 Bridge.
This gage replaced: N/A
Reason for gage replacement: N/A
Comments: *The seasonal gauges may go in several days before April 1 and remain in operation several days after August 31.

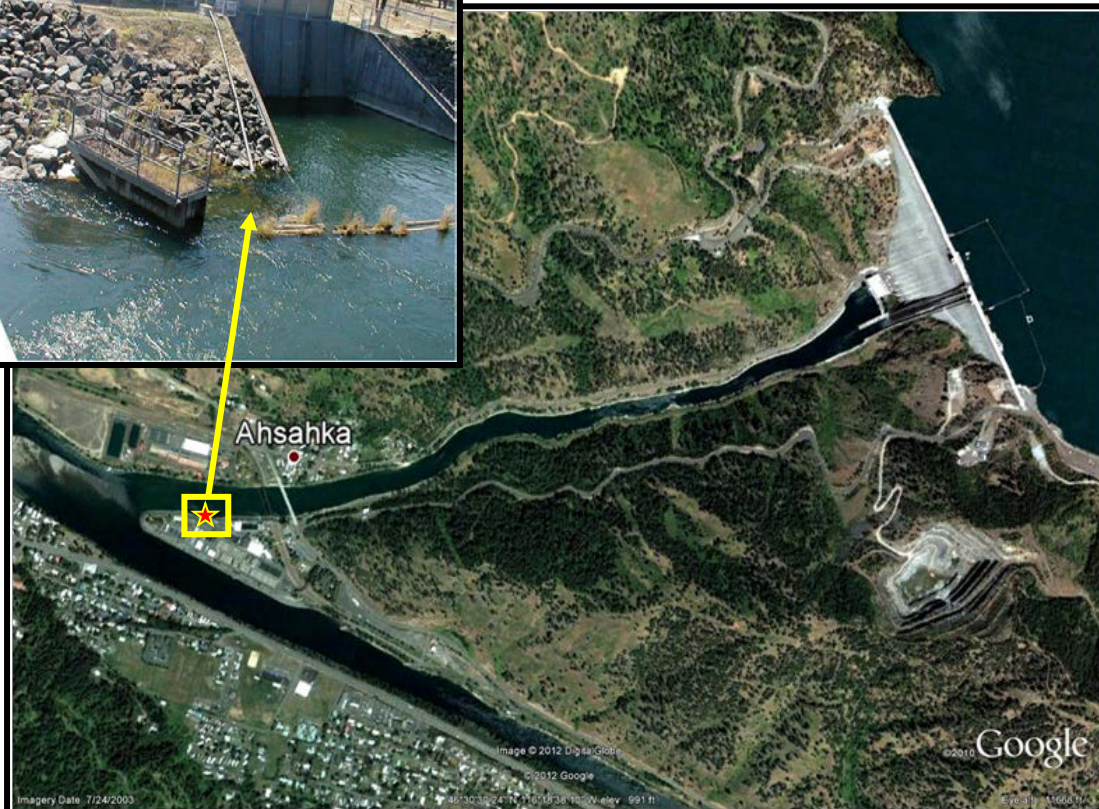
9. Dworshak TDG Monitoring Station (DWQI)

Gage Elevation: Fixed
Latitude: 46° 30' 11.6464" N
Longitude: 116° 19' 16.4090" W
Distance from Dam: 1.5 miles
Datum: NAD83
River: North Fork, Clearwater River
River Mile: 0.5
USGS-ID: 13341000
Owner: U.S. Army Corps of Engineers-NWW
Gauge Type: Hydrosonde
Data Transmission: GOES Satellite
Dates of Operation: Year round
Years of Operation: 1993 - Present
Water Conditions: Mixed
Location: On the southern bank of the North Fork, Clearwater River between the bridge and the U.S. Fish and Wildlife Service Fish Hatchery outflow pipe.
This gage replaced: N/A
Reason for replacement: N/A
Comments: --

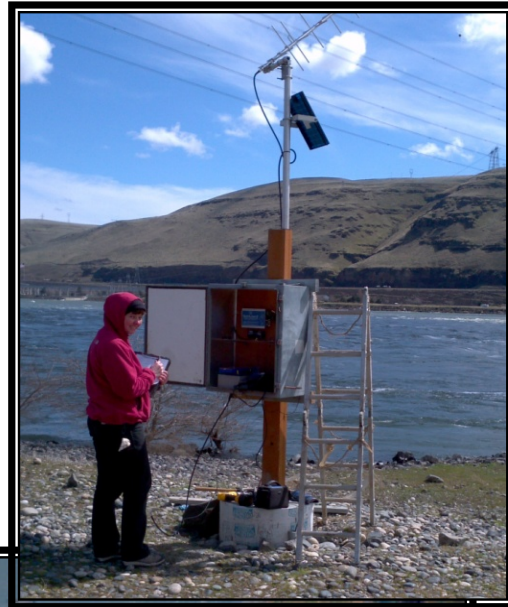
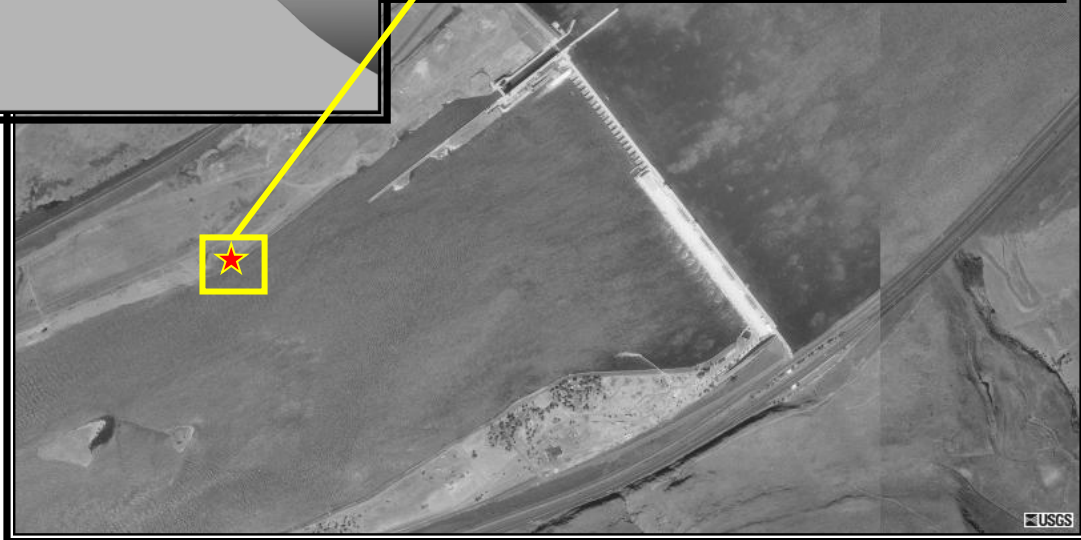
14. John Day Tailwater TDG Monitoring Station (JHAW)

Gage Elevation: Fixed
Latitude: 45° 42' 48.44859" N
Longitude: 120° 42' 39.21477" W
Distance from Dam: 0.8 miles
Datum: NAD83
River: Columbia
River Mile: 214.7
USGS-ID: 454249120423500
Owner: U.S. Army Corps of Engineers-NWP
Gauge Type: Hydrosonde
Data Transmission: GOES Satellite
Dates of Operation: Was seasonal prior to 2006, now year round.
Years of Operation: 1995 – Present
Water Conditions: Spillway
Location: Other Washington shore.
This gage replaced: N/A
Reason for replacement: Rising flows
Comments: Location of station moved about 12 feet higher elevation from shore, further up the hill.

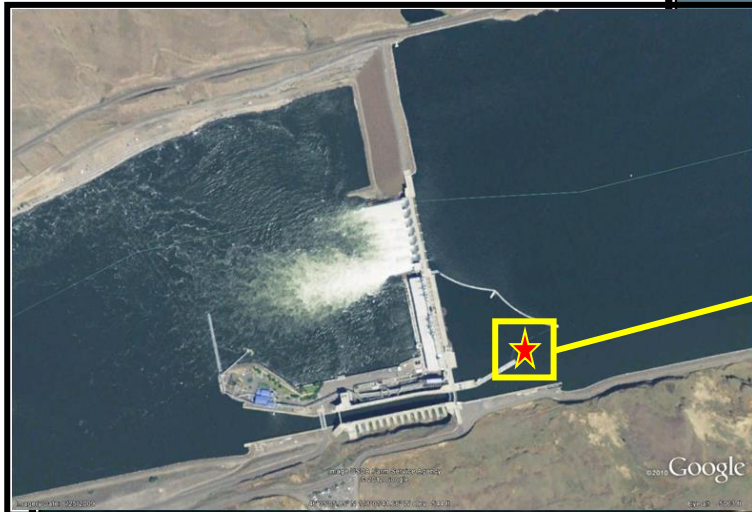
16. Little Goose Forebay TDG Monitoring Station (LGSA)

Location: At the upstream end of the navigation lock guidewall.

Reason for replacement: Move due to thermal influences and lowered from 15 ft to 45 ft.

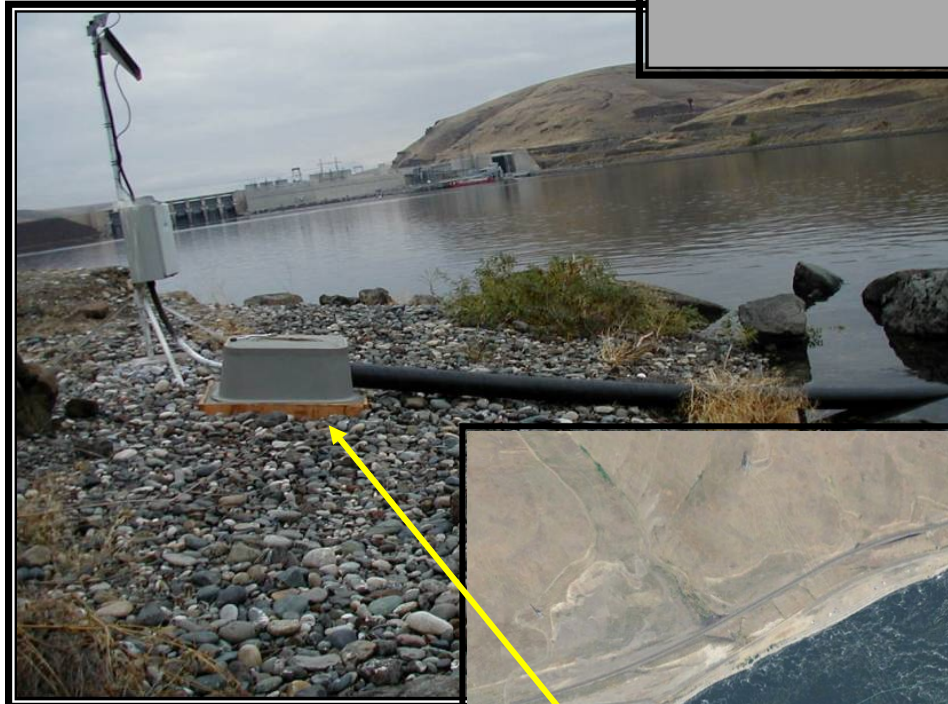
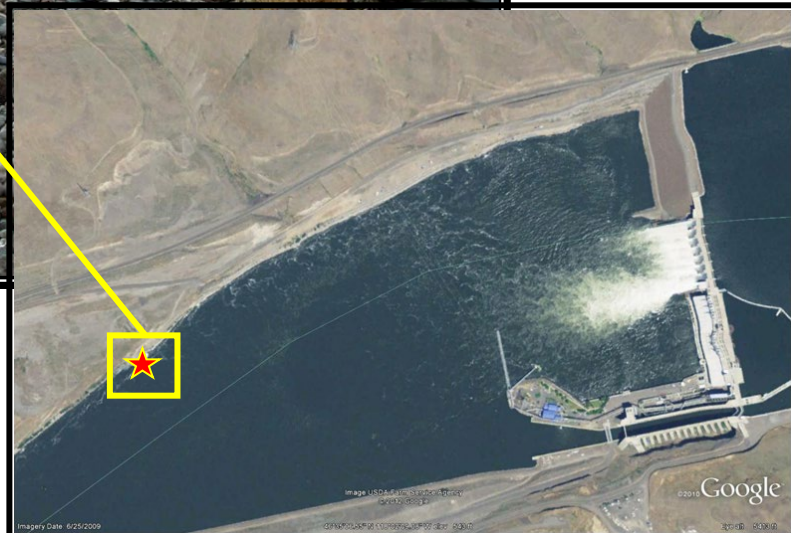
17. Little Goose Tailwater TDG Monitoring Station (LGSW)

Gage Elevation: Fixed
Latitude: 46° 35' 00.5280" N
Longitude: 118° 02' 37.4186" W
Distance from Dam: 0.7 miles
Datum: NAD83
River: Snake
River Mile: 69.6
USGS-ID: 13343860
Owner: U.S. Army Corps of Engineers-NWW
Gauge Type: Hydrosonde
Data Transmission: GOES Satellite
Dates of Operation: Was seasonal prior to 2006, now year round.
Years of Operation: 1995 – Present.
Water Conditions: Switches between mixed & spillway
Location: On the northern shore of the Snake River
This gage replaced: N/A
Reason for replacement: N/A
Comments: --

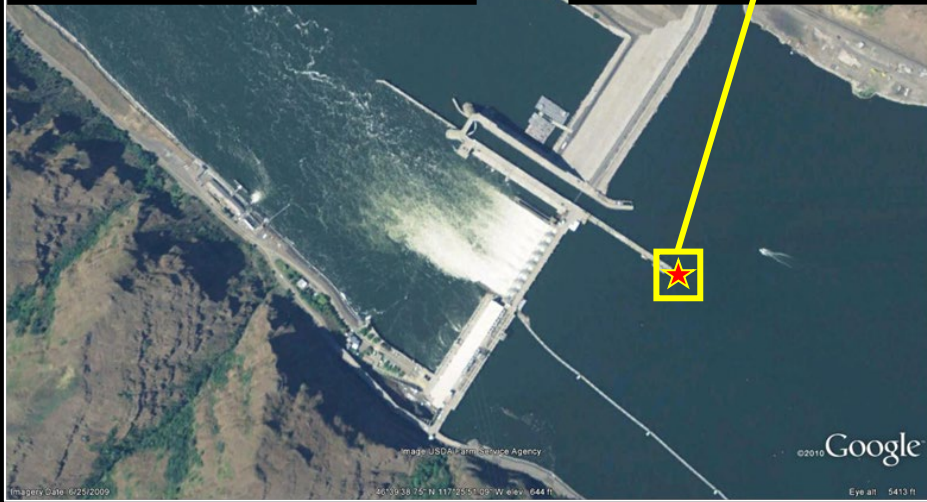
18. Lower Granite Forebay TDG Monitoring Station (LWG)

Gage Elevation: Fixed
Latitude: 46° 39' 34.1727" N
Longitude: 117° 25' 34.8564" W
Distance from Dam: 640 ft
Datum: NAD83
River: Snake
River Mile: 107.5
USGS-ID: 13343590
Owner: U.S. Army Corps of Engineers-NWW
Gauge Type: Hydrosonde
Data Transmission: GOES Satellite
Dates of Operation: Was year round prior to 2006, now seasonal (April 1 – Aug. 31*)
Years of Operation: 1985 – Present.
Water Conditions: Mixed
Location: At the upstream end of the navigation lock guidewall.
This gage replaced: N/A
Reason for replacement: In March, 2005, this gauge was moved from a depth of 15 ft to 45 ft to avoid thermal influences. The geographic location of the gauge was not changed.
Comments: * The seasonal gauges may go in several days before April 1 and remain in operation several days after August 31.

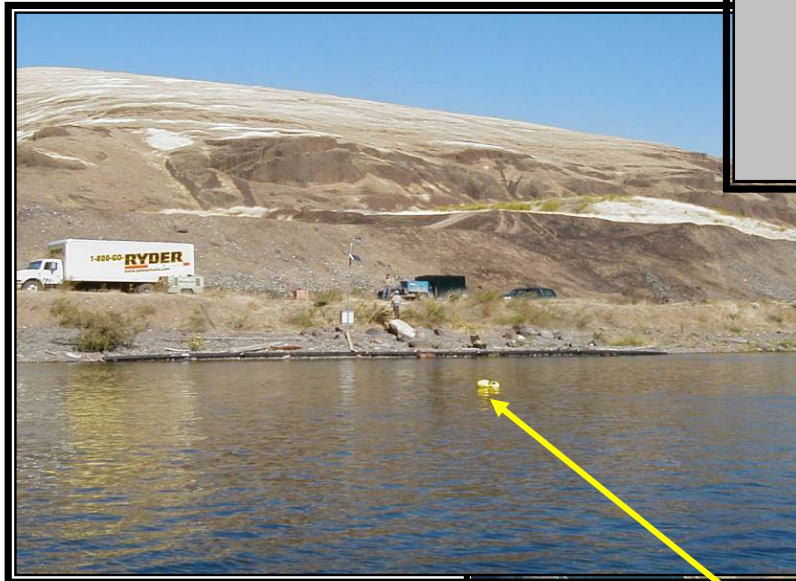
19. Lower Granite Tailwater TDG Monitoring Station (LGNW)

Gage Elevation: Fixed
Latitude: 46° 39' 58.0726" N
Longitude: 117° 26' 19.2595" W
Distance from Dam: 0.8 miles
Datum: NAD83
River: Snake
River Mile: 106.7
USGS-ID: 13343595
Owner: U.S. Army Corps of Engineers-NWW
Gauge Type: Hydrosonde
Data Transmission: GOES Satellite
Dates of Operation: Year around
Years of Operation: 1995 – Present.
Water Conditions: Switches between mixed & spillway
Location: On the northeastern shore of the Snake River.
This gage replaced: N/A
Reason for replacement: N/A
Comments: --

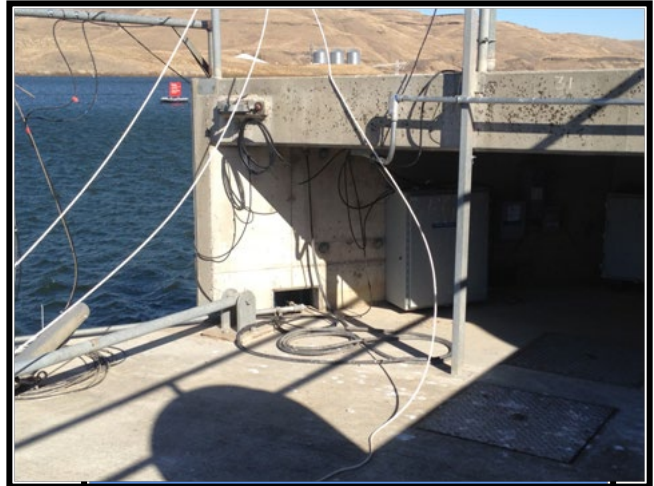
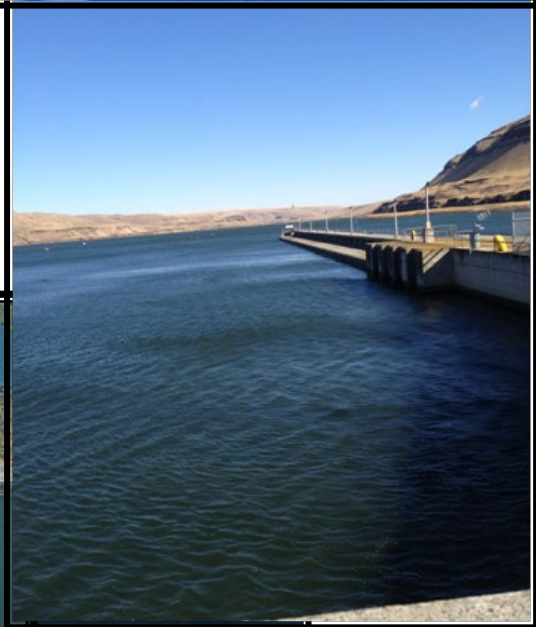
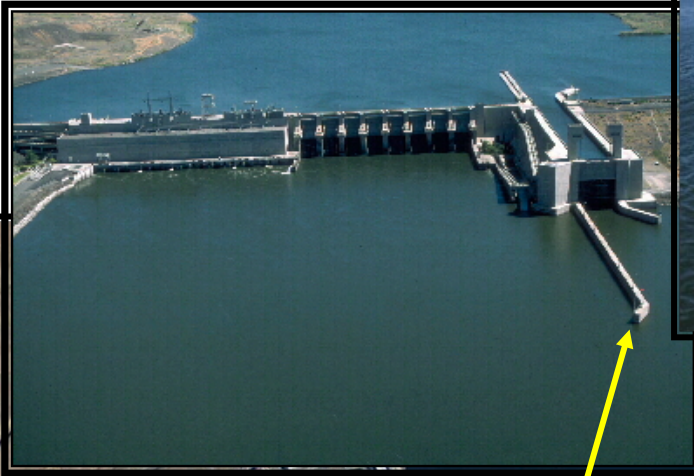
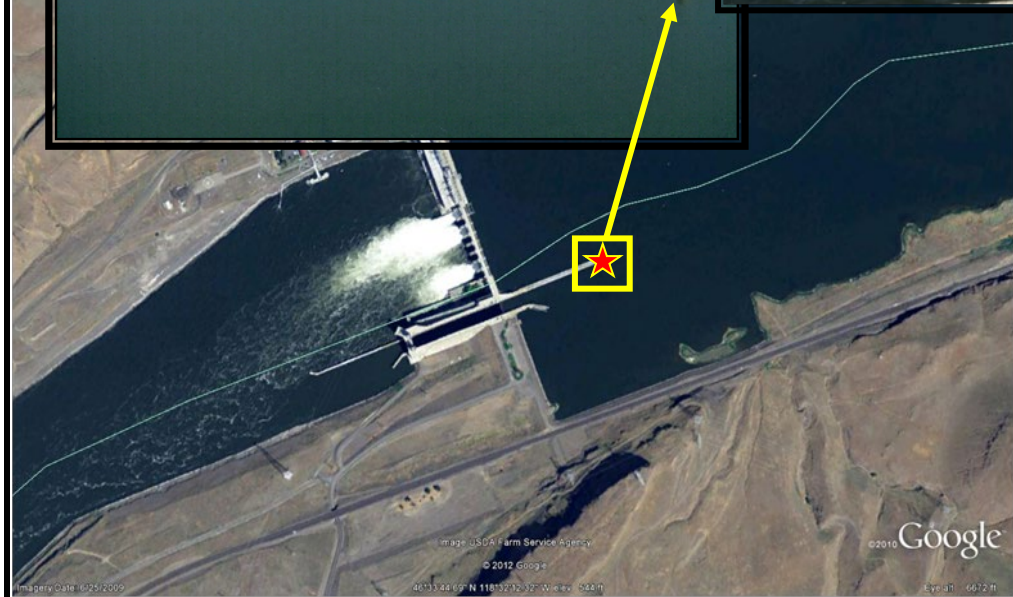
20. Lower Monumental Forebay TDG Monitoring Station (LMNA)

Gage Elevation: Fixed
Latitude: 46° 33' 44.6559" N
Longitude: 118° 32' 08.3477" W
Distance from Dam: 700 ft
Datum: NAD83
River: Snake
River Mile: 41.7
USGS-ID: 13352595
Owner: U.S. Army Corps of Engineers-NWW
Gauge Type: Hydrosonde
Data Transmission: GOES Satellite
Dates of Operation: April 1-Aug. 31*
Years of Operation: 2005 – Present
Water Conditions: Mixed
Location: At the upstream end of the navigation lock guidewall.
This gage replaced: Replaced LMN in 2005
Reason for replacement: Moved due to thermal influences and lowered from 15 ft to 45 ft.
Comments: * The seasonal gauges may go in several days before April 1 and remain in operation several days after August 31.

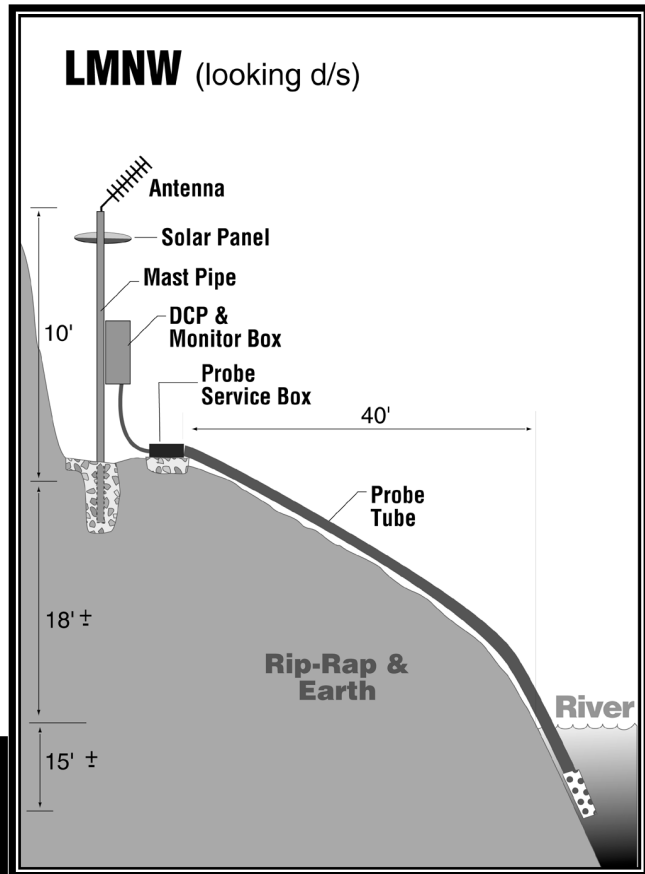
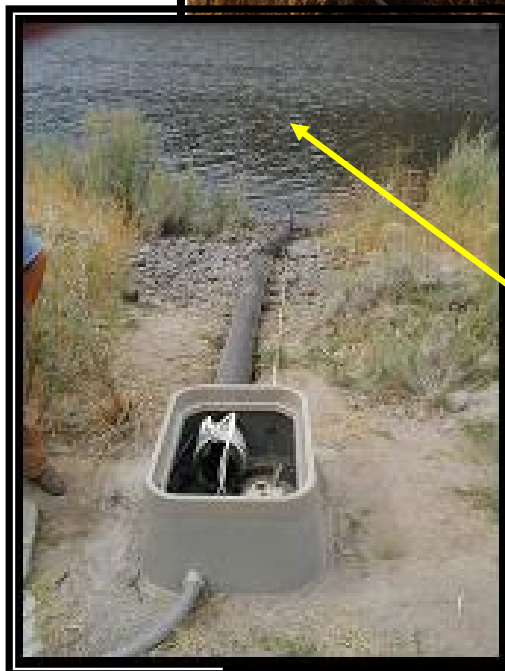
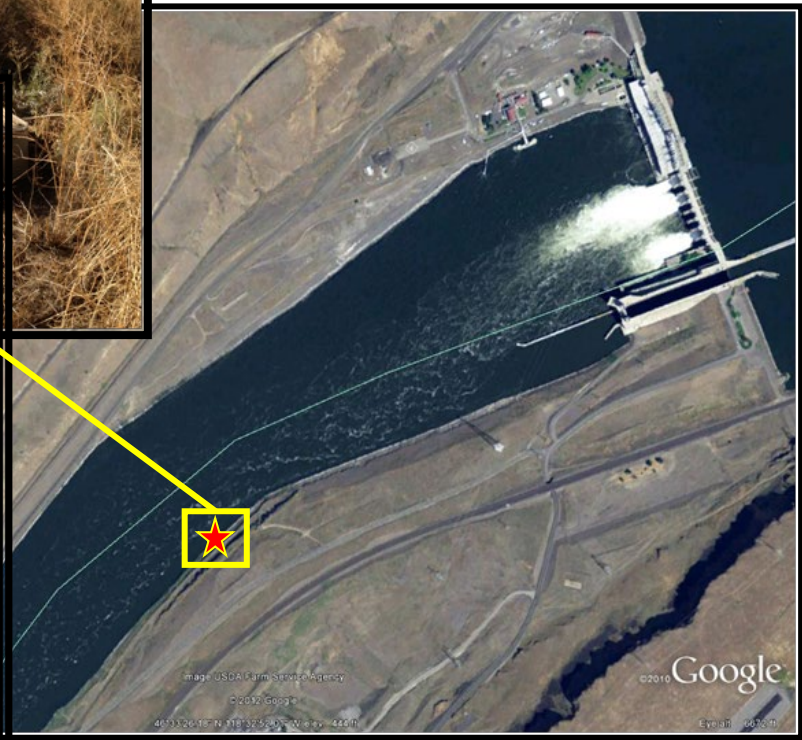
21. Lower Monumental Tailwater TDG Monitoring Station (LMNW)

Gage Elevation: Fixed
Latitude: 46° 33' 04.5051" N
Longitude: 118° 32' 58.9500" W
Distance from Dam: 1 mile
Datum: NAD83
River: Snake
River Mile: 40.4
USGS-ID: 13352600
Owner: U.S. Army Corps of Engineers-NWW
Gauge Type: Hydrosonde
Data Transmission: GOES Satellite
Dates of Operation: Was seasonal prior to 2006, now year around.
Years of Operation: 1995 – Present
Water Conditions: Switches between mixed & spillway.
Location: On the southeastern shore of the Snake River.
This gage replaced: N/A
Reason for replacement: N/A
Comments: --

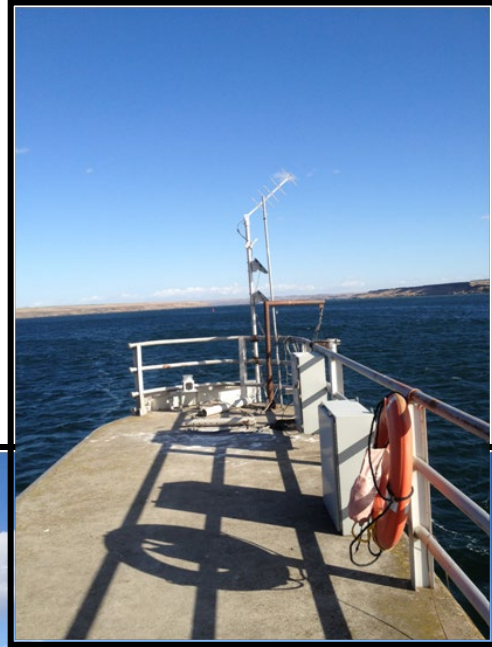
22. McNary Forebay TDG Monitoring Station (MCNA)

Gage Elevation: Variable
Latitude: 45° 56' 28.92" N
Longitude: 119° 17' 35.44" W
Distance from Dam: 1,460 ft
Datum: NAD83
River: Columbia
River Mile: 292.3
USGS-ID: 14019220
Owner: U.S. Army Corps of Engineers-NWW
Gauge Type: Hydrosonde
Data Transmission: GOES Satellite
Dates of Operation: April 1 – Aug. 31*
Years of Operation: 2005 – Present
Water Conditions: Mixed
Location: At the end of the navigation lock guidewall near the Washington shoreline.
This gage replaced: MCQW (Washington side) and MCQO (Oregon side)
Reason for replacement: Moved due to thermal influences and lowered from 15 ft to 45 ft.
Comments: *The seasonal gauges may go in operation several days before April 1 and remain in operation several days after August 31.

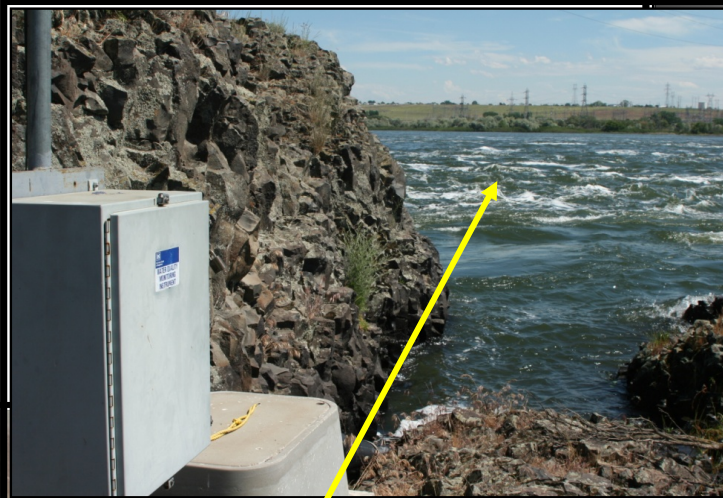
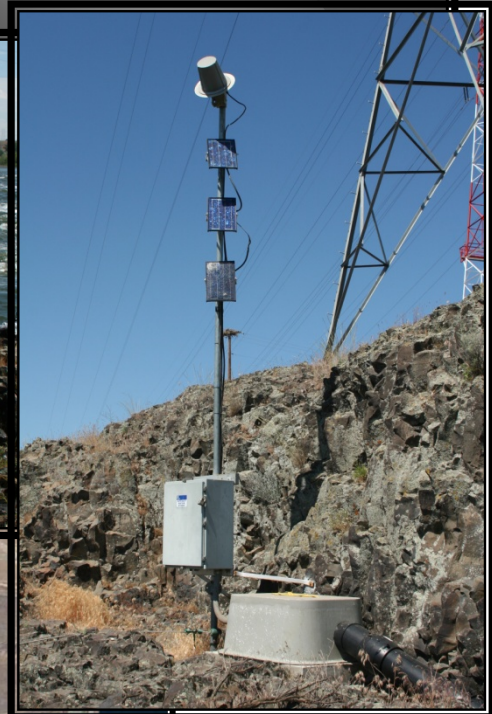
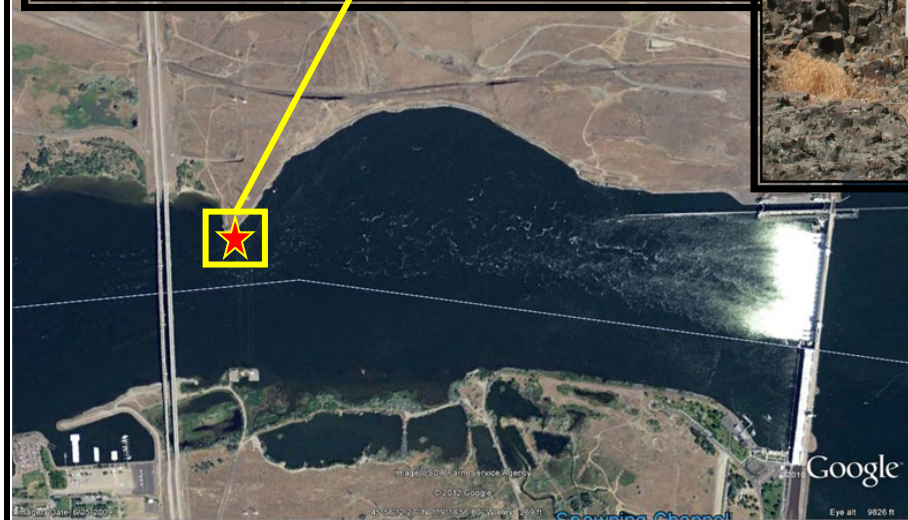
23. McNary Tailwater TDG Monitoring Station (MCPW)

Gage Elevation: Fixed
Latitude: 45° 56' 02.7775" N
Longitude: 119° 19' 35.4628" W
Distance from Dam: 1.3 miles
Datum: NAD83
River: Columbia
River Mile: 290.7
USGS-ID: 14019240
Owner: U.S. Army Corps of Engineers-NWW
Gauge Type: Hydrosonde
Data Transmission: GOES Satellite
Dates of Operation: Year around
Years of Operation: 1995 - Present
Water Conditions: Spillway
Location: On a rocky outcrop on the Washington shore and just upstream of the Highway 395 Bridge.
This gage replaced: N/A
Reason for replacement: N/A
Comments: --

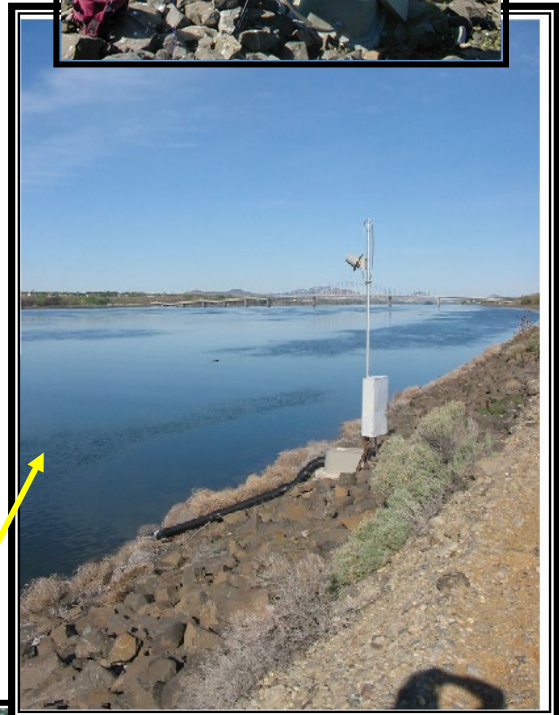
24. Pasco TDG Monitoring Station (PAQW)

Location: On the northern shore of the Columbia River between the S. 10th Avenue Bridge and the Highway 395 Bridge in Pasco, WA. It is on the levee adjacent to a wetland area near the Pasco Youth Baseball Complex. The site is within Lake Wallula approximately 5 miles upstream of the Snake River confluence.

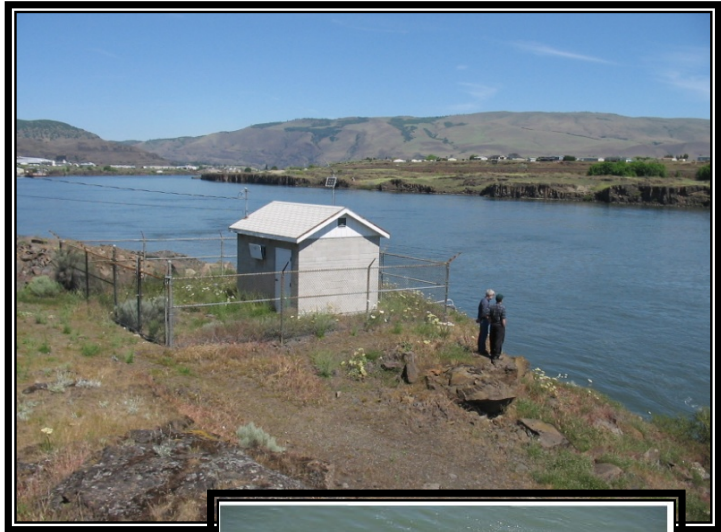
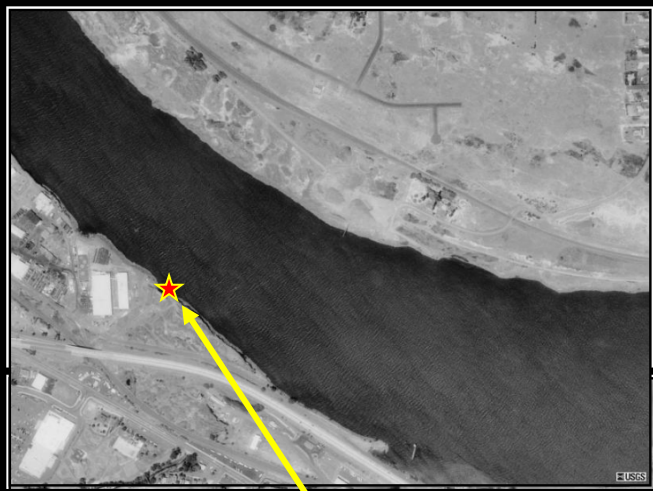
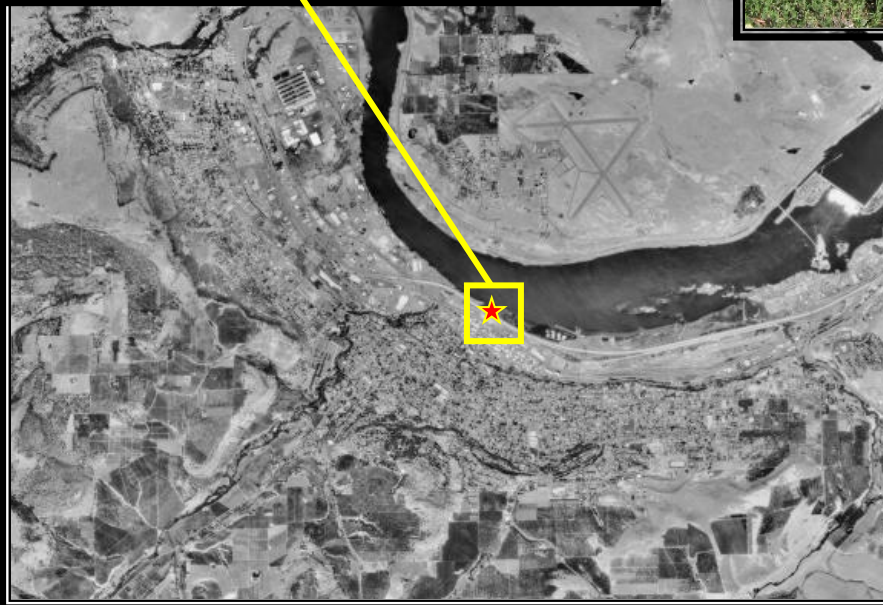
27. The Dalles Tailwater TDG Monitoring Station (TDDO)

Gage Elevation: Fixed (107.6 ft)
Latitude: 45° 36' 26.43330" N
Longitude: 121° 10' 24.25569" W
Distance from Dam: 2.5 miles
Datum: NAD83
River: Columbia
River Mile: 189.1
USGS-ID: 14105700
Owner: U.S. Army Corps of Engineers-NWP
Gauge Type: Hydrosonde
Data Transmission: GOES Satellite
Dates of Operation: Was seasonal prior to 2006, now year around
Years of Operation: 1996 – Present
Water Conditions: Mixed
Location: Off Bargeway Road from Webber Street, near industrial complex.
This gage replaced: N/A
Reason for replacement: N/A
Comments: --

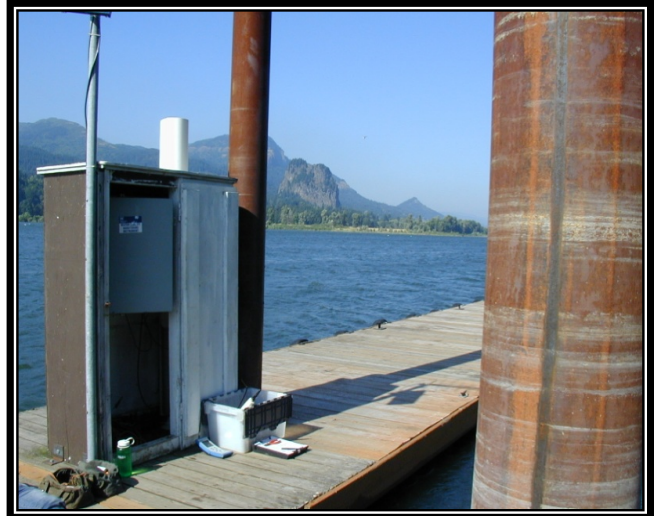
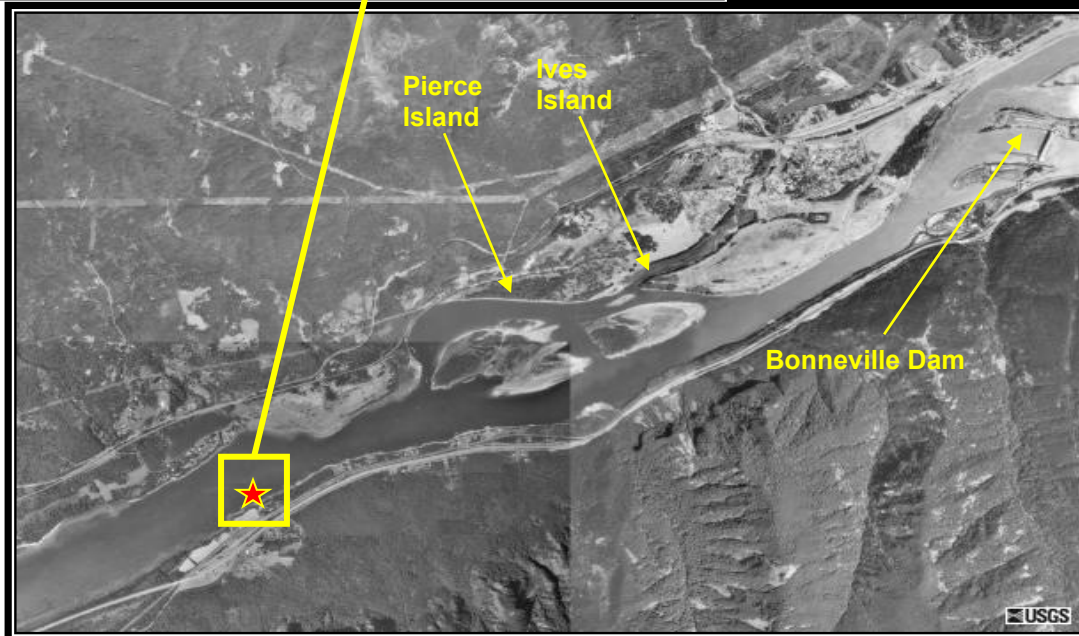
28. Warrendale TDG Monitoring Station (WRNO)

Gage Elevation: Variable
Latitude: 45° 36' 29.42299" N
Longitude: 122° 02' 18.30278" W
Distance from Dam: Approximately 6 miles downstream of dam
Datum: NAD83
River: Columbia
River Mile: 140.3
USGS-ID: 453630122021400
Owner: U.S. Army Corps of Engineers-NWP
Gauge Type: Hydrosonde
Data Transmission: GOES Satellite
Dates of Operation: Year around
Years of Operation: 1985 – Present
Water Conditions: Mixed
Location: This gauge is fixed to the boat dock at “The Fishery” off NE Enquist Pl in Dodson, Oregon (Near Warrendale) approximately 6 miles downstream of Bonneville Dam.
This gage replaced: N/A
Reason for replacement: N/A
Comment: Up until the 2004 spill season, this gauge was used as the BON tailwater gauge for spill management and was operated year around. Currently, this gauge is being used as a fall, winter, and spring TDG monitor for Chum spawning.
