# **Appendix A**

**2024 Total Dissolved Gas**

**Fixed Monitoring Stations**

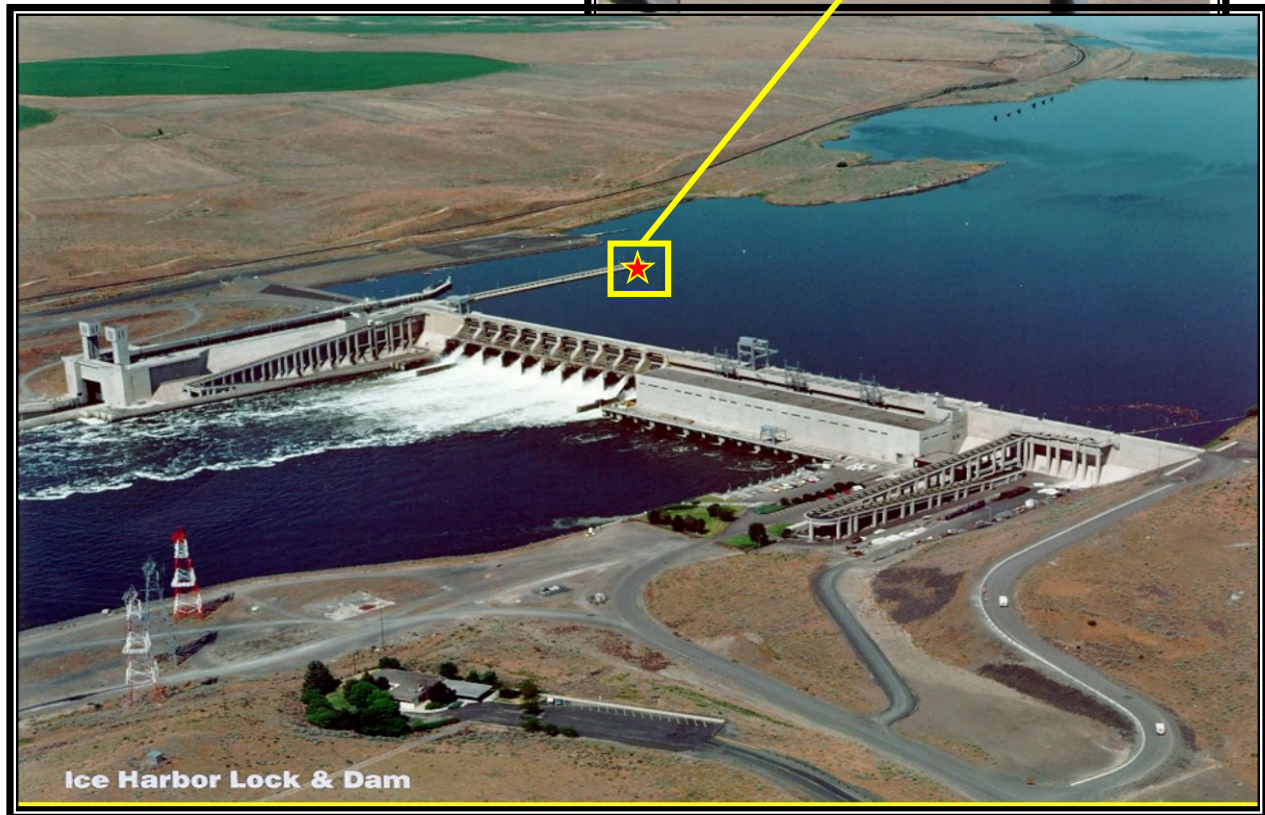
## 11. Ice Harbor Forebay TDG Monitoring Station (IHRA)

**Location:** At the upstream end of the navigation lock guidewall.

**Reason for replacement:** Moved due to thermal influences and lowered from 15 ft to 45 ft.

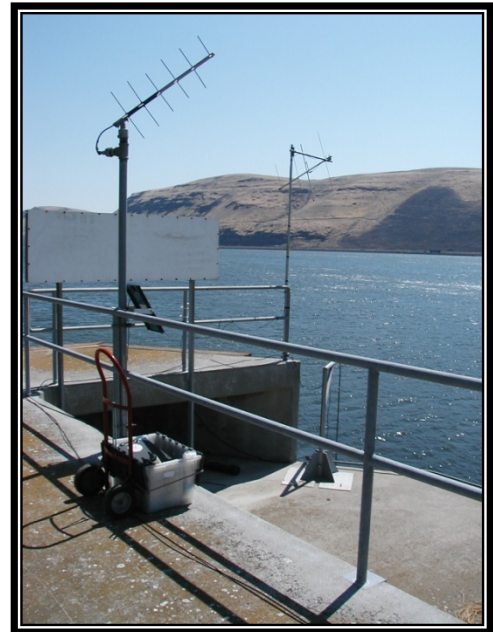
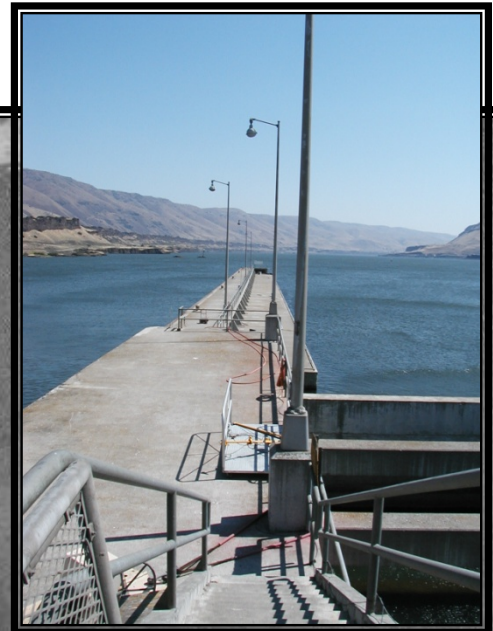
### 13. John Day Forebay TDG Monitoring Station (JDY)

**Location:** At upstream end of the navigation lock guidewall.

**Reason for replacement:** Moved due to thermal influences and lowered from 15 ft to 45 ft.

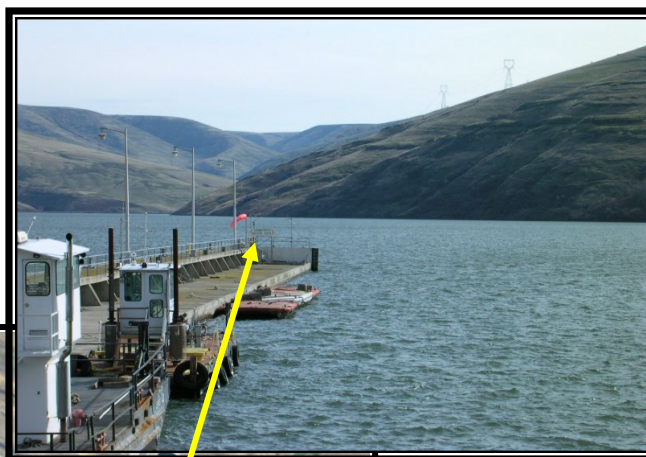
## 18. Lower Granite Forebay TDG Monitoring Station (LWG)

**Location:** At the upstream end of the navigation lock guidewall.

**Reason for replacement:** In March, 2005, this gauge was moved from a depth of 15 ft to 45 ft to avoid thermal influences. The geographic location of the gauge was not changed.
