Appendix A

**2025 Total Dissolved Gas
Fixed Monitoring Stations**

Figure A- 1: Total Dissolved Gas Fixed Monitoring Stations System

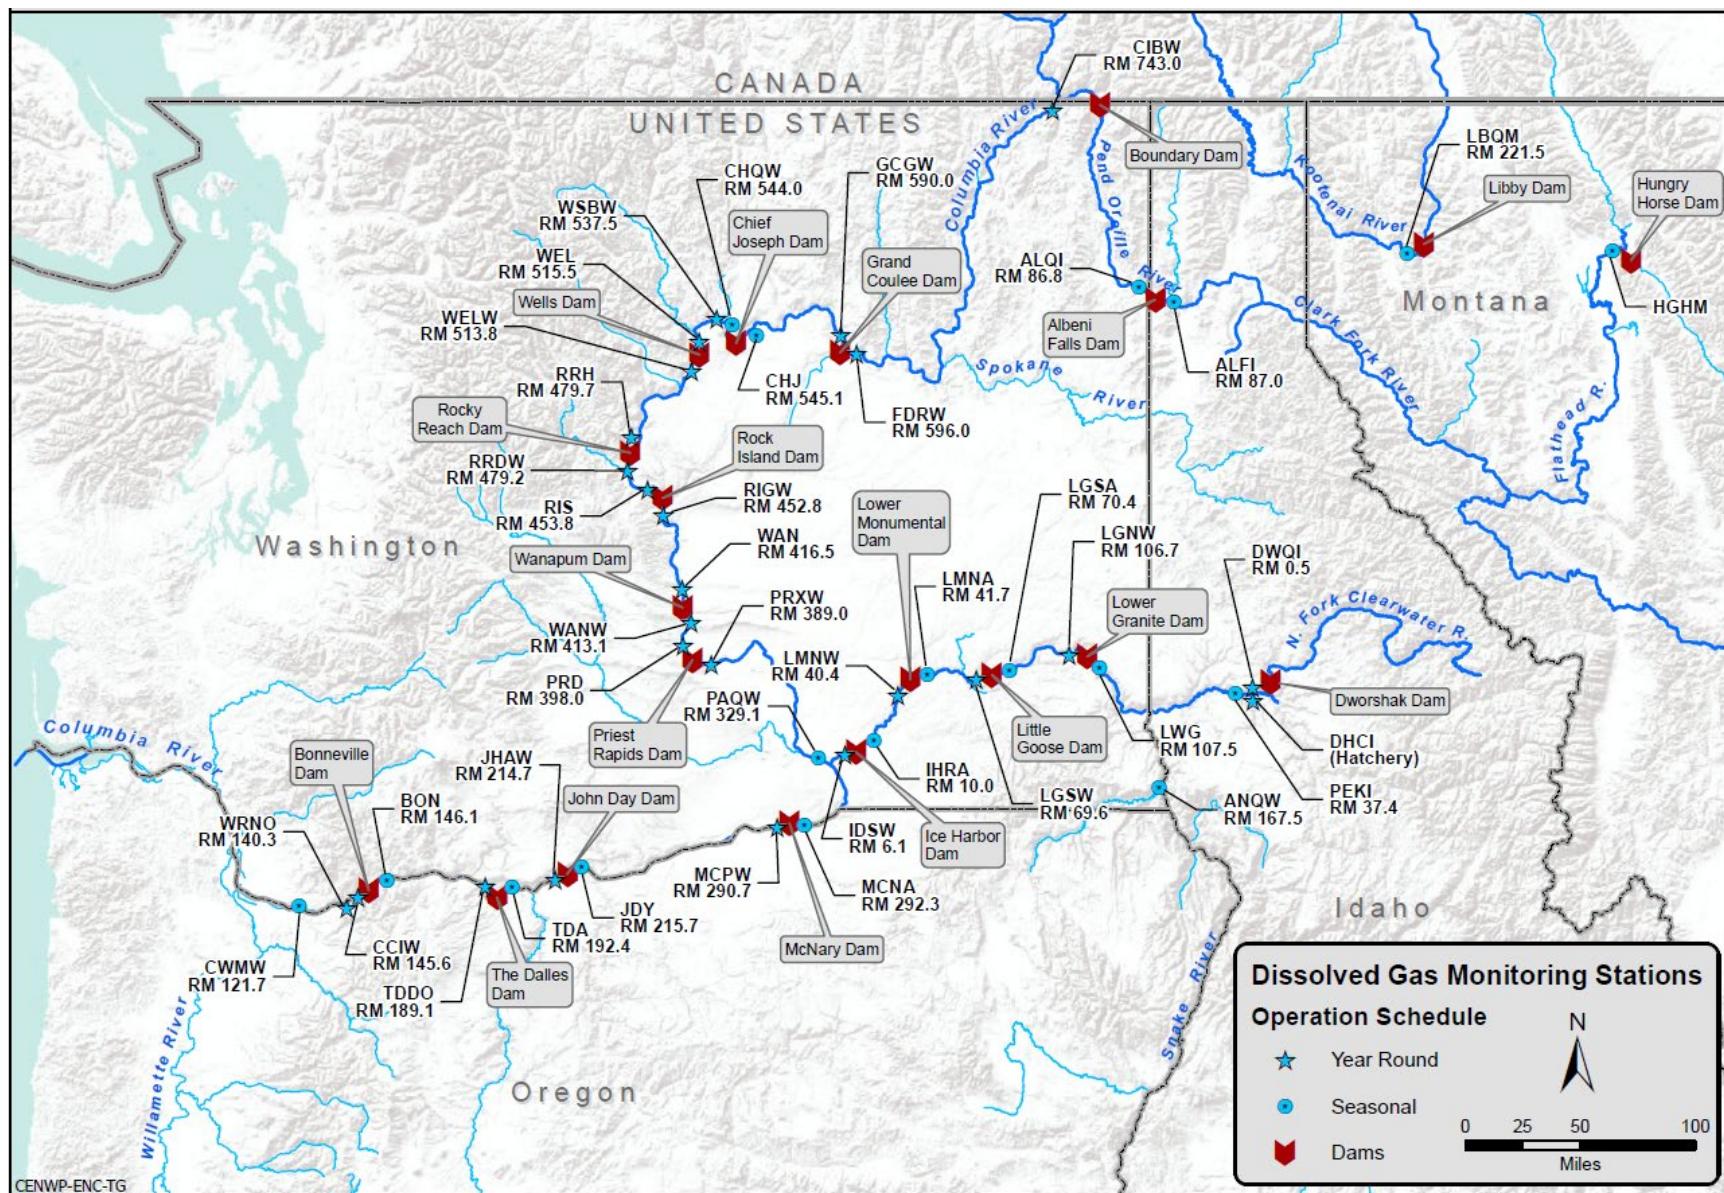
The Corps fixed monitoring station (FMS) system is composed of 27 active gauges that collect hourly readings of total dissolved gas (TDG), barometric pressure, percent TDG saturation, and water temperature. This monitoring system is associated with 19 projects on the Columbia, Lower Snake, Clearwater, Kootenai, and Pend Oreille rivers as shown in Figure 1. Table 1 lists each FMS identifying the station name, station code, dates of operation, river name, project, FMS location, and maintenance and calibration responsibilities. More details, including photos, for each station can be found on pages A-4 through A-30.

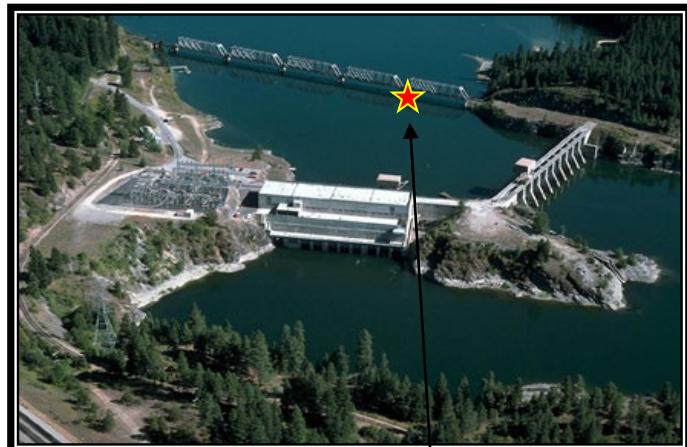
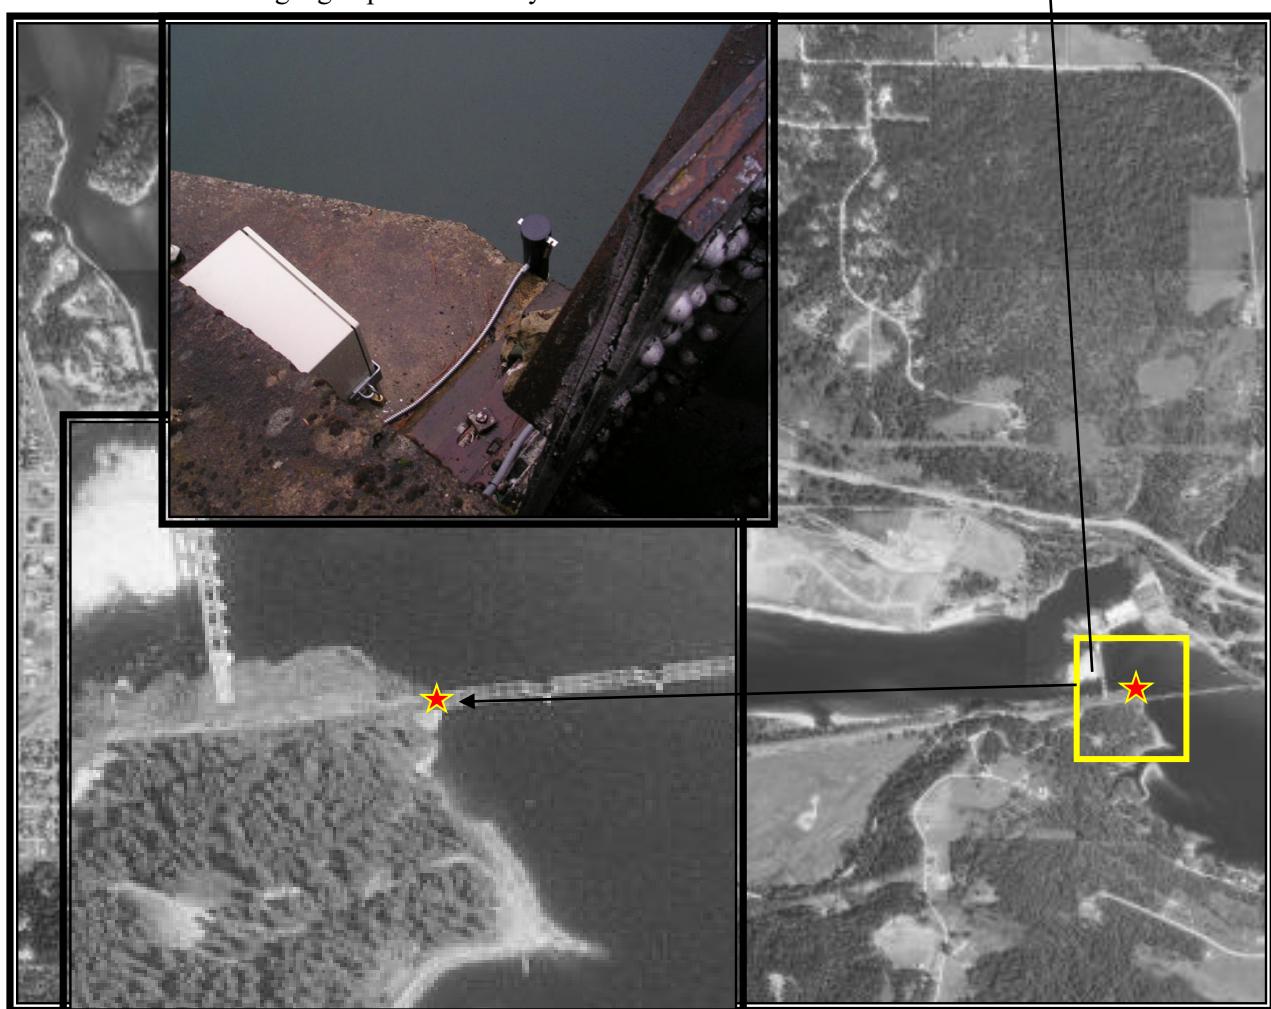
1. Albeni Falls Forebay TDG Monitoring Station (ALFI)

Location: Attached to the railroad bridge pier on the southern shoreline of the Pend Oreille River

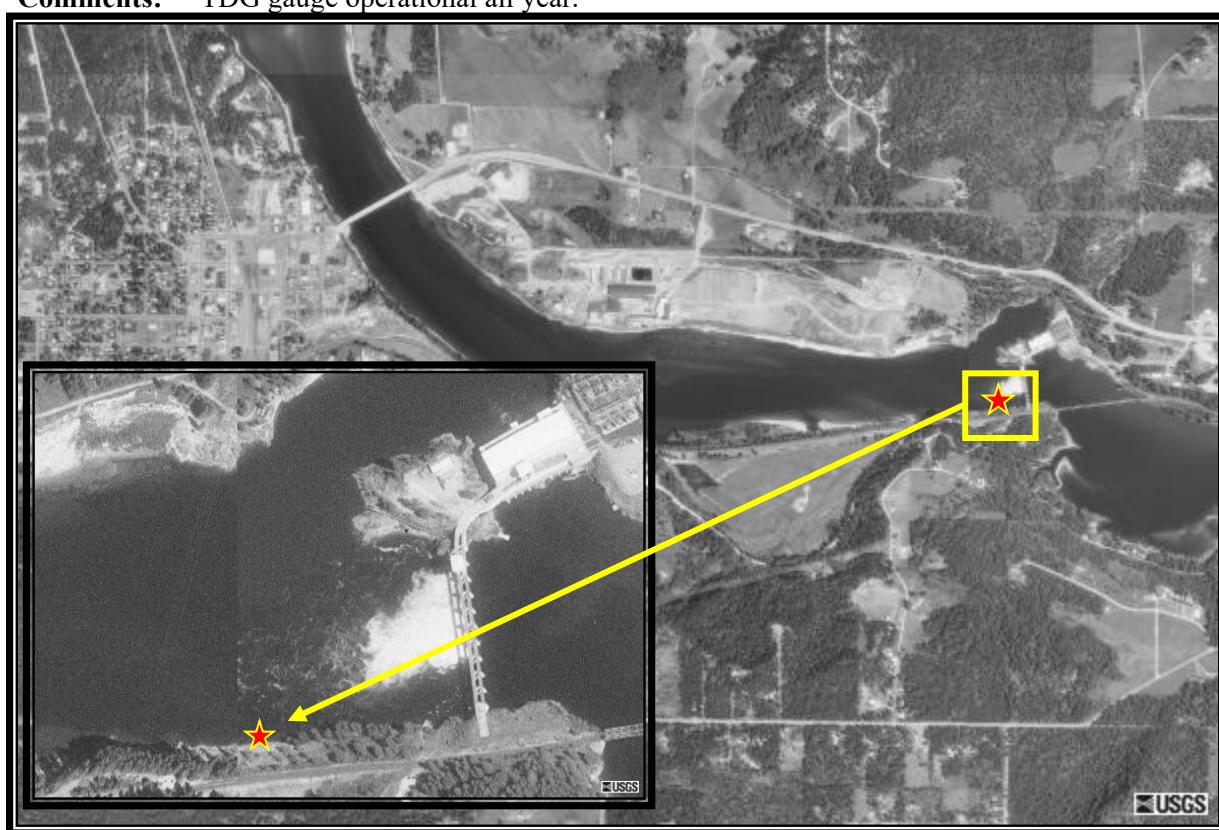
2. Albeni Falls Tailwater TDG Monitoring Station (ALQI)

Location: On the southern shoreline of the Pend Oreille River.

Reasons for replacement: This gauge was initiated at this site on July 28, 2005 due to sediment burying the previous site several times. This newer location is immediately below the spillway aerated zone in deeper water which should minimize sedimentation problems.

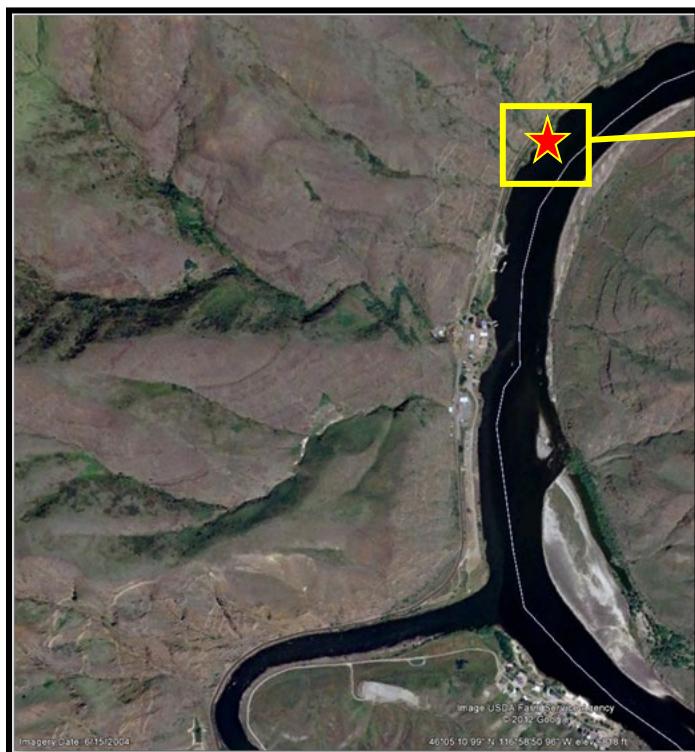
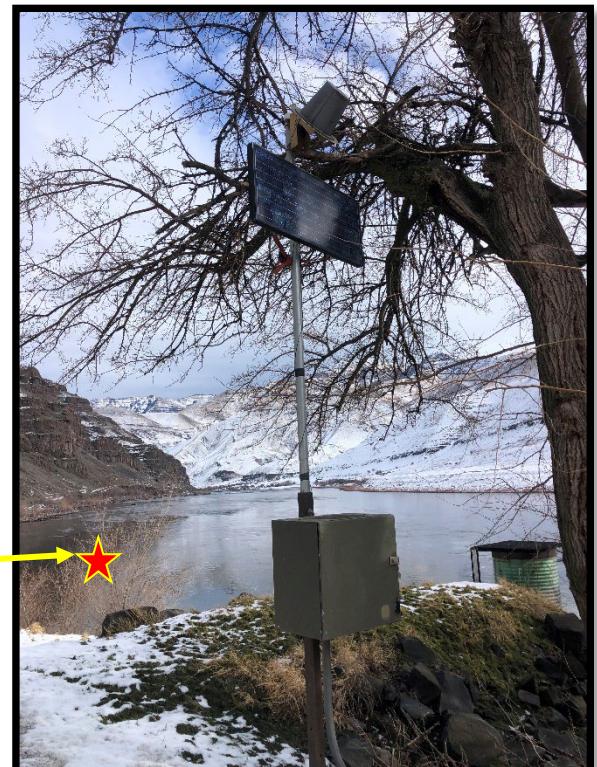
3. Anatone TDG Monitoring Station on the Snake River (ANQW)

Location: This gauge is located on the Washington shoreline of the Snake River approximately 1.3 miles downstream of the Grande Ronde River confluence. It is located 30-ft downstream of USGS Anatone Stream gauge (ANAW).

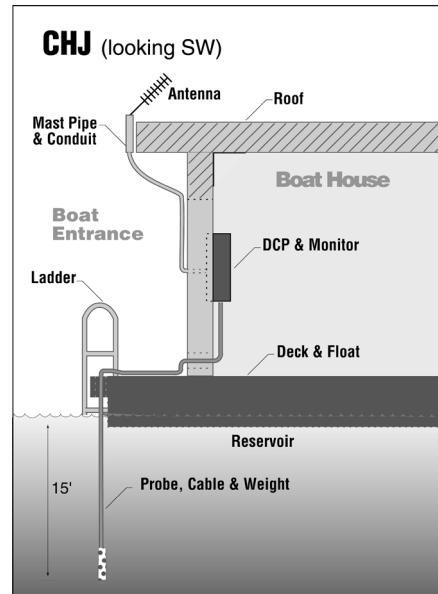
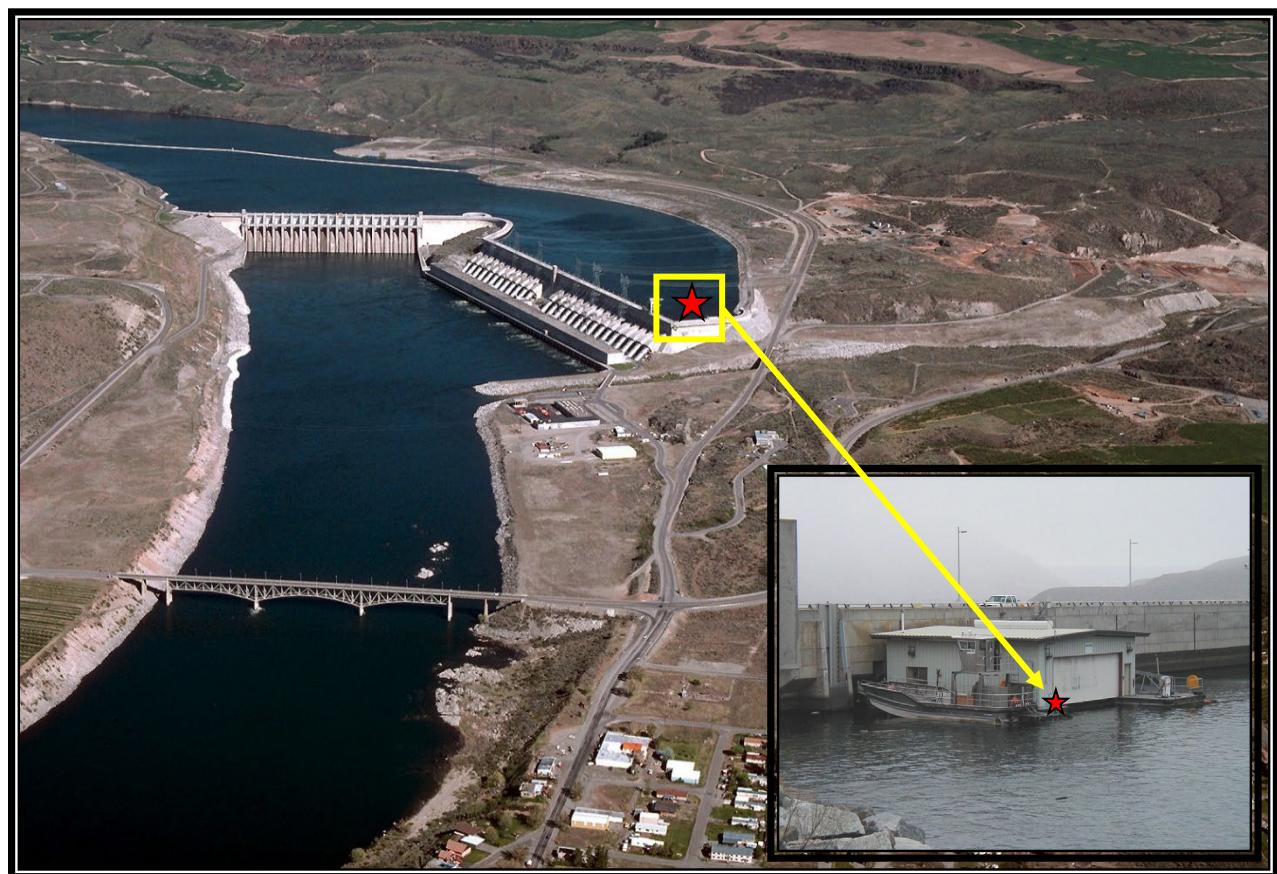
7. Chief Joseph Forebay TDG Monitoring Station (CHJ)

Location: Along the southern edge of Lake Rufus Woods (inside the boat house).

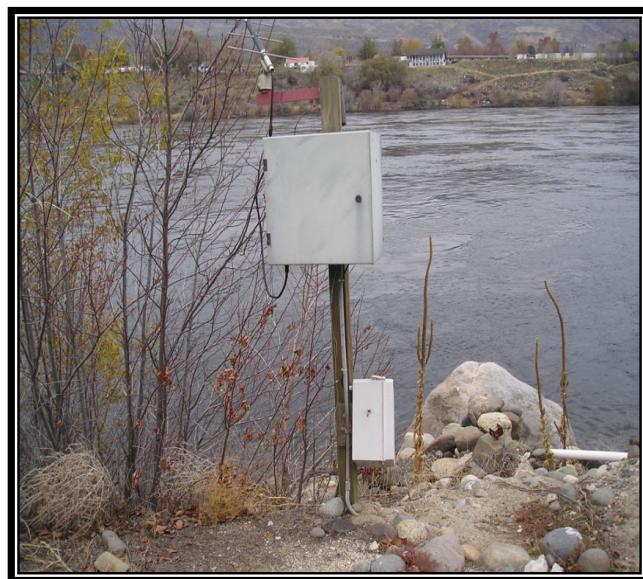
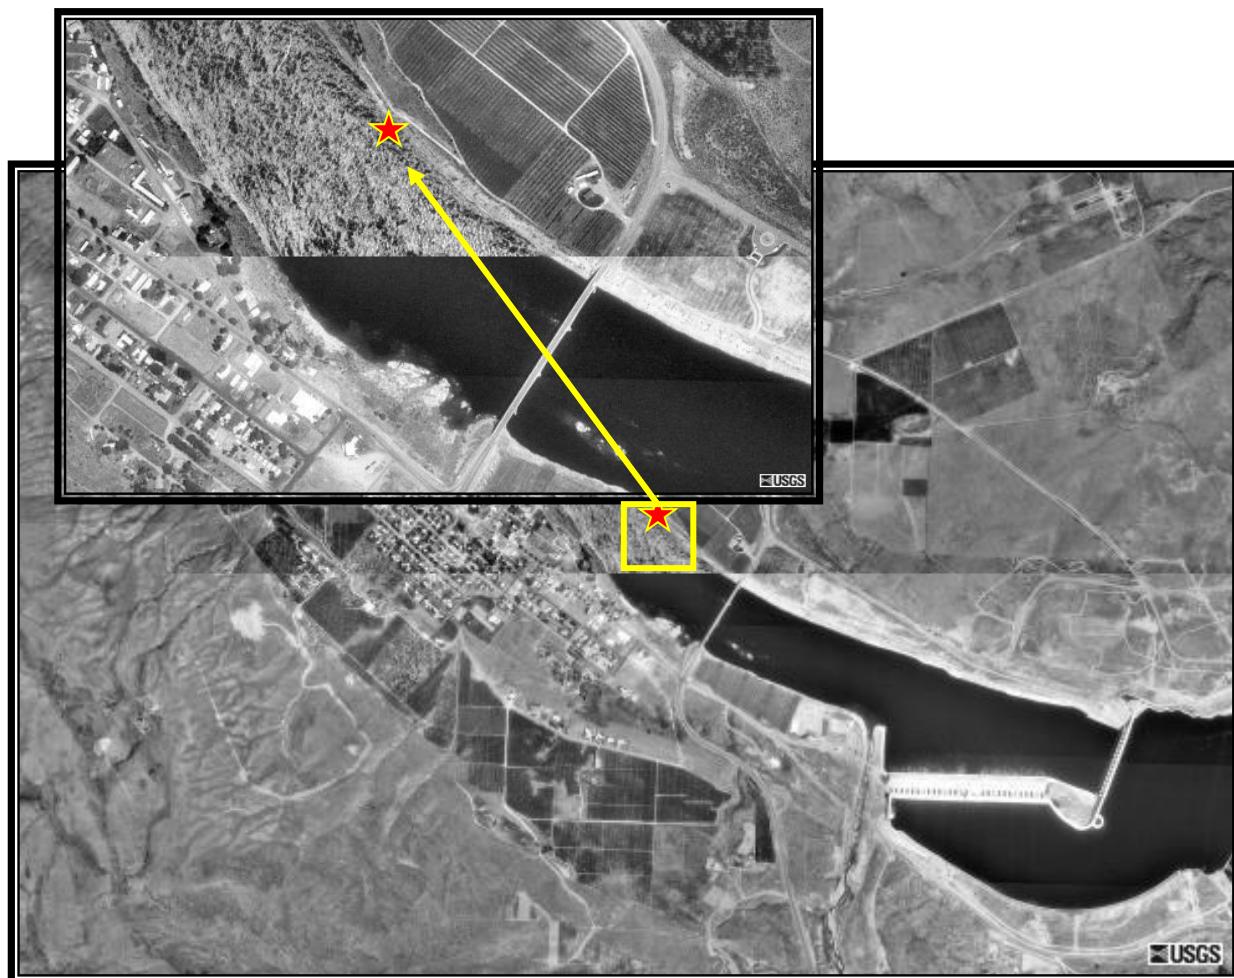
8. Chief Joseph Tailwater TDG Monitoring Station (CHQW)

Location: North bank of the river, just downstream of the Highway 17 Bridge.

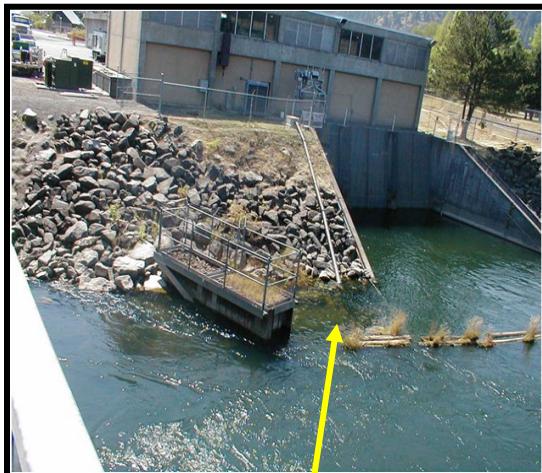
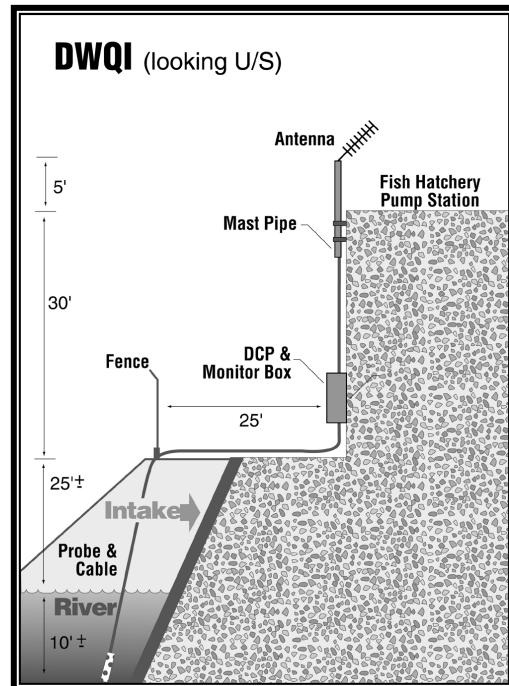
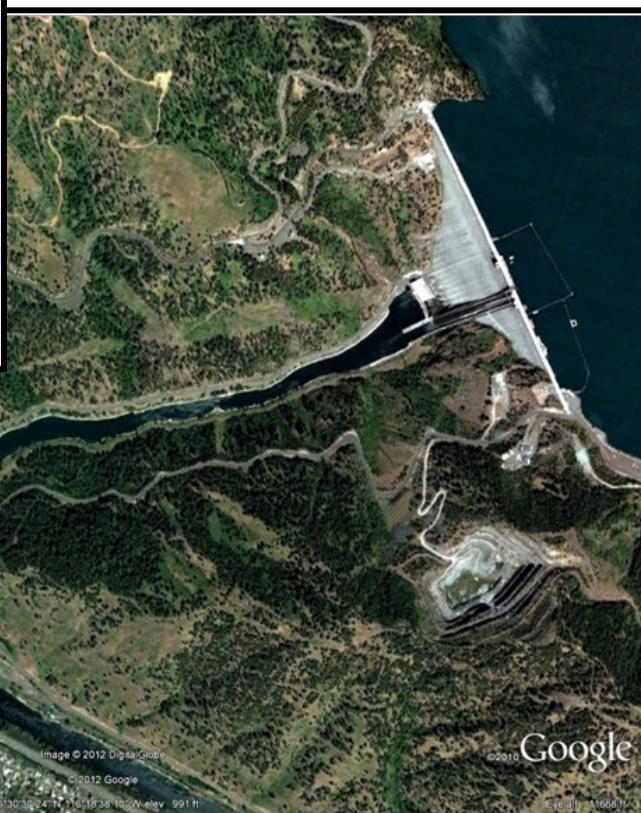
9. Dworshak TDG Monitoring Station (DWQI)

Location: On the southern bank of the North Fork, Clearwater River between the bridge and the Dworshak National Fish Hatchery outflow pipe.

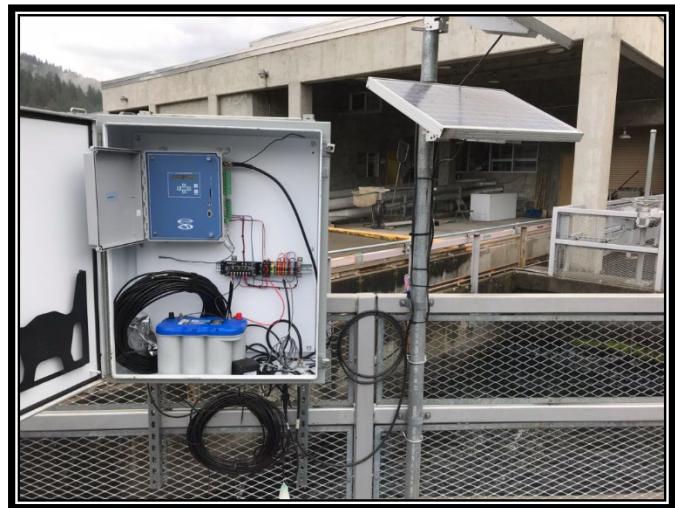
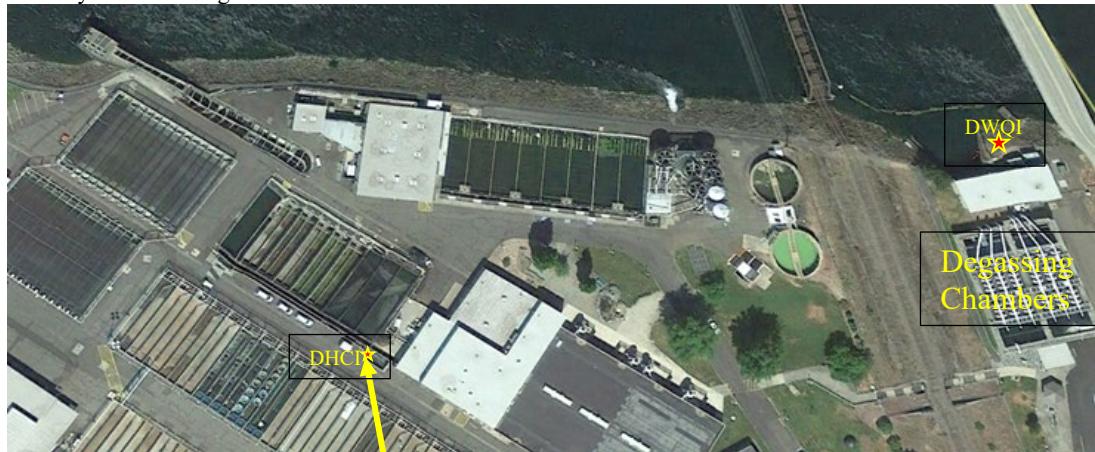
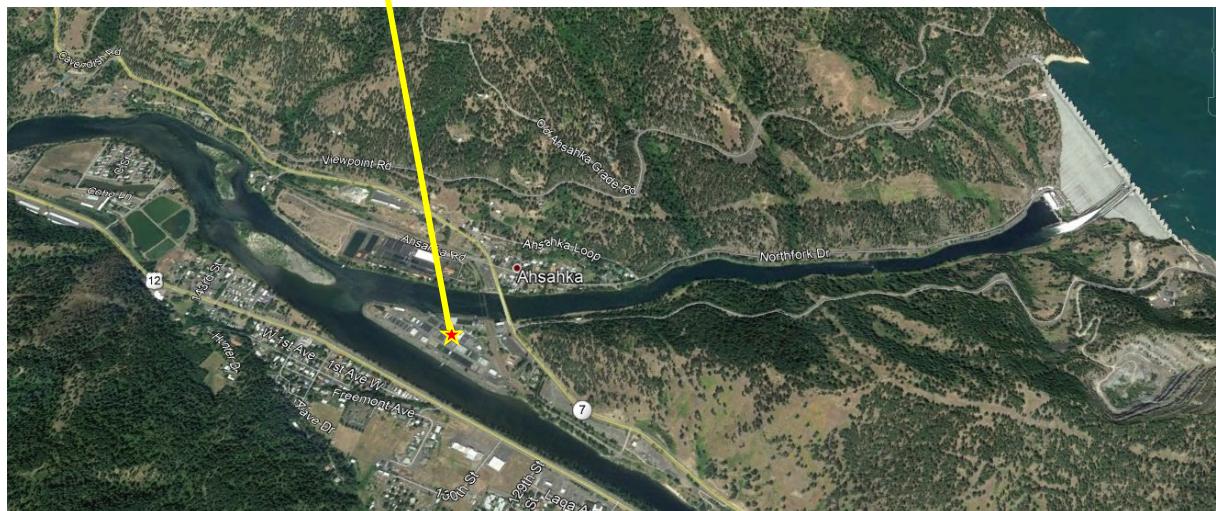
10. Dworshak Hatchery Collection Channel TDG Monitoring Station (DHCI)

Location: Gauge is located in a collection channel of the U.S. Fish and Wildlife Service Dworshak National Fish Hatchery.

Comments: This gauge is used to assess the TDG levels at Dworshak National Fish Hatchery during Dworshak Dam spill. The water being measured has been treated by the hatchery's vacuum degassers.

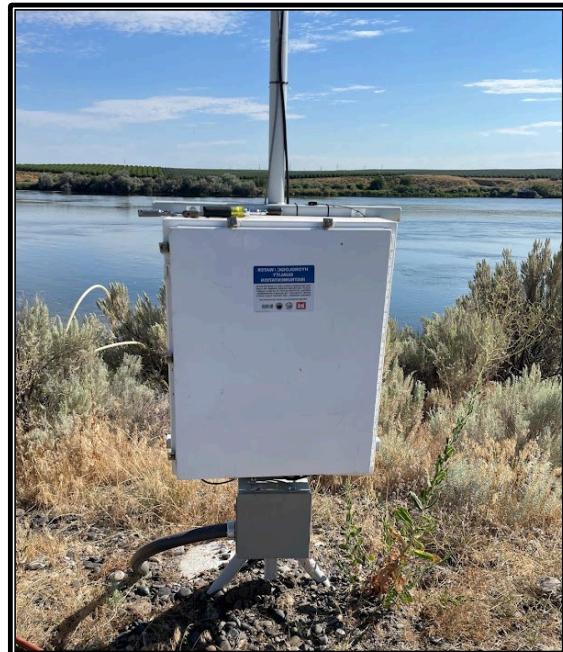
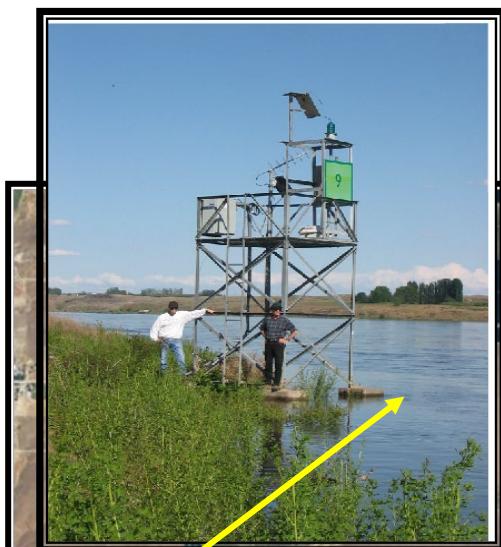
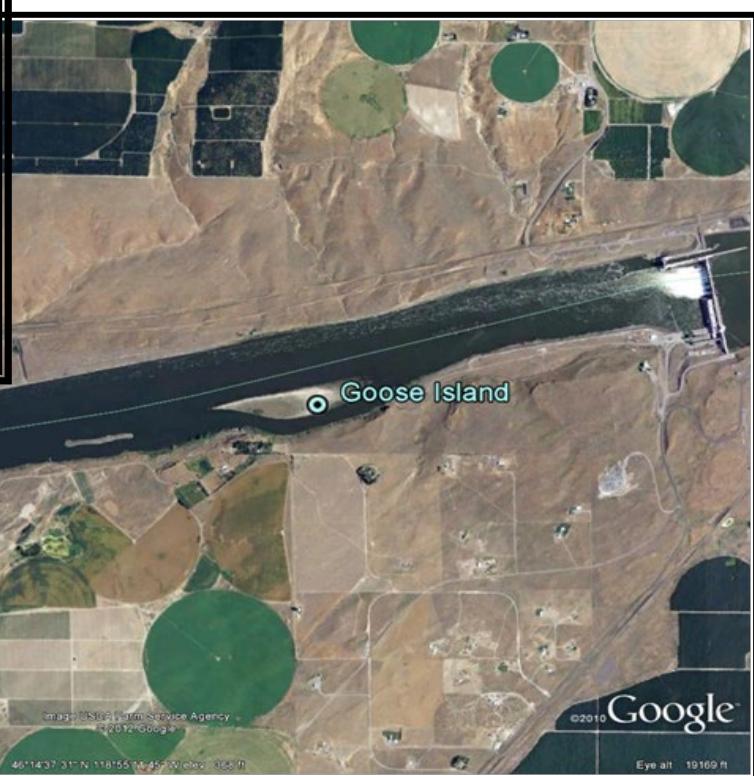
12. Ice Harbor Tailwater TDG Monitoring Station (IDSW)

Location: On the northern shore of the Snake River

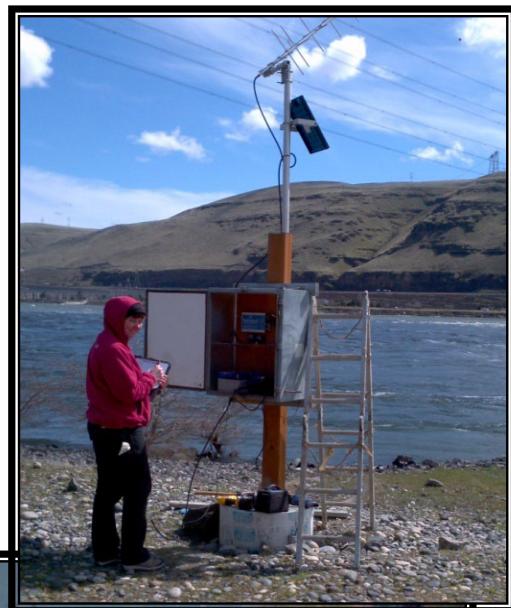
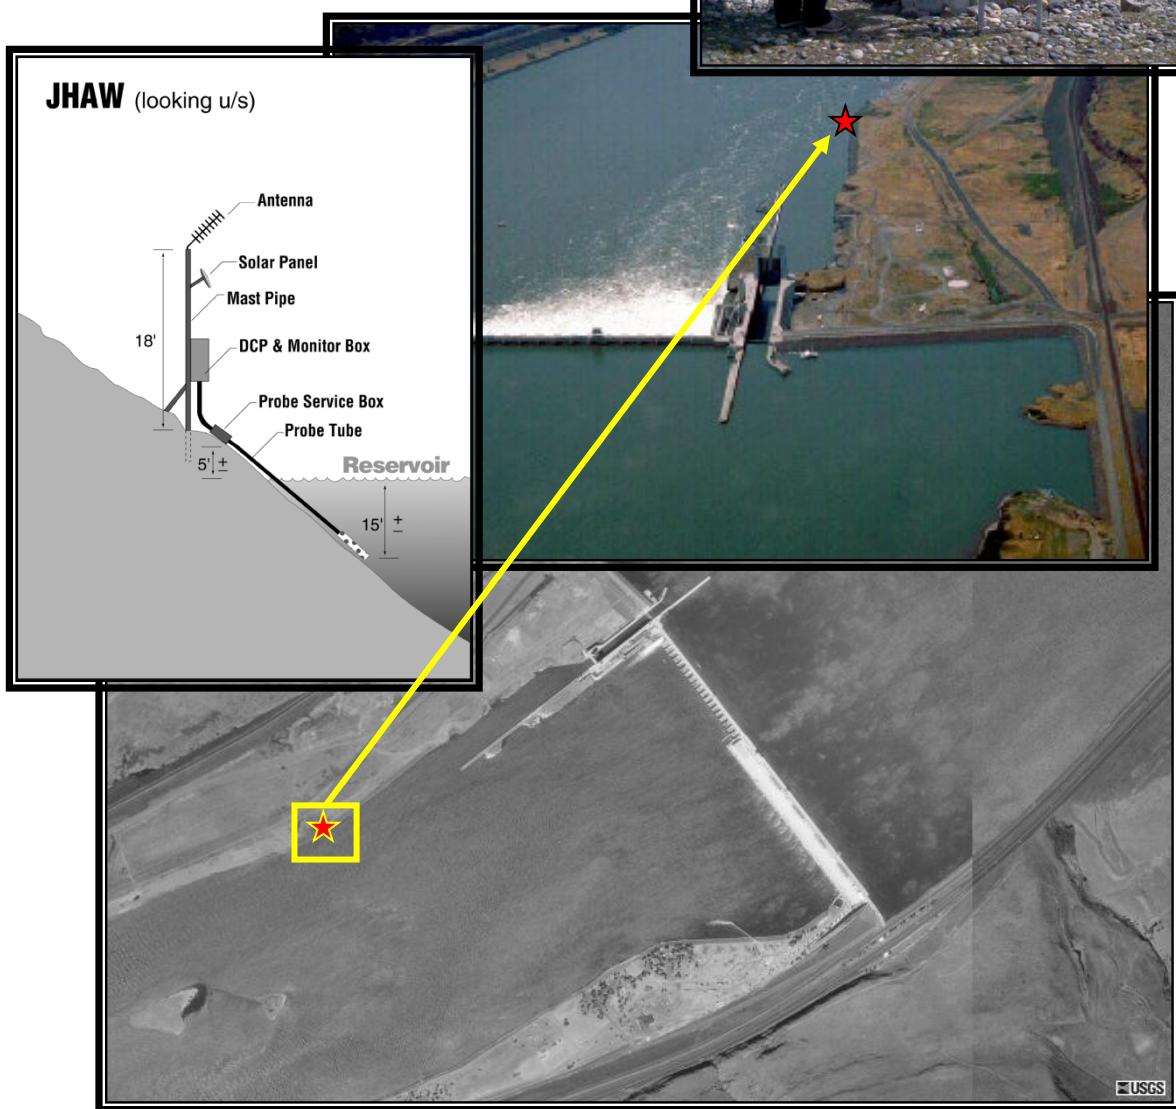
14. John Day Tailwater TDG Monitoring Station (JHAW)

Location: Other Washington shore.

Comments: Location of station moved about 12 feet higher elevation from shore, further up the hill.

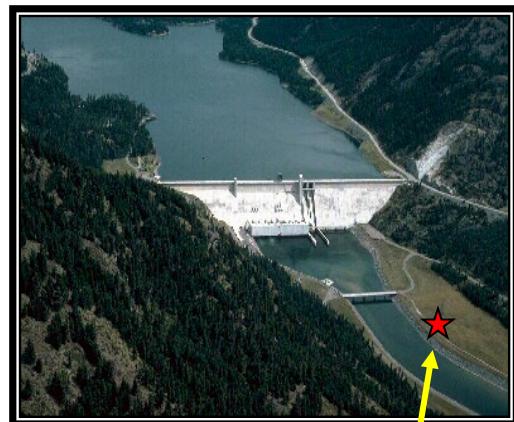
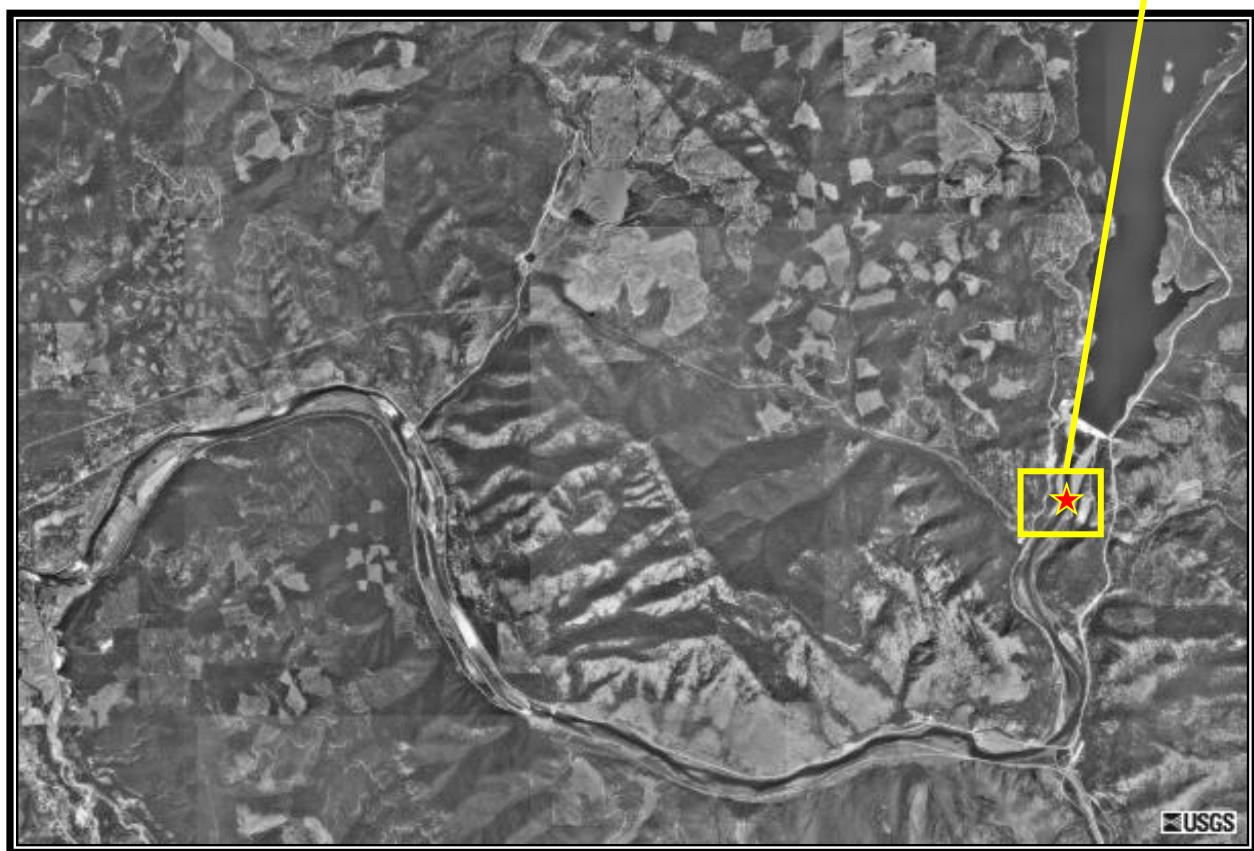
15. Libby Tailwater TDG Monitoring Station (LBQM)

Location: This gauge is located on the eastern shore of the Kootenai River approximately 750 feet downstream of the Libby Dam access road bridge.

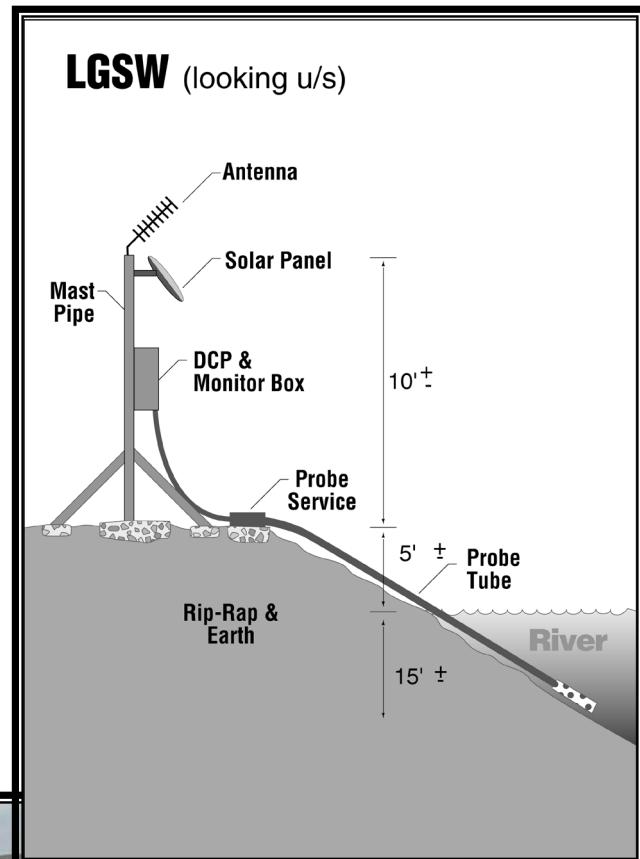
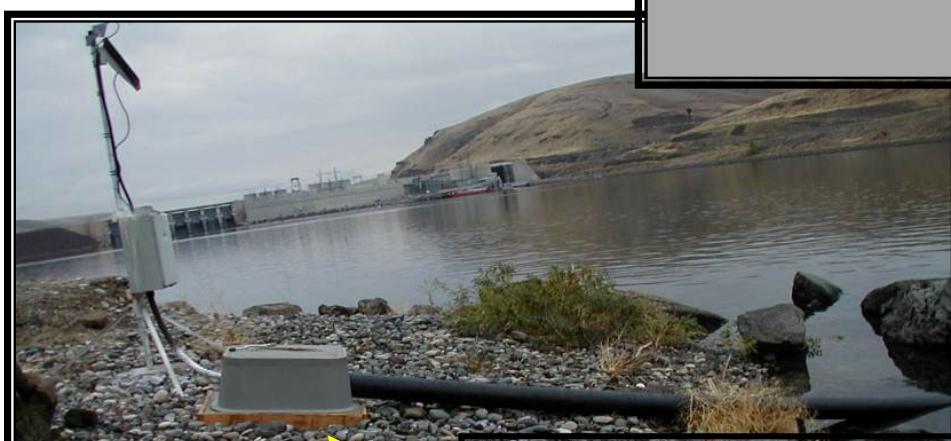
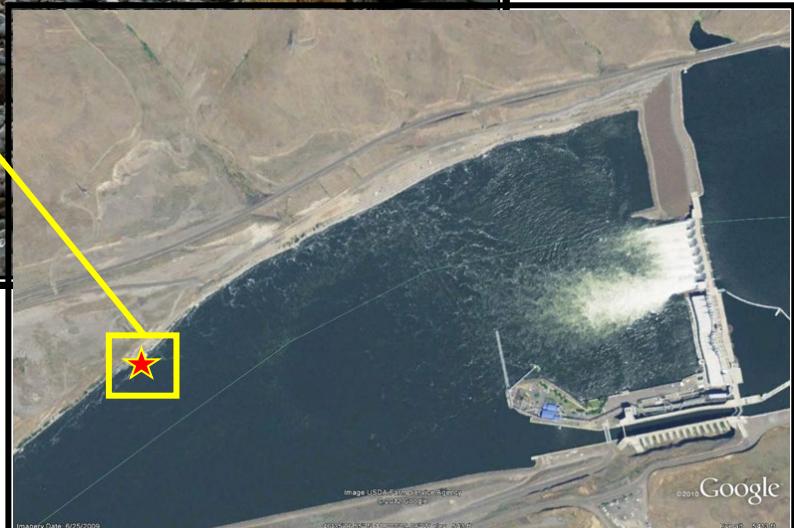
17. Little Goose Tailwater TDG Monitoring Station (LGSW)

Location: On the northern shore of the Snake River

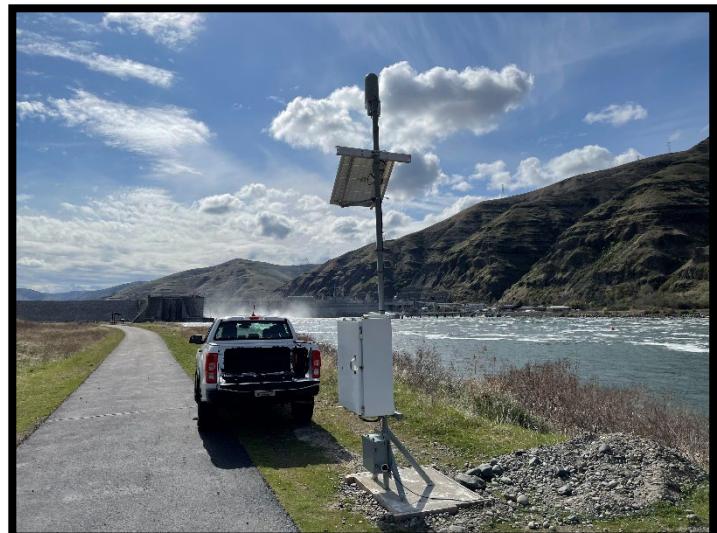
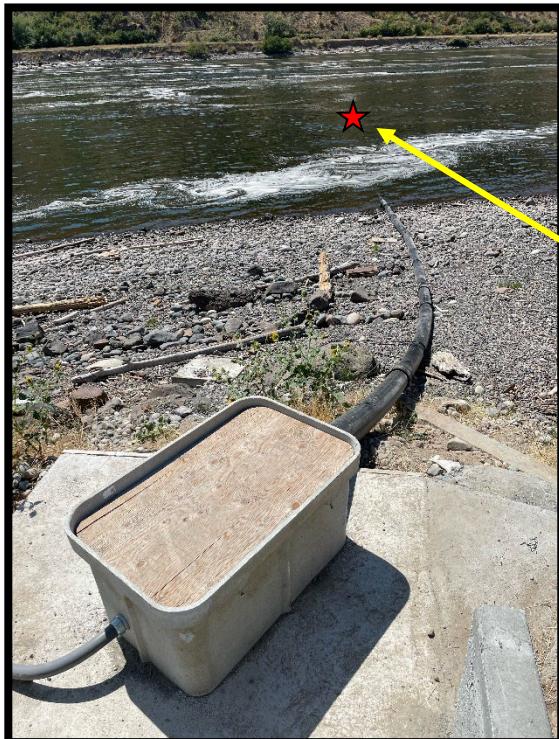
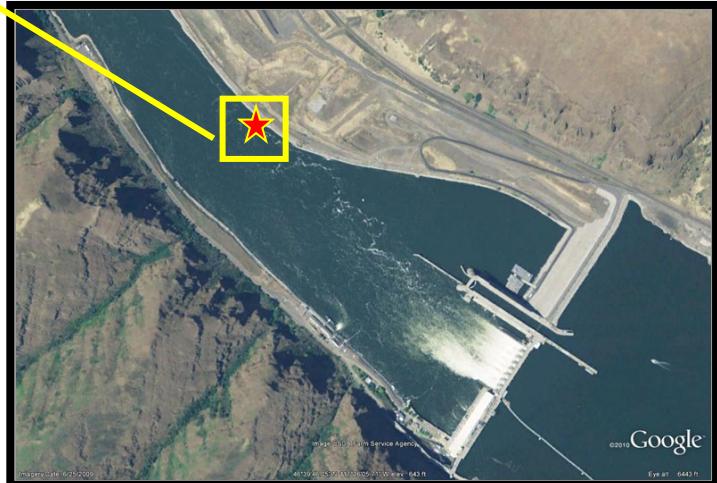
19. Lower Granite Tailwater TDG Monitoring Station (LGNW)

Location: On the northeastern shore of the Snake River.

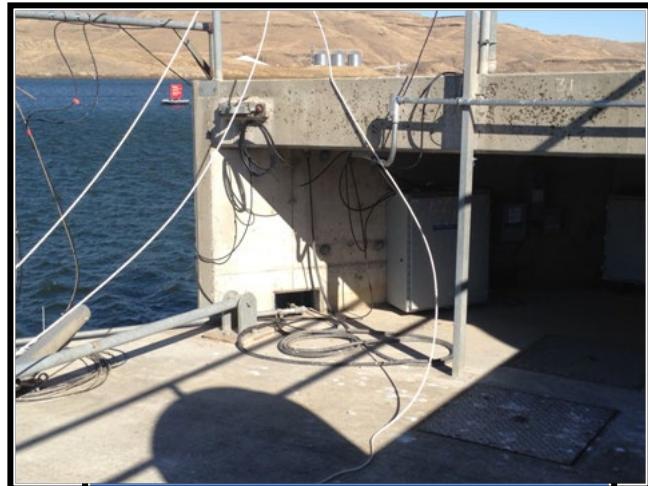
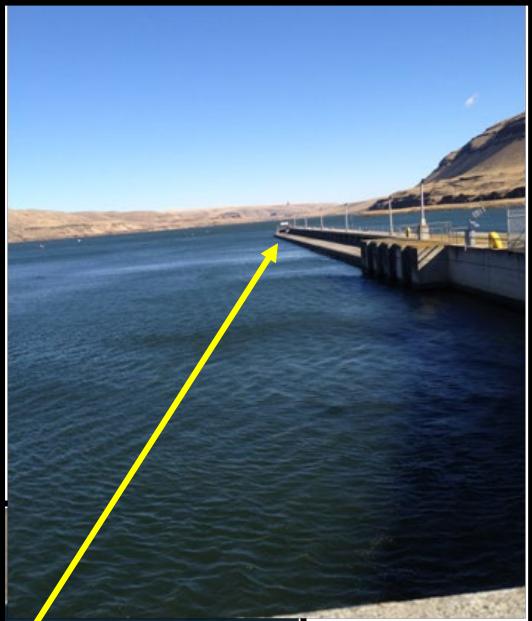
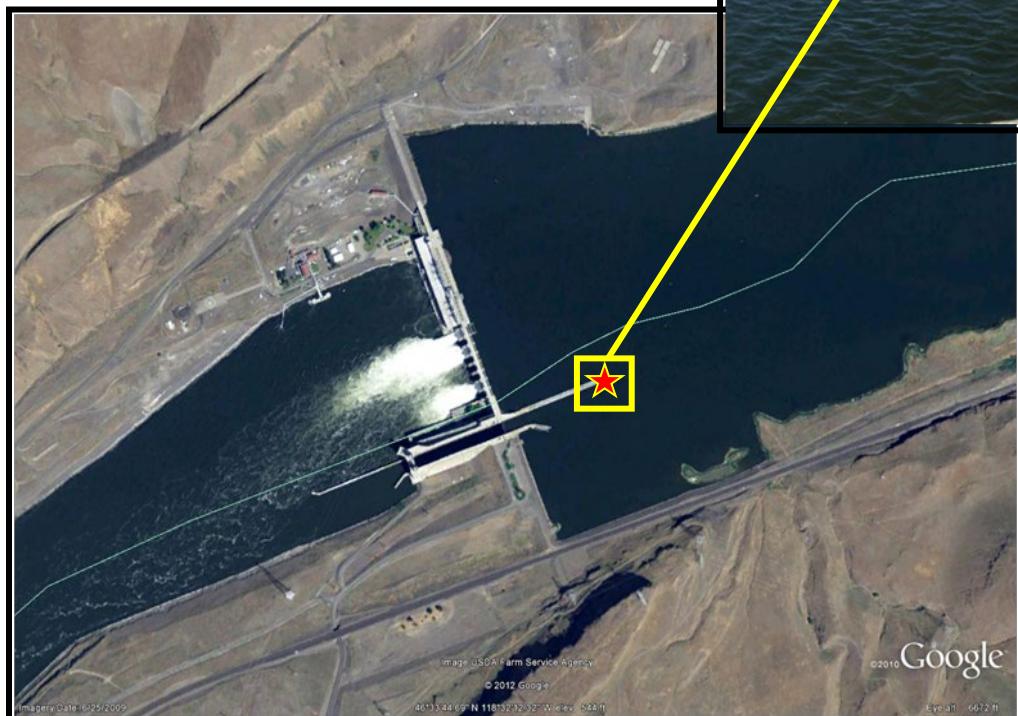
20. Lower Monumental Forebay TDG Monitoring Station (LMNA)

Location: At the upstream end of the navigation lock guidewall.

Reason for replacement: Moved due to thermal influences and lowered from 15 ft to 45 ft.

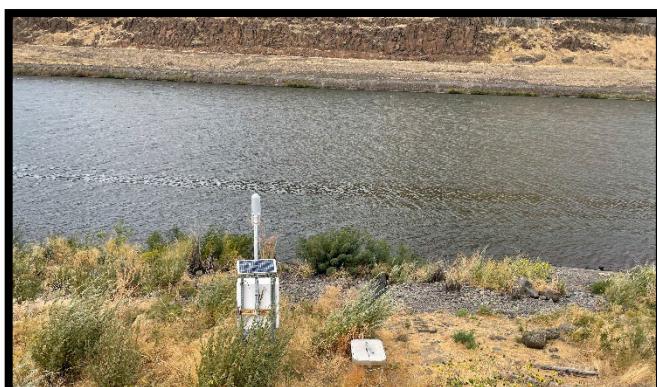
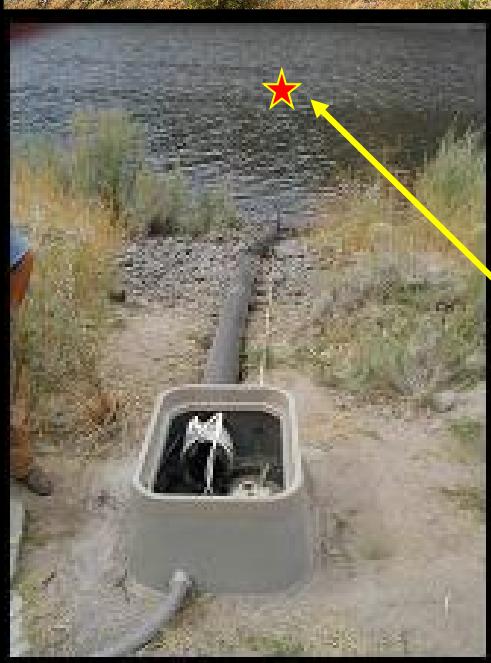
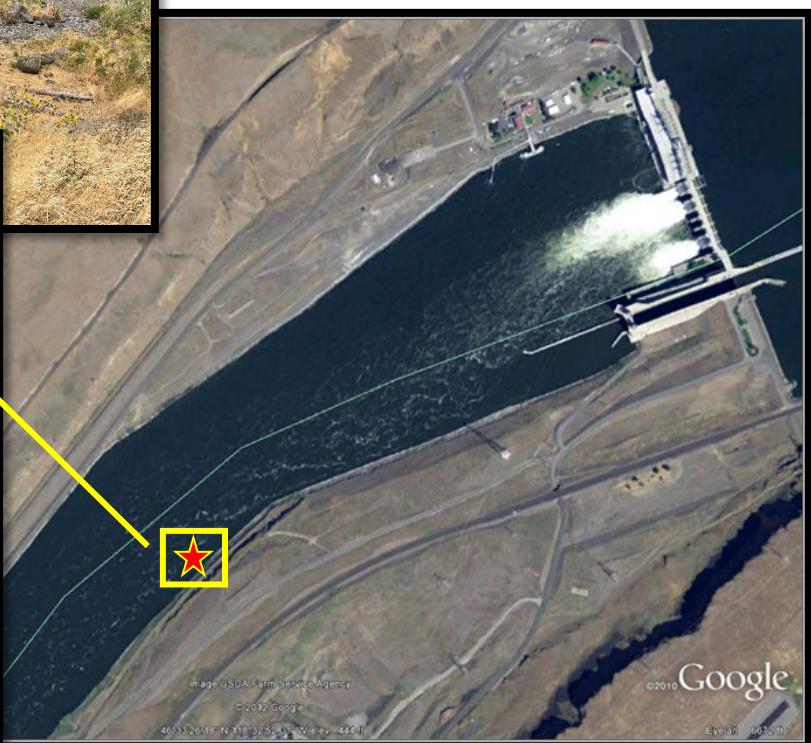
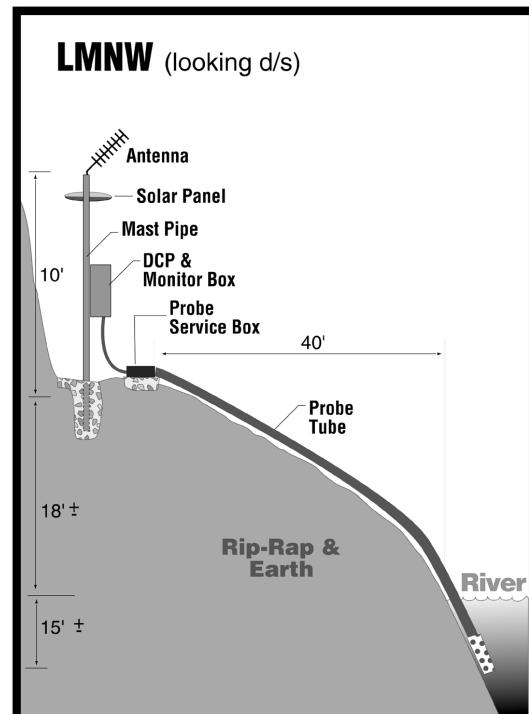
21. Lower Monumental Tailwater TDG Monitoring Station (LMNW)

Location: On the southeastern shore of the Snake River.

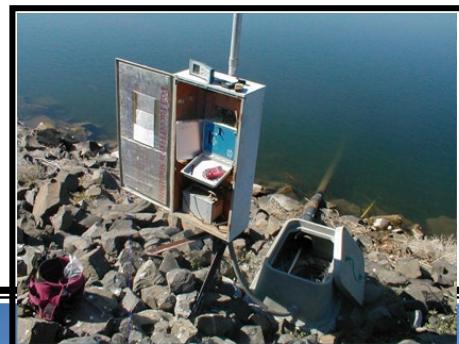
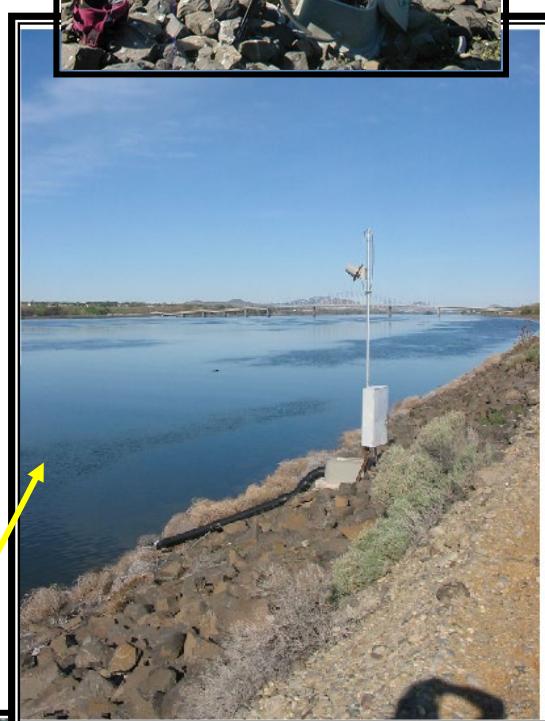
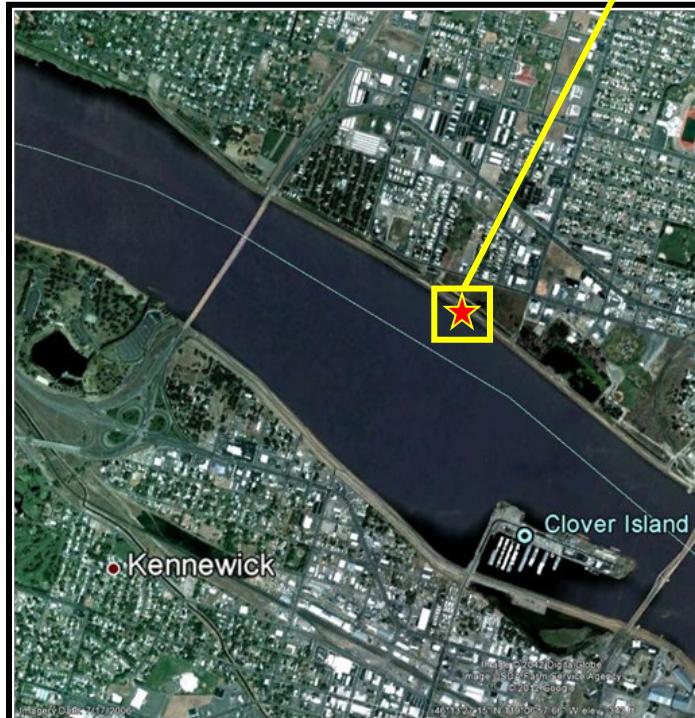
24. Pasco TDG Monitoring Station (PAQW)

Location: On the northern shore of the Columbia River between the S. 10th Avenue Bridge and the Highway 395 Bridge in Pasco, WA. It is on the levee adjacent to a wetland area near the Pasco Youth Baseball Complex. The site is within Lake Wallula approximately 5 miles upstream of the Snake River confluence.

PAQW (Looking Downstream)
