Appendix A

**2025 Total Dissolved Gas
Fixed Monitoring Stations**

Figure A- 1: Total Dissolved Gas Fixed Monitoring Stations System

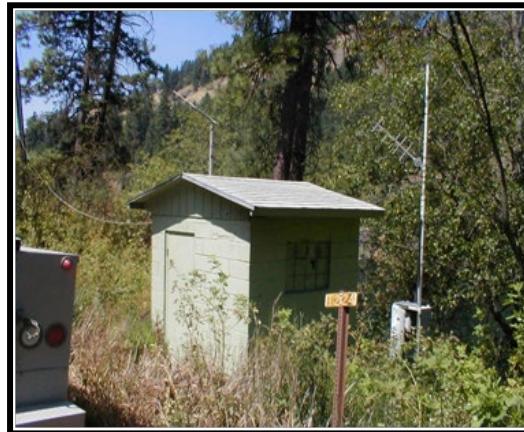
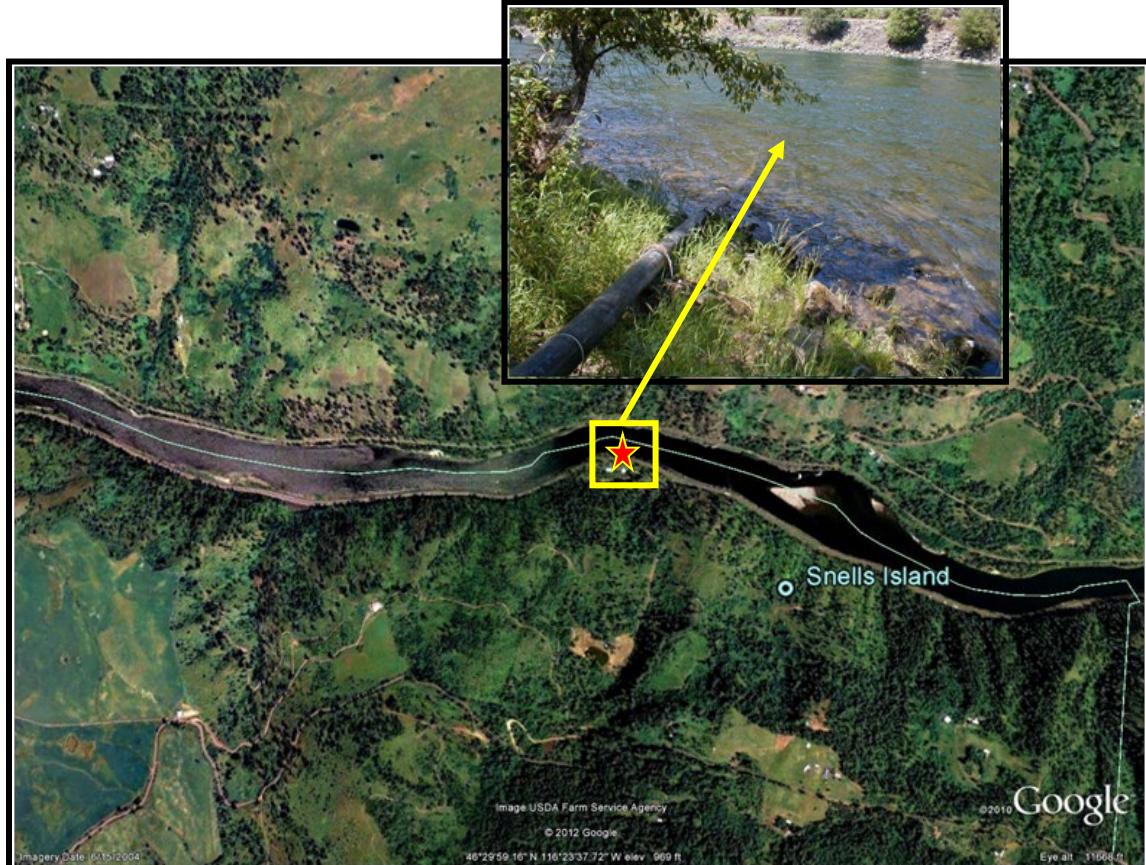
25. Peck TDG Monitoring Station (PEKI)

Location: On the southern shore of the Clearwater River approximately 3.5 miles downstream of the North Fork Clearwater River confluence. Collocated with USGS water quantity station.

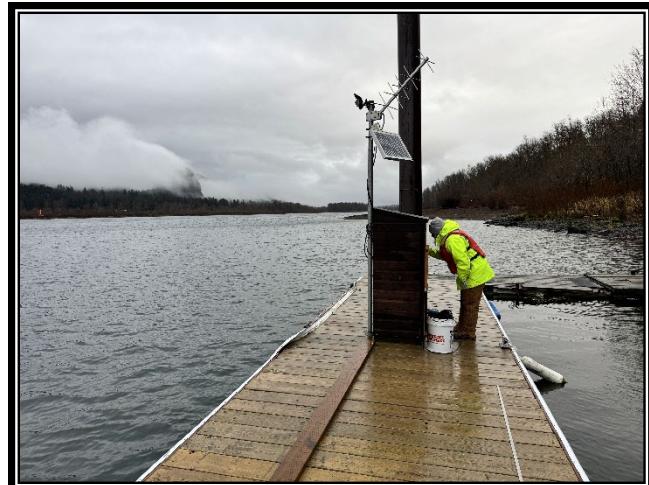
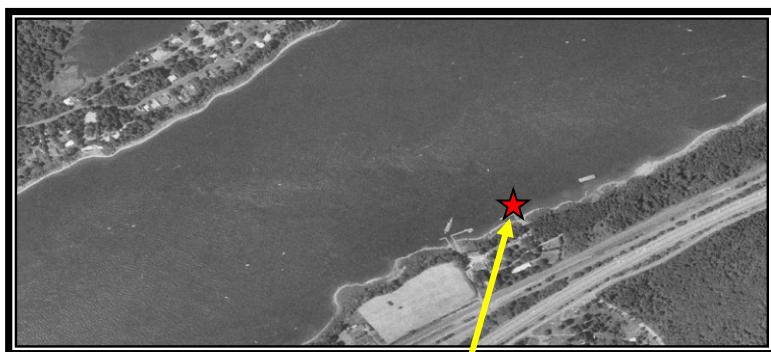
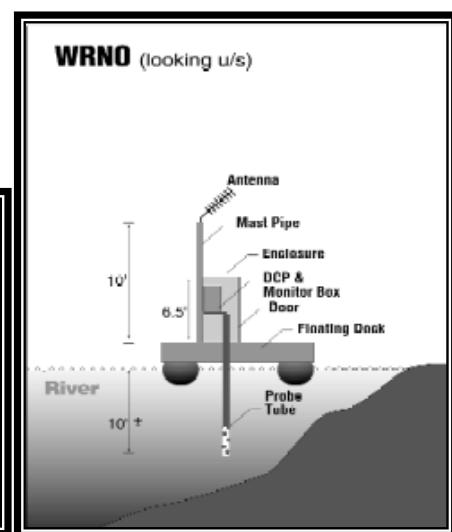
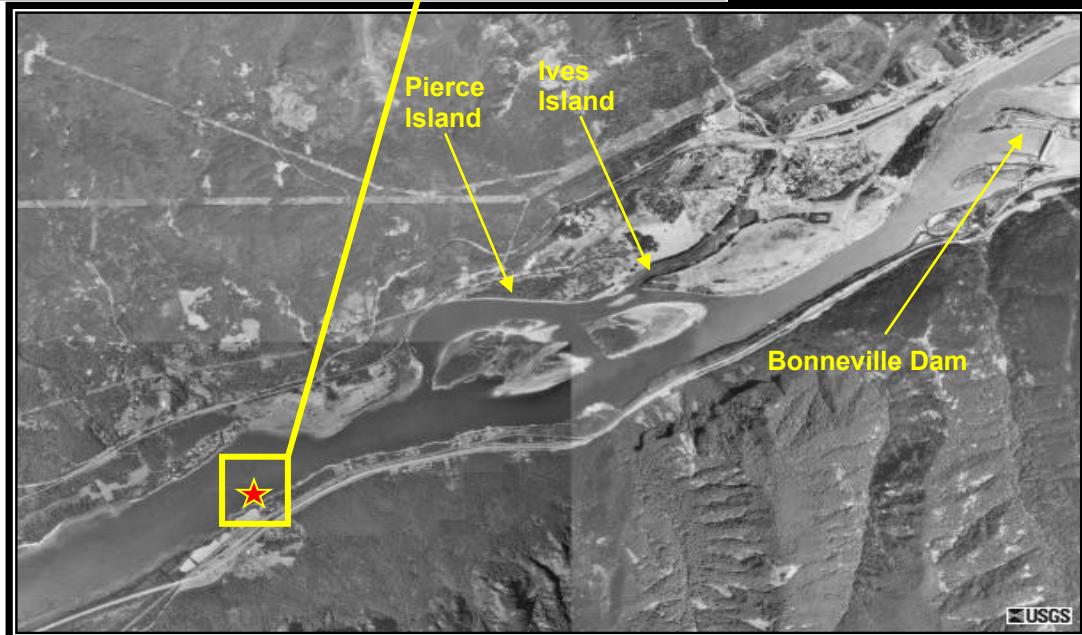
28. Warrendale TDG Monitoring Station (WRNO)

Location: This gauge is fixed to the boat dock at "The Fishery" off NE Enquist Pl in Dodson, Oregon (Near Warrendale) approximately 6 miles downstream of Bonneville Dam.

Comment: Up until the 2004 spill season, this gauge was used as the BON tailwater gauge for spill management and was operated year around. Currently, this gauge is being used as a fall, winter, and spring TDG monitor for Chum spawning. The gauge was moved to an upstream dock in 2022.
