Appendix A

**2021 Total Dissolved Gas
Fixed Monitoring Stations**

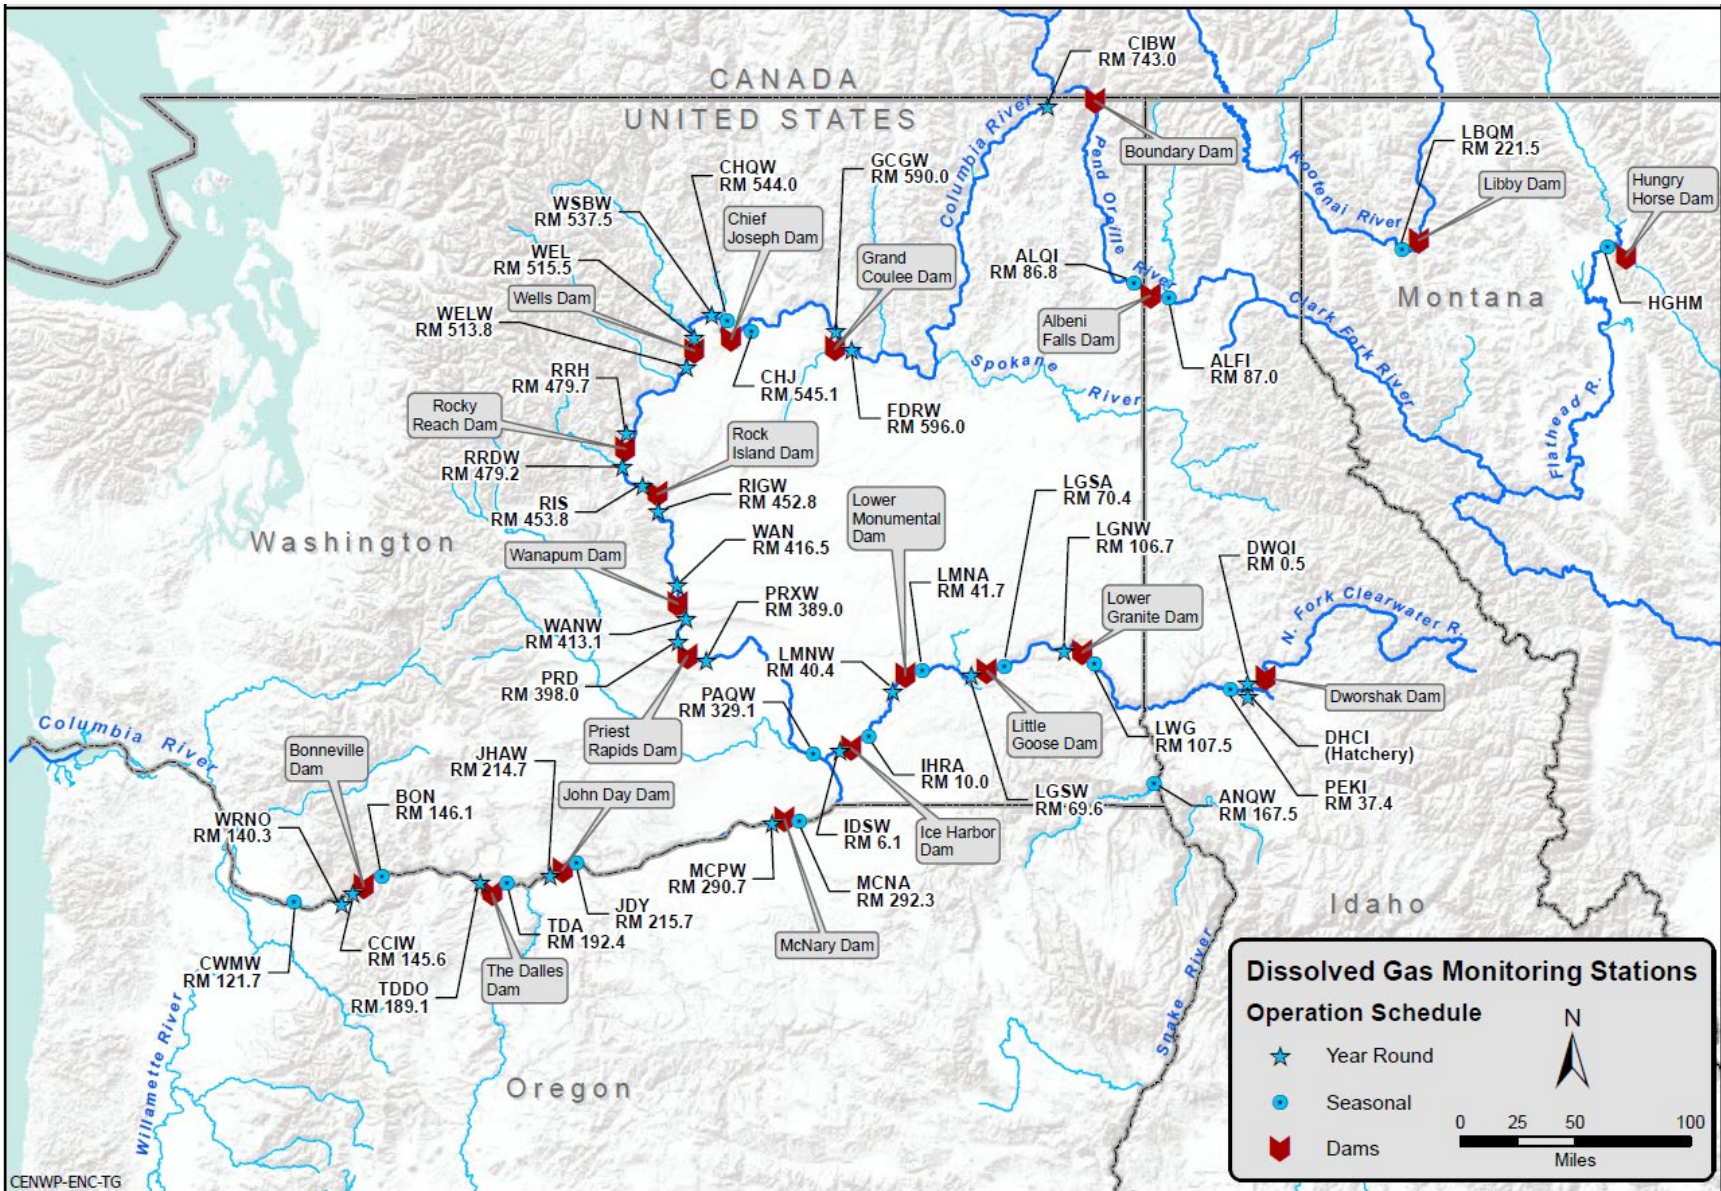
The Corps fixed monitoring station (FMS) system is composed of 28 (27 active) gauges that collect hourly readings of total dissolved gas (TDG), barometric pressure, percent TDG saturation, and water temperature. This monitoring system is associated with 19 projects on the Columbia, Lower Snake, Clearwater, Kootenai, and Pend Oreille rivers as shown in Figure 1. Table 1 lists each FMS identifying the station name, station code, dates of operation, river name, project, FMS location, and maintenance and calibration responsibilities. More details, including photos, for each station can be found on pages A-5 through A-32.

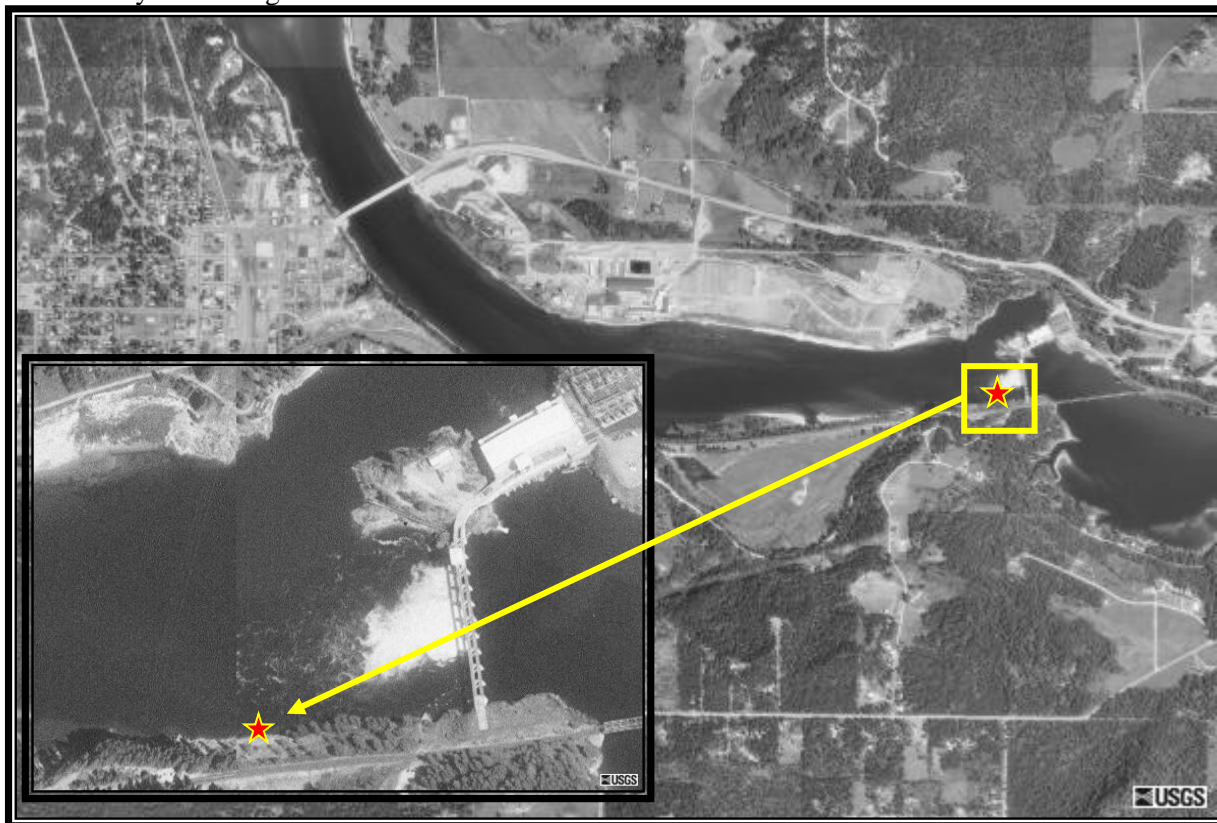
2. Albeni Falls Tailwater TDG Monitoring Station (ALQI)

Location: On the southern shoreline of the Pend Oreille River.

Reasons for replacement: This gauge was initiated at this site on July 28, 2005 due to sediment burying the previous site several times. This newer location is immediately below the spillway aerated zone in deeper water which should minimize sedimentation problems.

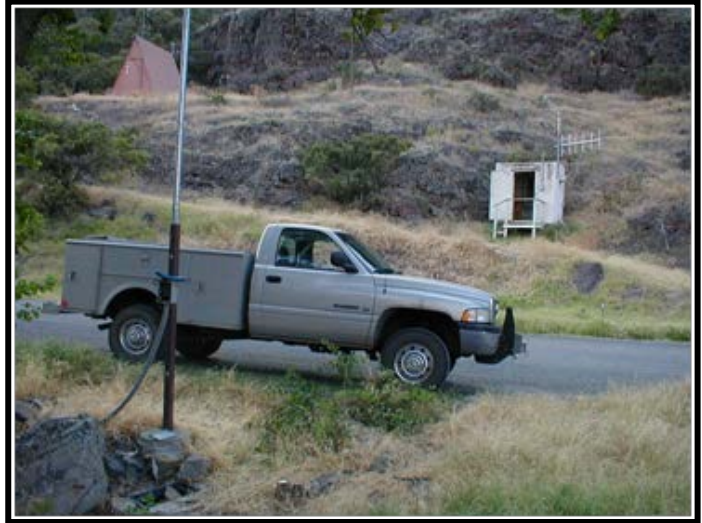
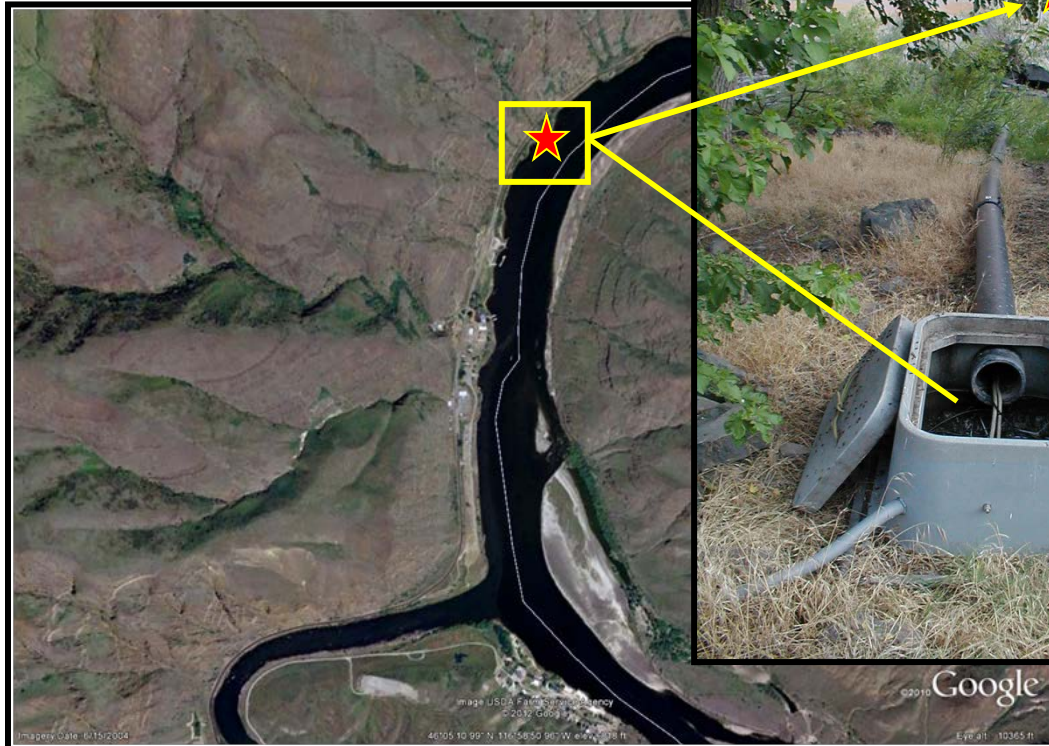
3. Anatone TDG Monitoring Station on the Snake River (ANQW)

Location: This gauge is located on the Washington shoreline of the Snake River approximately 1.3 miles downstream of the Grande Ronde River confluence. It is co-located with the USGS Anatone Stream gauge (ANAW).

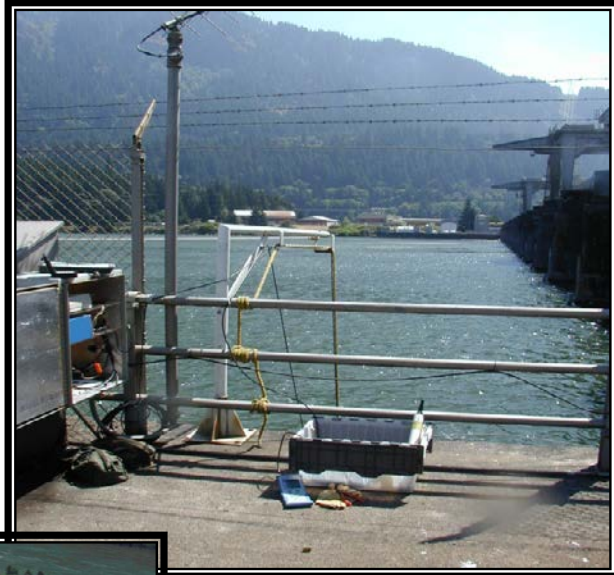
4. Bonneville Forebay TDG Monitoring Station (BON)

Gage Elevation: Fixed
Latitude: 45° 38' 44.42147" N
Longitude: 121° 56' 24.29279" W
Distance from Dam: On face of dam
Datum: NAD83
River: Columbia
River Mile: 146.1
USGS-ID: 453845121562000
Owner: U.S. Army Corps of Engineers-NWP
Gauge Type: Hydrosonde
Data Transmission: GOES Satellite
Dates of Operation: April 1 – August 31*
Years of Operation: 1986 – Present
Water Conditions: Mixed
Location: On the northern side of the spillway channel on Cascade Island just upstream of Spillbay #1.
This gage replaced: N/A
Reason for replacement: N/A
Comments: *The seasonal gauges may go in several days before April 1 and remain in operation several days after August 31.

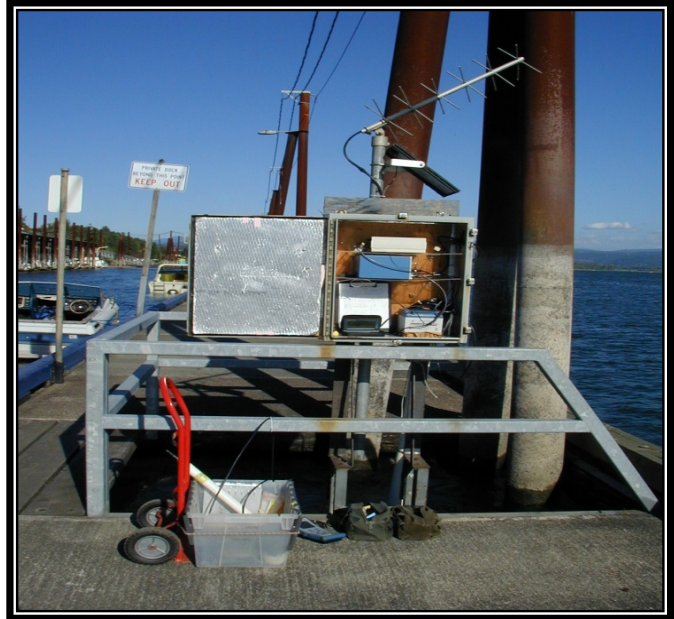
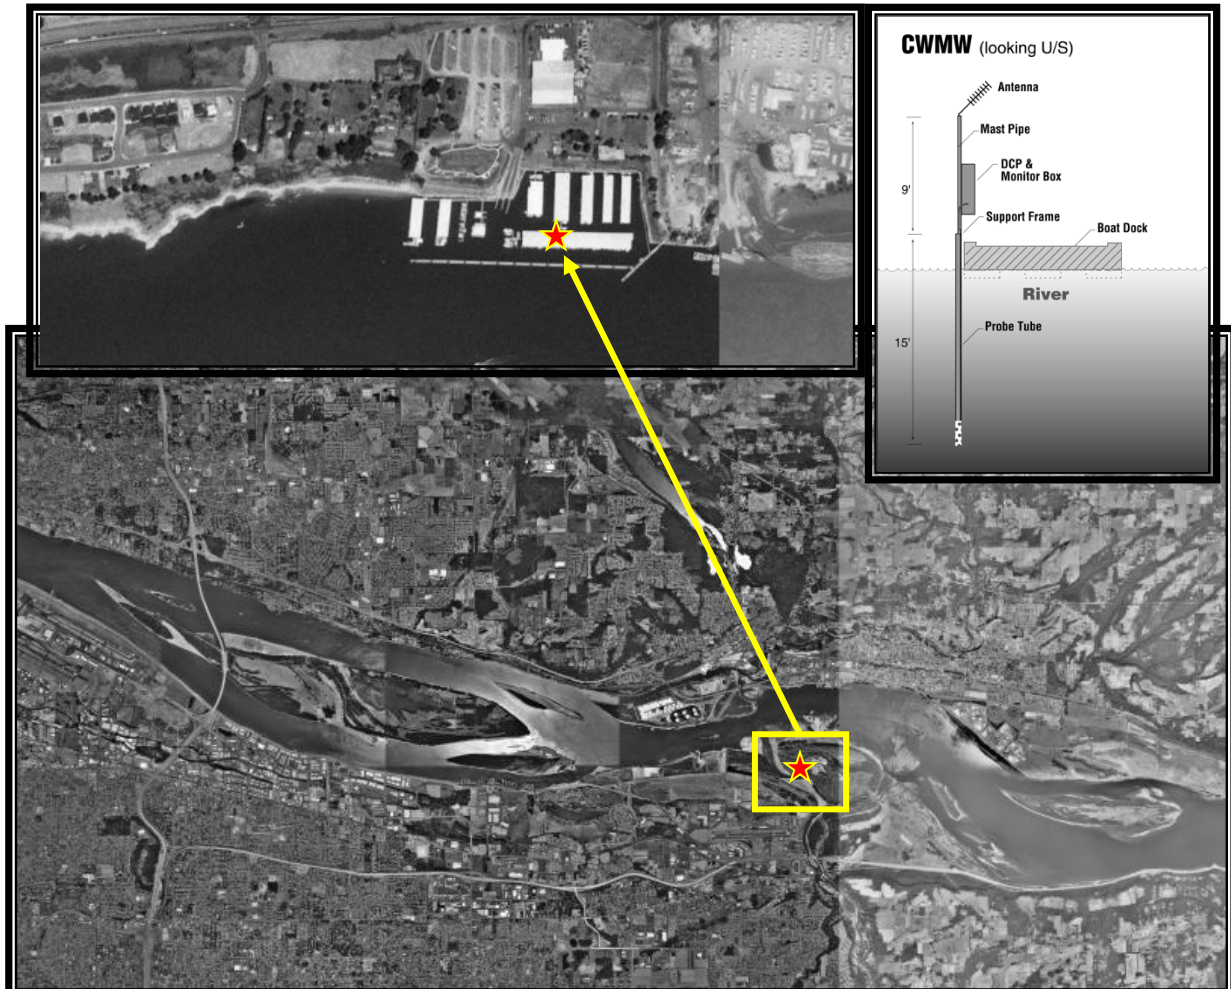
5. Camas-Washougal TDG Monitoring Station (CWMW)

Gage Elevation: Variable
Latitude: 45° 34' 38.42788" N
Longitude: 122° 22' 43.32961" W
Distance from Dam: 24 miles downstream from Bonneville
Datum: NAD83
River: Columbia
River Mile: 121.7
USGS-ID: 453439122223900
Owner: U.S. Army Corps of Engineers-NWP
Gauge Type: Hydrosonde
Data Transmission: GOES Satellite
Dates of Operation: April 1 – August 31*
Years of Operation: 1993 – 2020
Water Conditions: Mixed
Location: Attached to the boat dock at the outer edge of the harbor at the Port of Camas/Washougal, WA
This gage replaced: N/A
Reason for replacement: N/A
Comments: This gauge is currently being utilized as a surrogate forebay gauge for the management of spill at Bonneville Dam.

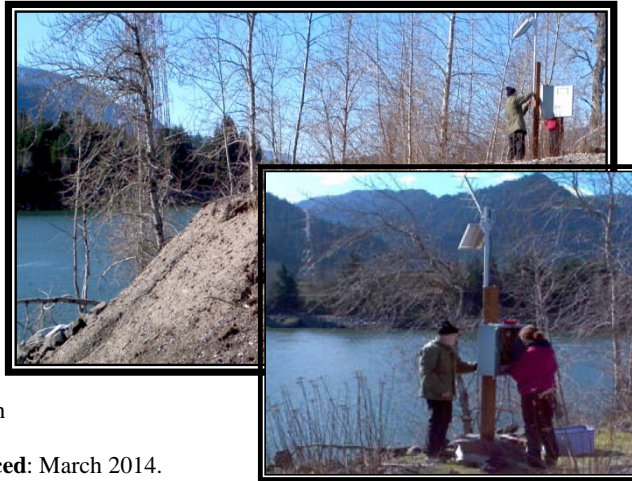
6. Cascades Island TDG Monitoring Station (CCIW)

Gage Elevation: Fixed
Latitude: 45° 38' 44.42143" N
Longitude: 121° 56' 44.29340" W
Distance from Dam: 0.27 miles (1400 ft)
Datum: NAD83
River: Columbia
River Mile: 145.6
USGS-ID: 453845121564001
Owner: U.S. Army Corps of Engineers-NWP
Gauge Type: Hydrosonde
Data Transmission: GOES Satellite
Dates of Operation: April 1 – August 31*
Years of Operation: 2004 – Present
Water Conditions: Spillway
Location: Within the Bonneville Dam spillway channel on Cascade Island.
This gage replaced: September 2011; **Probe pipes replaced:** March 2014.
Reason for replacement: Old gage destroyed due to high velocity flows.
Comments: Became the spill management gage as of 2004. Location of station moved to higher elevation.

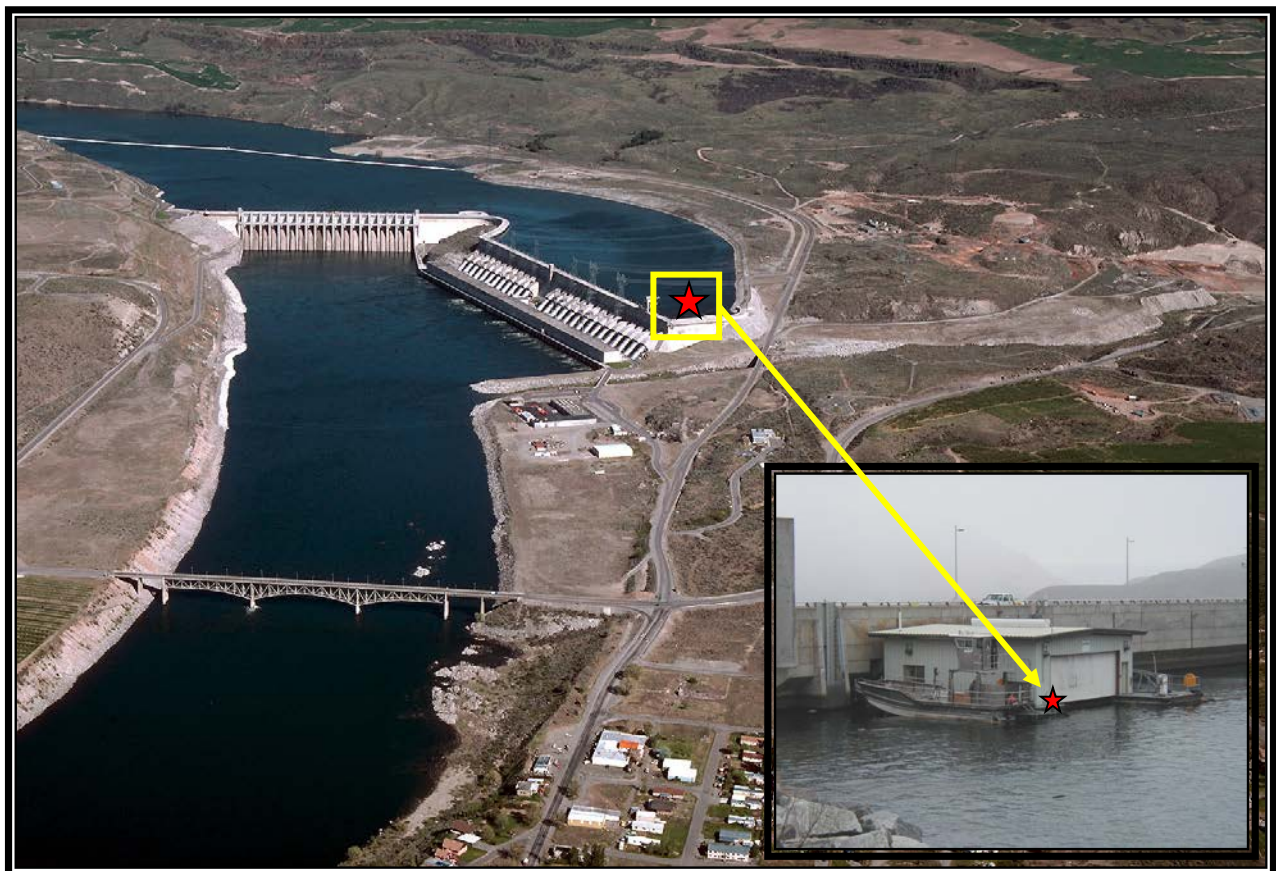
7. Chief Joseph Forebay TDG Monitoring Station (CHJ)

Location: Along the southern edge of Lake Rufus Woods
(inside the boat house).

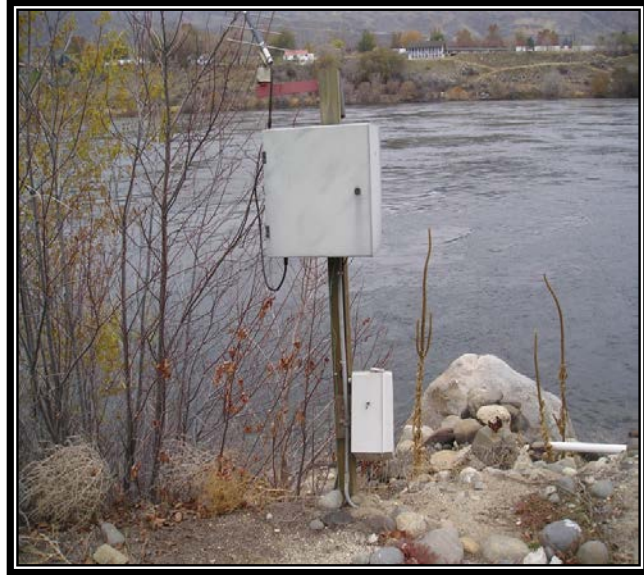
8. Chief Joseph Tailwater TDG Monitoring Station (CHQW)

Gage Elevation: Fixed
Latitude: 48° 00' 17.2" N
Longitude: 119° 39' 30.3" W
Distance from Dam: 1 mile
Datum: NAD83
River: Columbia
River Mile: 543.8
USGS-ID: --
Owner: U.S. Army Corps of Engineers-NWS
Gauge Type: Hydrosonde
Data Transmission: GOES Satellite
Dates of Operation: April 1 – Aug 31*
Years of Operation: 1985 – Present
Water Conditions: Spillway
Location: North bank of the river, just downstream of the Highway 17 Bridge.
This gage replaced: N/A
Reason for gage replacement: N/A
Comments: *The seasonal gauges may go in several days before April 1 and remain in operation several days after August 31.

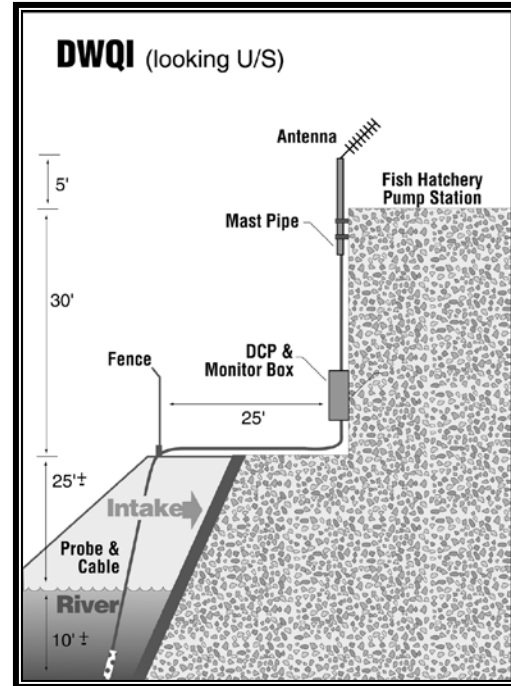
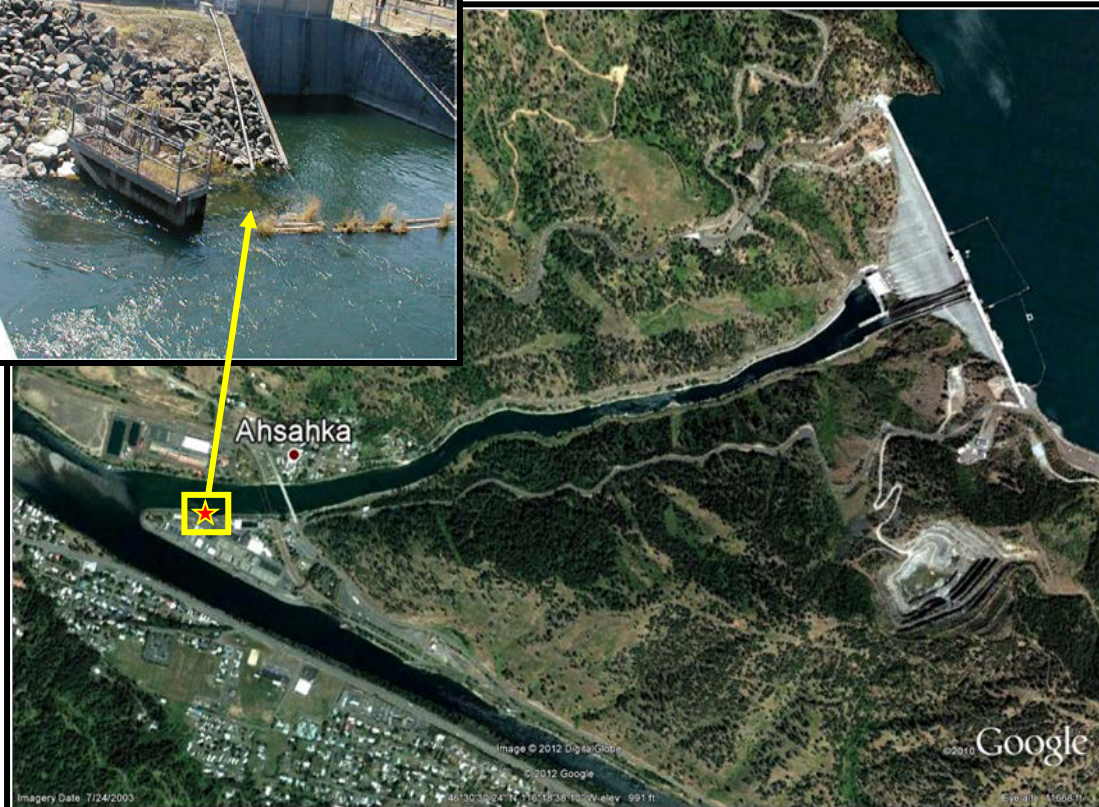
9. Dworshak TDG Monitoring Station (DWQI)

Gage Elevation: Fixed
Latitude: 46° 30' 11.6464" N
Longitude: 116° 19' 16.4090" W
Distance from Dam: 1.5 miles
Datum: NAD83
River: North Fork, Clearwater River
River Mile: 0.5
USGS-ID: 13341000
Owner: U.S. Army Corps of Engineers-NWW
Gauge Type: Hydrosonde
Data Transmission: GOES Satellite
Dates of Operation: Year round
Years of Operation: 1993 - Present
Water Conditions: Mixed
Location: On the southern bank of the North Fork, Clearwater River between the bridge and the U.S. Fish and Wildlife Service Fish Hatchery outflow pipe.
This gage replaced: N/A
Reason for replacement: N/A
Comments: --

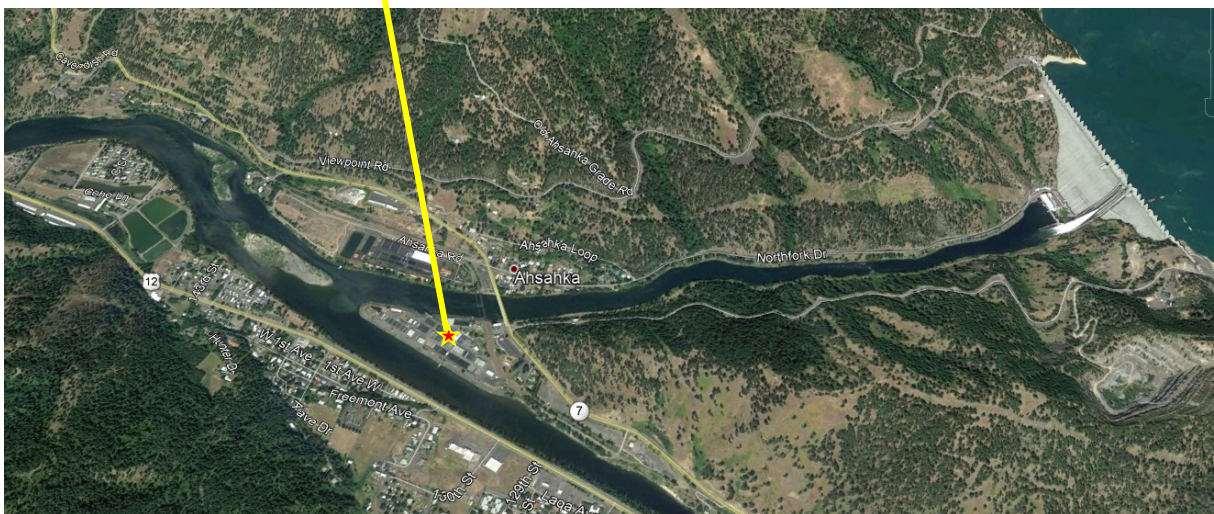
10. Dworshak Hatchery Collection Channel TDG Monitoring Station (DHCI)

Location: Gauge is located in a collection channel of the U.S. Fish and Wildlife Service Dworshak National Fish Hatchery.

Comments: This gauge is used to assess the TDG levels at Dworshak National Fish Hatchery during Dworshak Dam spill. The water being measured has been treated by the hatchery's vacuum degassers.

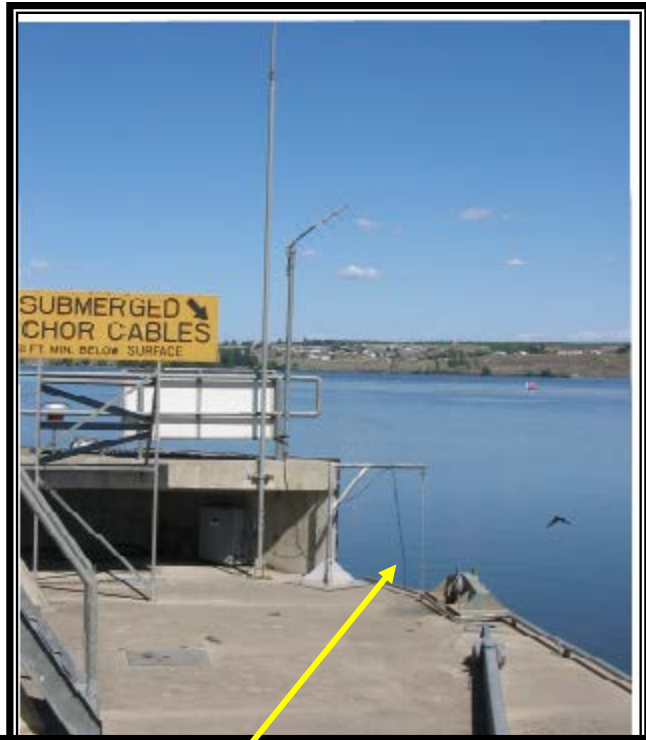
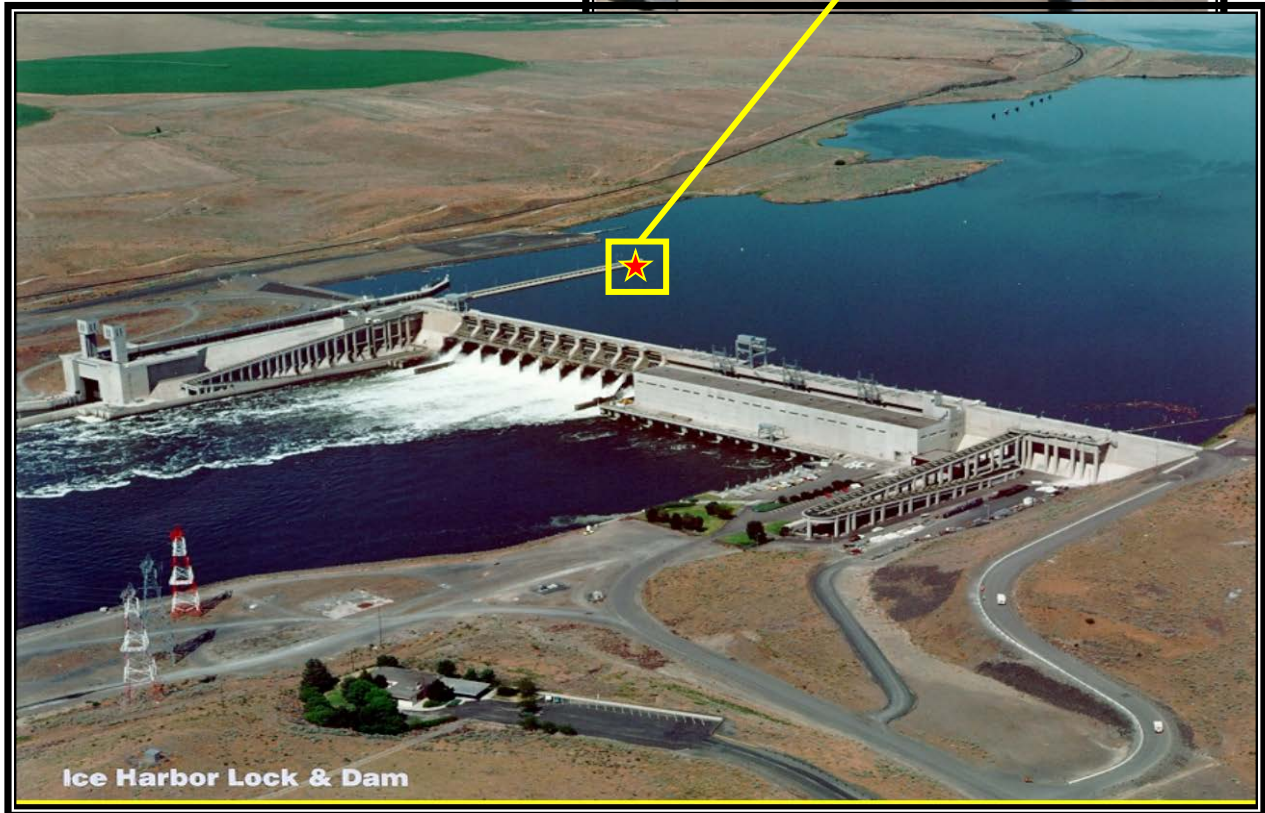
11. Ice Harbor Forebay TDG Monitoring Station (IHRA)

Gage Elevation: Fixed
Latitude: 46° 15' 5.2792" N
Longitude: 118° 52' 43.0096" W
Distance from Dam: 695 ft
Datum: NAD83
River: Snake
River Mile: 10.0
USGS-ID: 13352950
Owner: U.S. Army Corps of Engineers-NWW
Gauge Type: Hydrosonde
Data Transmission: GOES Satellite
Dates of Operation: Was year round prior to 2006, now seasonal (April 1 – Aug. 31*).
Years of Operation: 2005 – Present.
Water Conditions: Mixed
Location: At the upstream end of the navigation lock guidewall.
This gage replaced: IHR
Reason for replacement: Moved due to thermal influences and lowered from 15 ft to 45 ft.
Comments: *The seasonal gauges may go in several days before April 1 and remain in operation several days after August 31.

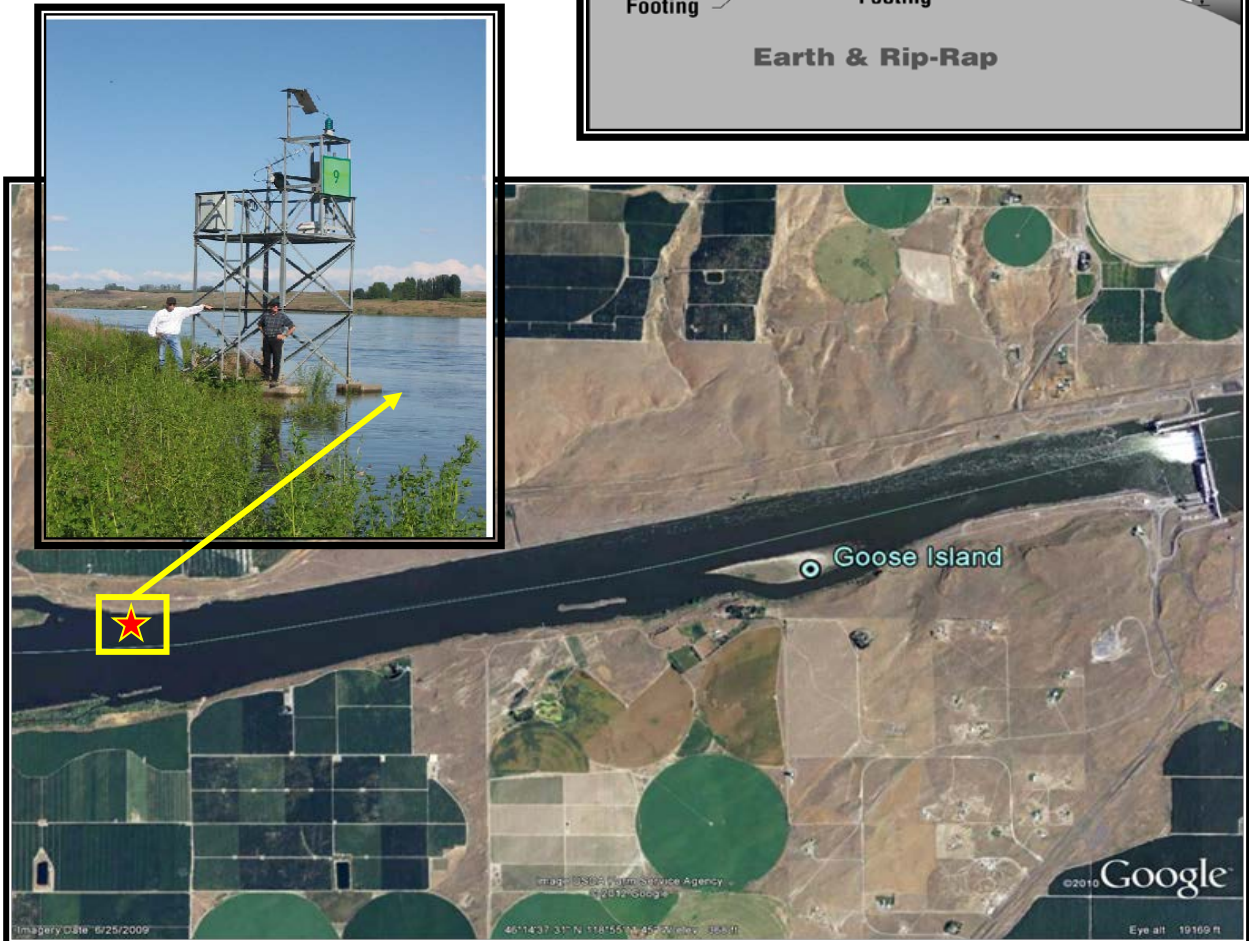
12. Ice Harbor Tailwater TDG Monitoring Station (IDSW)

Gage Elevation: Fixed
Latitude: 46° 14' 27.5868" N
Longitude: 118° 57' 13.7130" W
Distance from Dam: 3.6 miles
Datum: NAD83
River: Snake
River Mile: 6.1
USGS-ID: 13353010
Owner: U.S. Army Corps of Engineers-NWW
Gauge Type: Hydrosonde
Data Transmission: GOES Satellite
Dates of Operation: Was seasonal prior to 2006, now year round.
Years of Operation: 1994 – Present.
Water Conditions: Mixed & spillway
Location: On the northern shore of the Snake River
This gage replaced: N/A
Reason for replacement: N/A
Comments: --

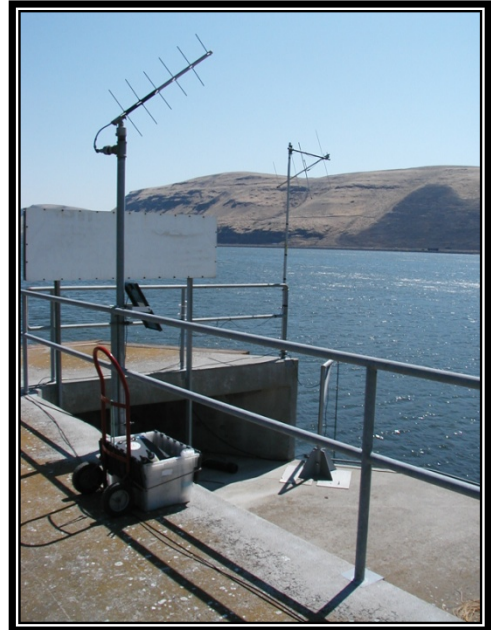
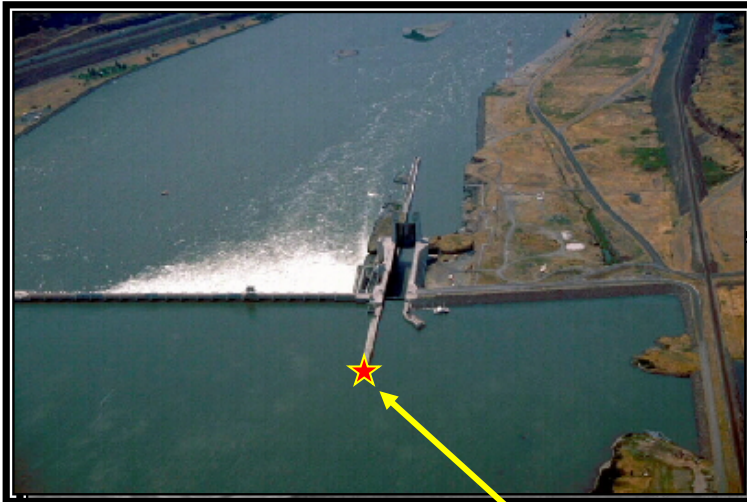
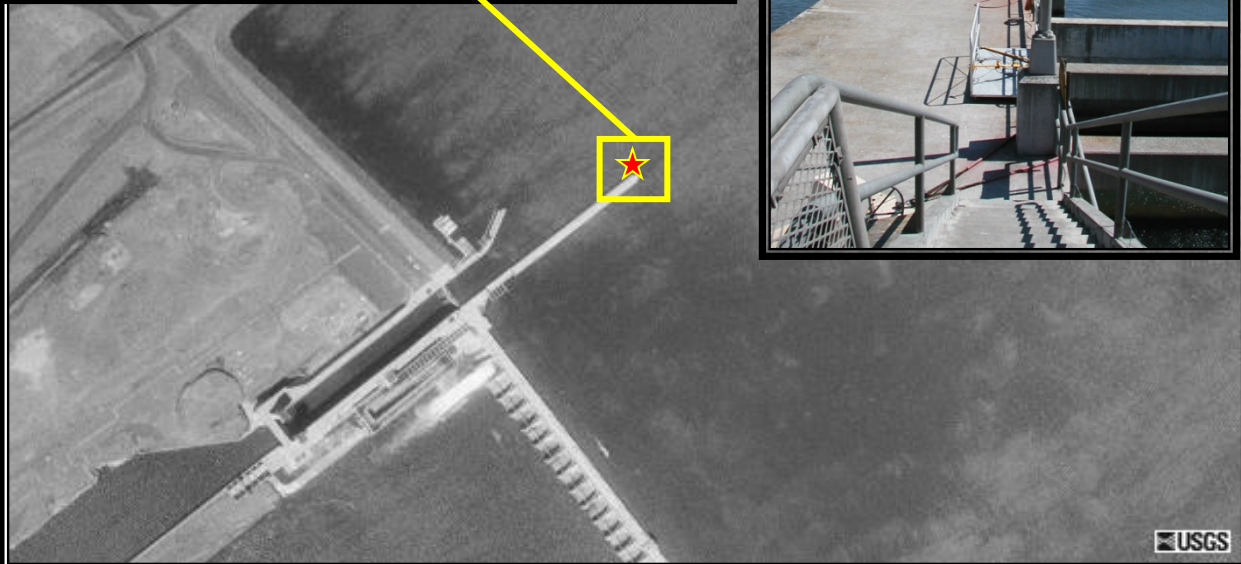
13. John Day Forebay TDG Monitoring Station (JDY)

Gage Elevation: Variable
Latitude: 45° 43' 13.44908" N
Longitude: 120° 41' 41.21307" W
Distance from Dam: On extended guidewall from dam
Datum: NAD83
River: Columbia
River Mile: 215.7
USGS-ID: 453439122223900
Owner: U.S. Army Corps of Engineers-NWP
Gauge Type: Hydrosonde
Data Transmission: GOES Satellite
Dates of Operation: April 1 – August 31*
Years of Operation: 2004 – Present
Water Conditions: Mixed
Location: At upstream end of the navigation lock guidewall.
This gage replaced: JDA
Reason for replacement: Moved due to thermal influences and lowered from 15 ft to 45 ft.
Comments: *The seasonal gauges may go in several days before April 1 and remain in operation several days after August 31.

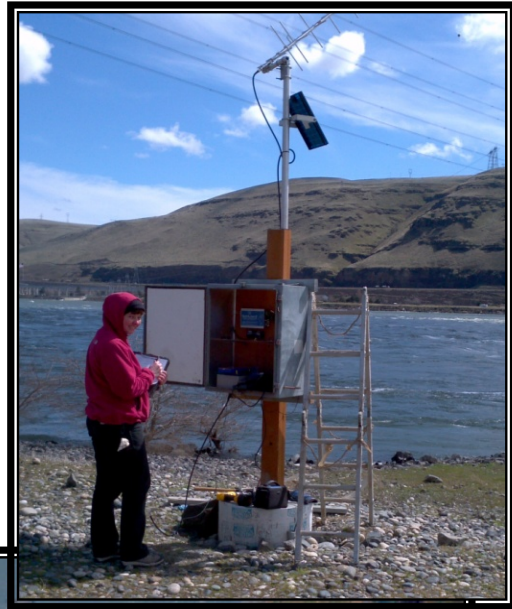
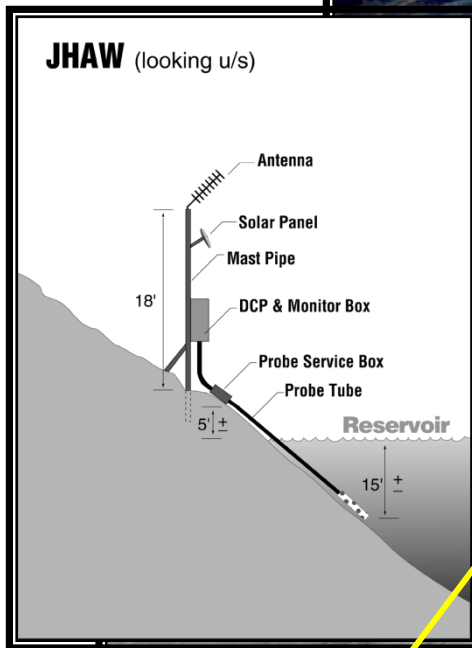
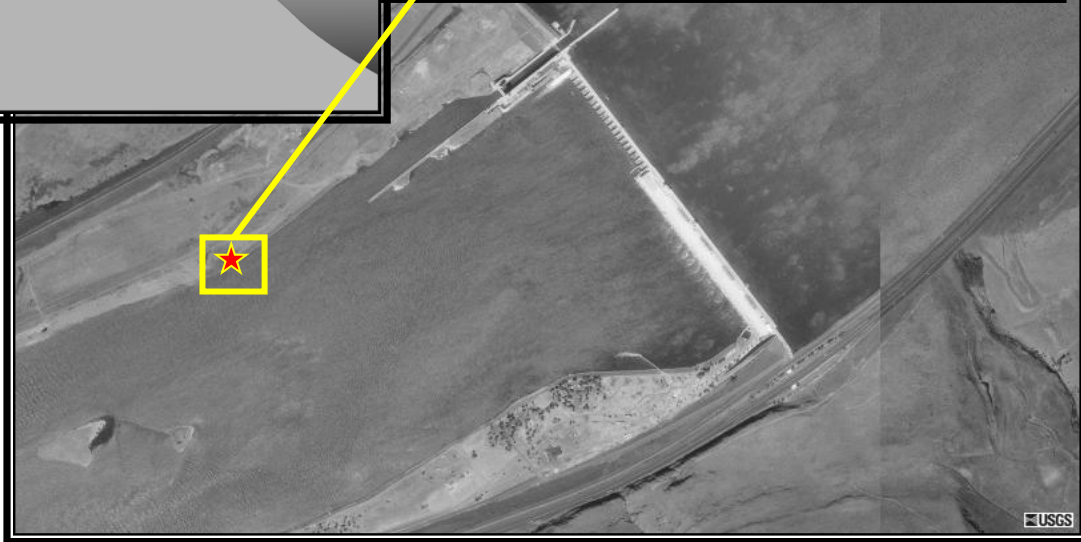
14. John Day Tailwater TDG Monitoring Station (JHAW)

Gage Elevation: Fixed
Latitude: 45° 42' 48.44859" N
Longitude: 120° 42' 39.21477" W
Distance from Dam: 0.8 miles
Datum: NAD83
River: Columbia
River Mile: 214.7
USGS-ID: 454249120423500
Owner: U.S. Army Corps of Engineers-NWP
Gauge Type: Hydrosonde
Data Transmission: GOES Satellite
Dates of Operation: Was seasonal prior to 2006, now year round.
Years of Operation: 1995 – Present
Water Conditions: Spillway
Location: Other Washington shore.
This gage replaced: N/A
Reason for replacement: Rising flows
Comments: Location of station moved about 12 feet higher elevation from shore, further up the hill.

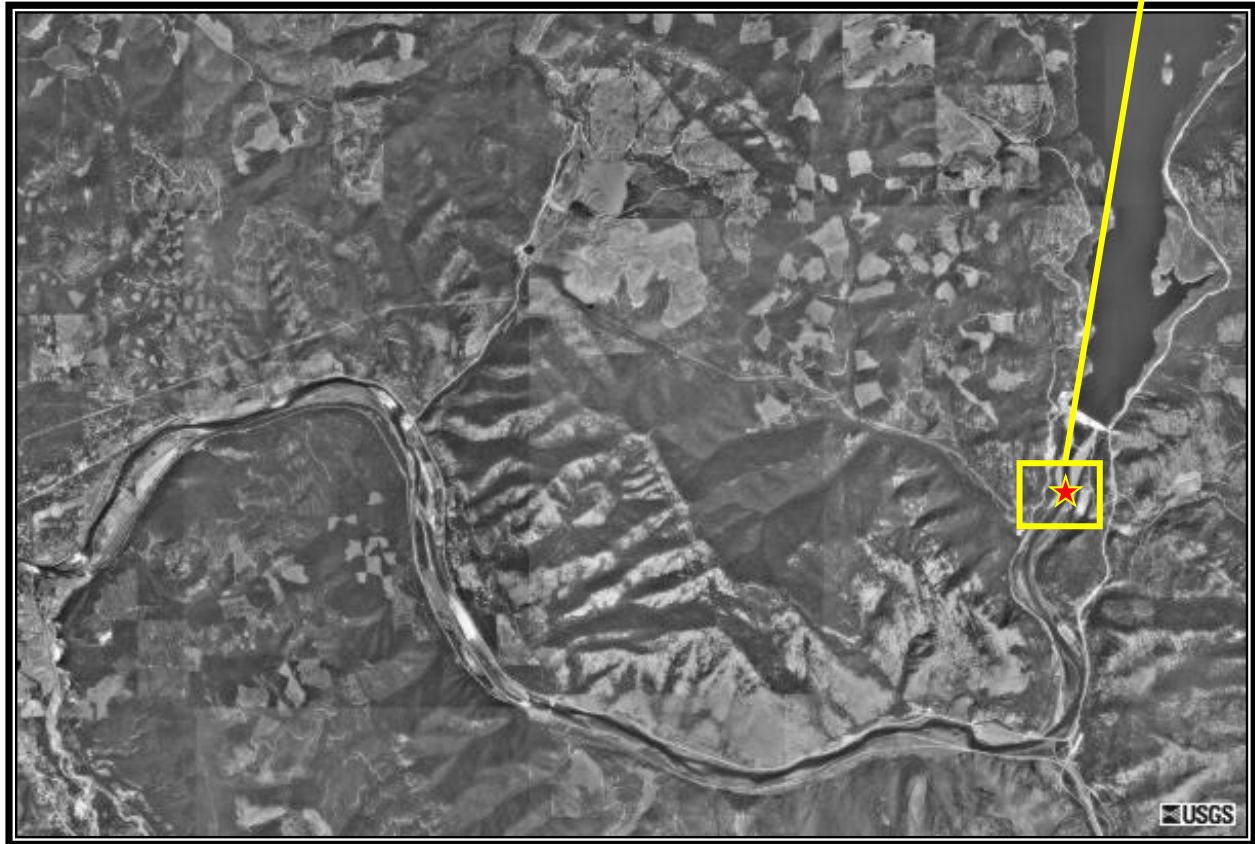
15. Libby Tailwater TDG Monitoring Station (LBQM)

Location: This gauge is located on the eastern shore of the Kootenai River approximately 750 feet downstream of the Libby Dam access road bridge.

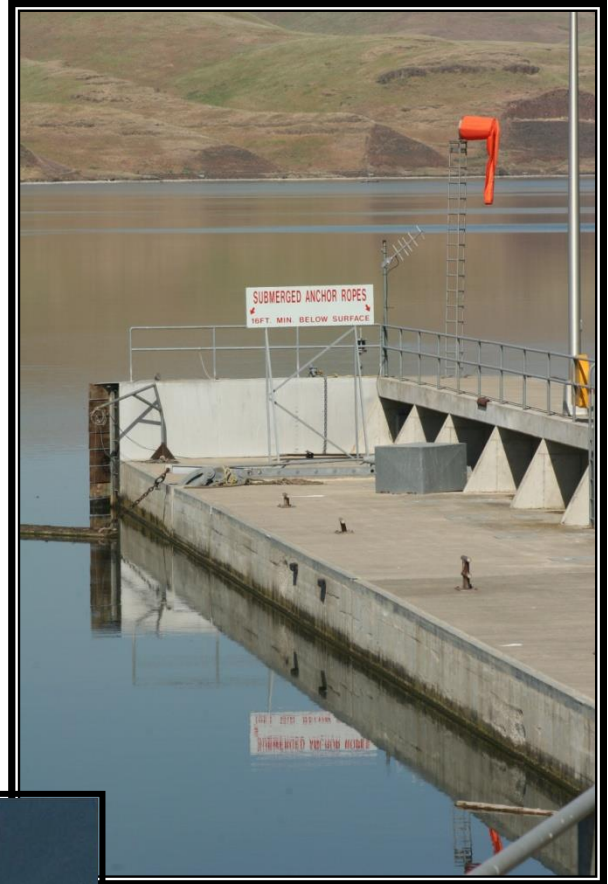
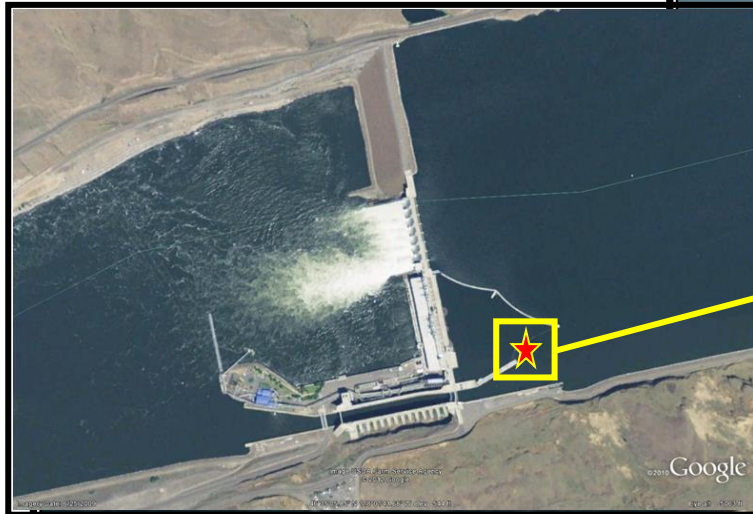
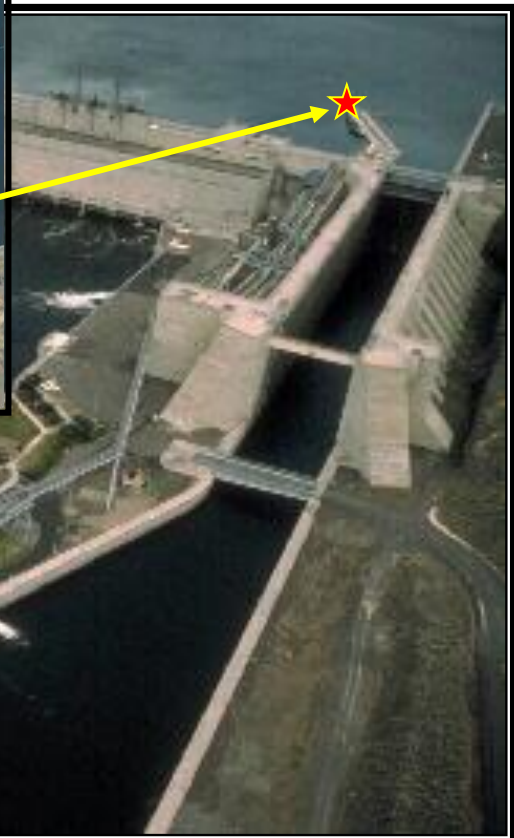
16. Little Goose Forebay TDG Monitoring Station (LGSA)

Location: At the upstream end of the navigation lock guidewall.

Reason for replacement: Move due to thermal influences and lowered from 15 ft to 45 ft.

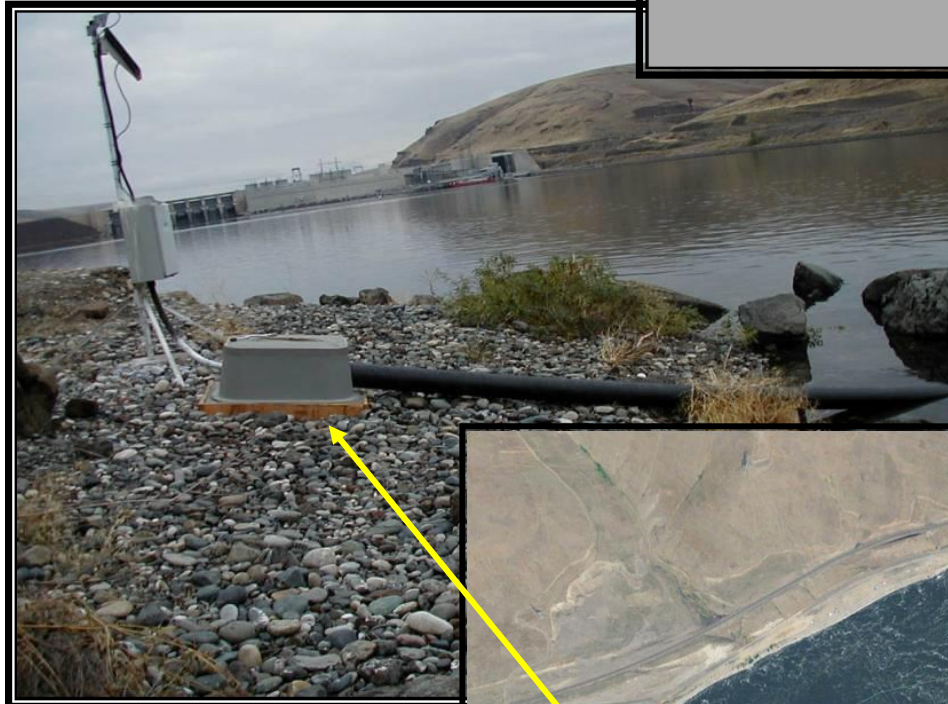
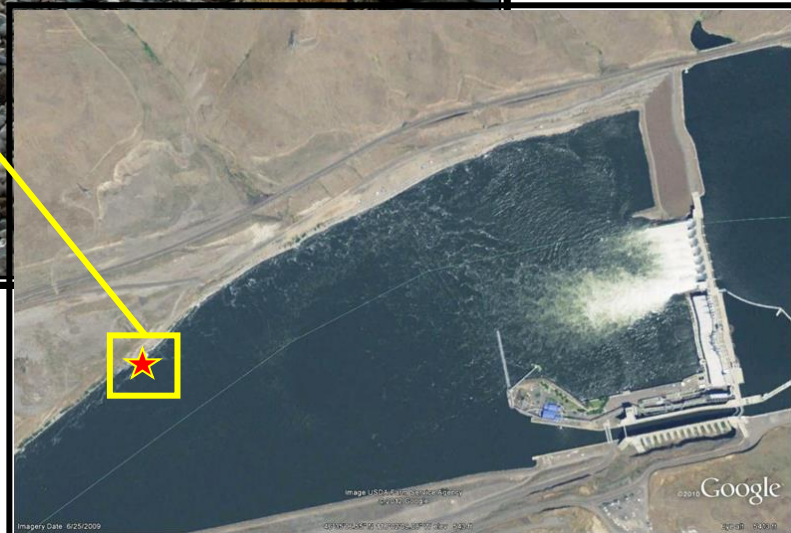
17. Little Goose Tailwater TDG Monitoring Station (LGSW)

Gage Elevation: Fixed
Latitude: 46° 35' 00.5280" N
Longitude: 118° 02' 37.4186" W
Distance from Dam: 0.7 miles
Datum: NAD83
River: Snake
River Mile: 69.6
USGS-ID: 13343860
Owner: U.S. Army Corps of Engineers-NWW
Gauge Type: Hydrosonde
Data Transmission: GOES Satellite
Dates of Operation: Was seasonal prior to 2006, now year round.
Years of Operation: 1995 – Present.
Water Conditions: Switches between mixed & spillway
Location: On the northern shore of the Snake River
This gage replaced: N/A
Reason for replacement: N/A
Comments: --

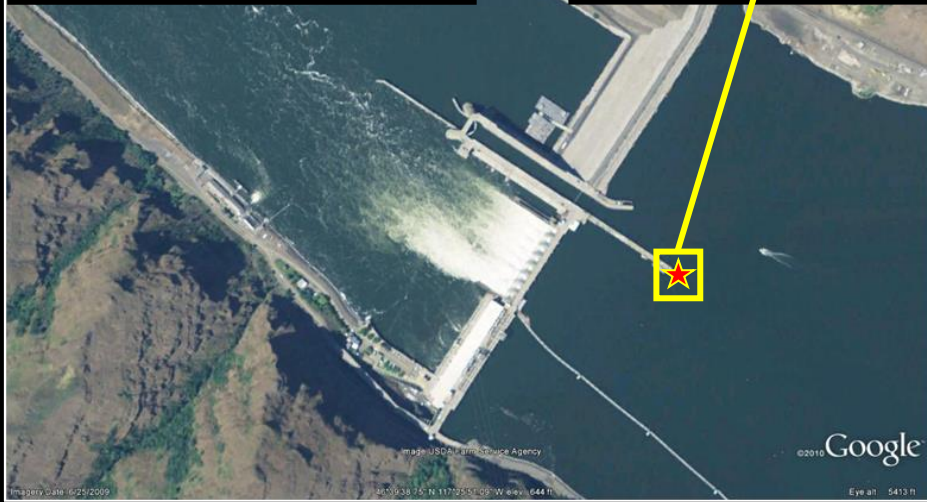
18. Lower Granite Forebay TDG Monitoring Station (LWG)

Location: At the upstream end of the navigation lock guidewall.

Reason for replacement: In March, 2005, this gauge was moved from a depth of 15 ft to 45 ft to avoid thermal influences. The geographic location of the gauge was not changed.

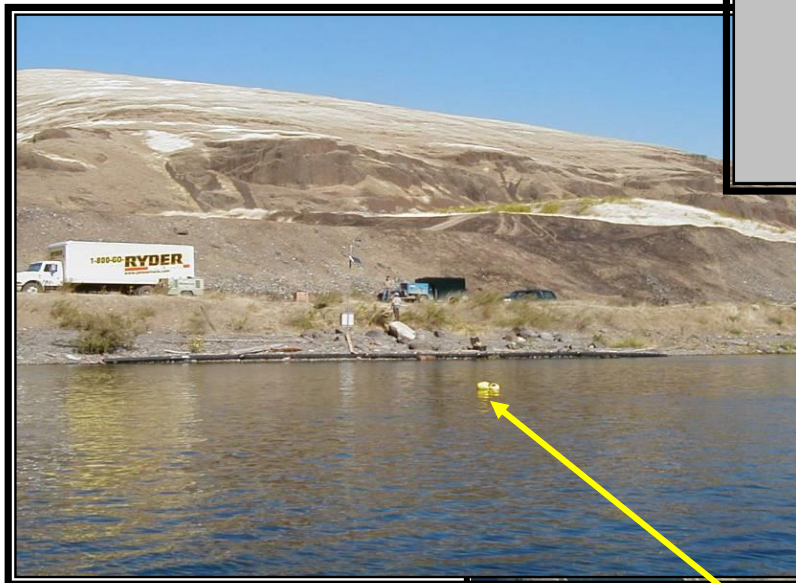
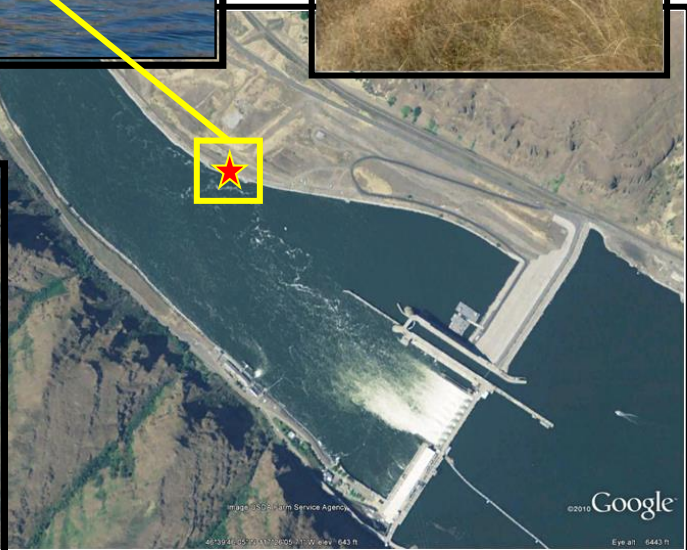
19. Lower Granite Tailwater TDG Monitoring Station (LGNW)

Gage Elevation: Fixed
Latitude: 46° 39' 58.0726" N
Longitude: 117° 26' 19.2595" W
Distance from Dam: 0.8 miles
Datum: NAD83
River: Snake
River Mile: 106.7
USGS-ID: 13343595
Owner: U.S. Army Corps of Engineers-NWW
Gauge Type: Hydrosonde
Data Transmission: GOES Satellite
Dates of Operation: Year around
Years of Operation: 1995 – Present.
Water Conditions: Switches between mixed & spillway
Location: On the northeastern shore of the Snake River.
This gage replaced: N/A
Reason for replacement: N/A
Comments: --
