Appendix A

**2021 Total Dissolved Gas
Fixed Monitoring Stations**

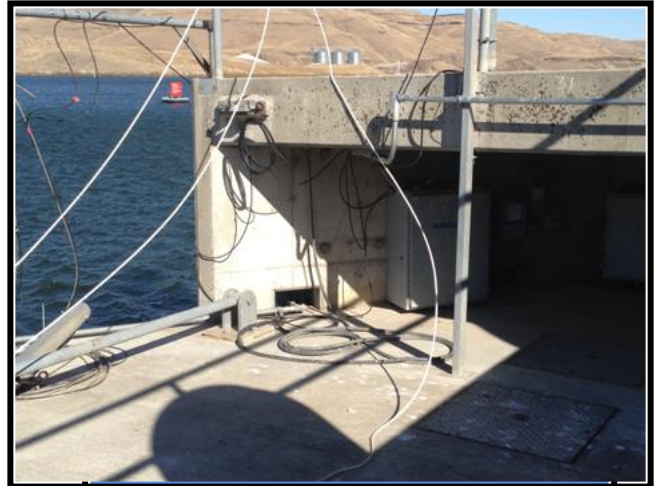
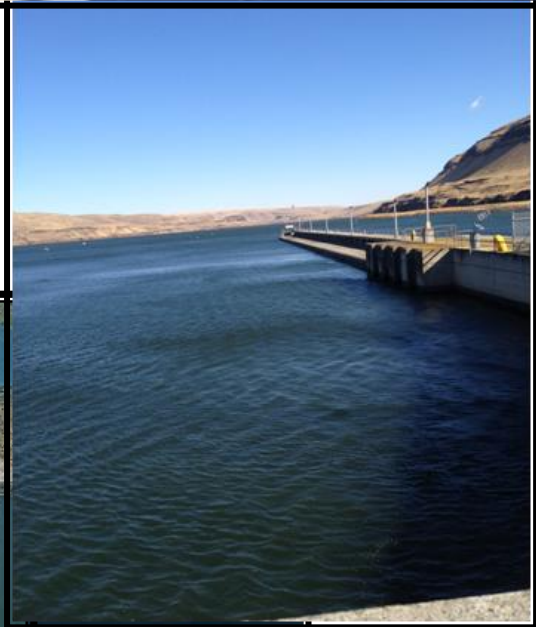
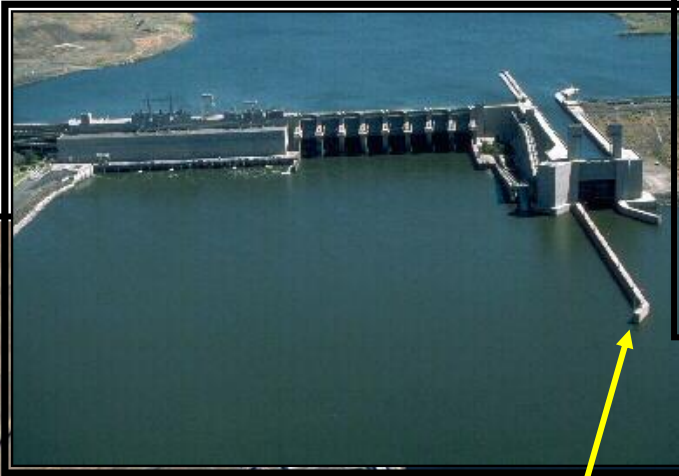
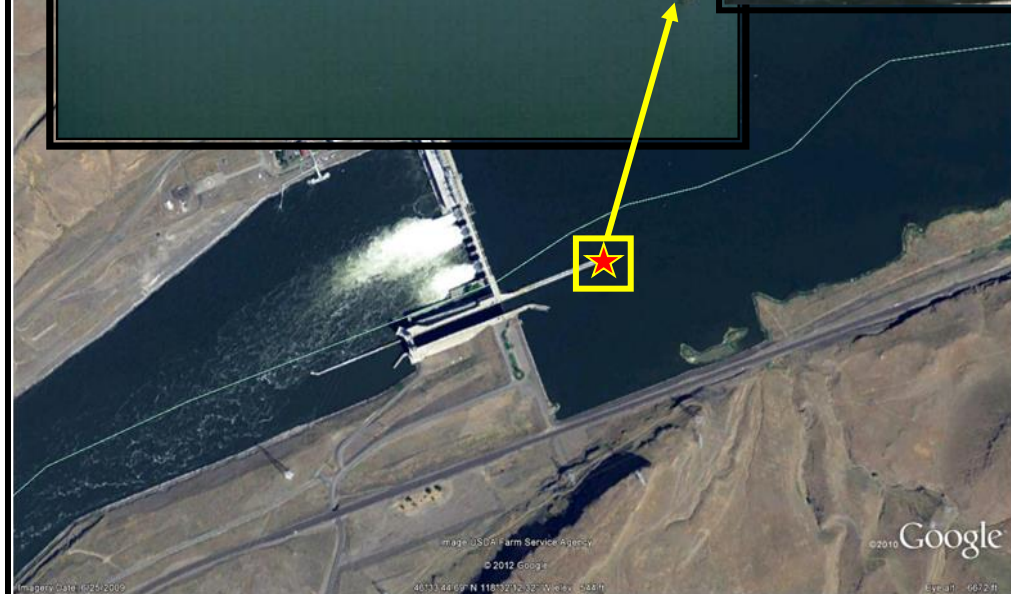
22. Lower Monumental Forebay TDG Monitoring Station (LMNA)

Location: At the upstream end of the navigation lock guidewall.

Reason for replacement: Moved due to thermal influences and lowered from 15 ft to 45 ft.

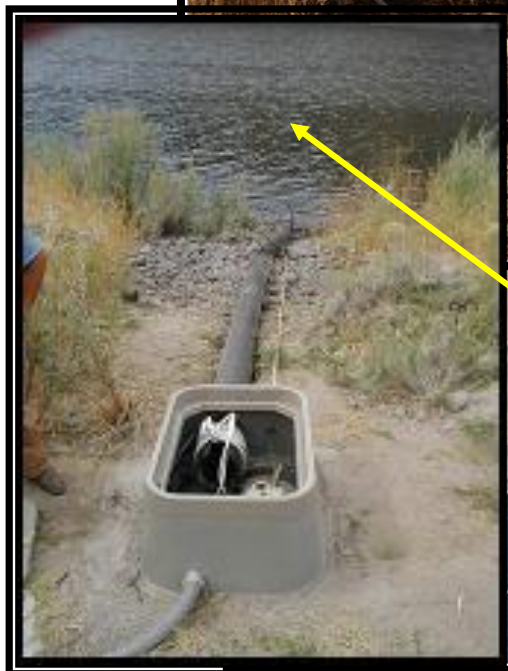
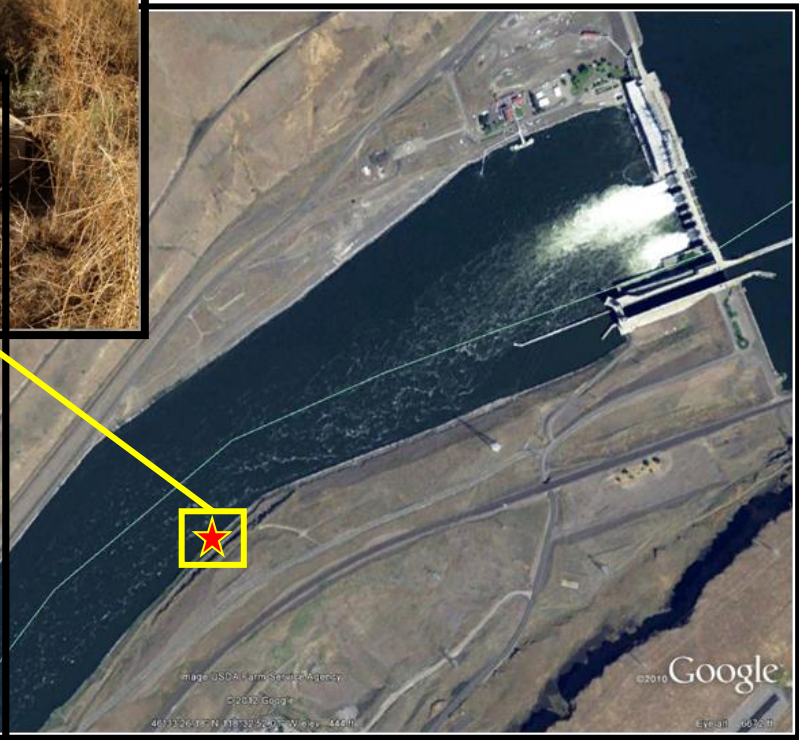
21. Lower Monumental Tailwater TDG Monitoring Station (LMNW)

Gage Elevation: Fixed
Latitude: 46° 33' 04.5051" N
Longitude: 118° 32' 58.9500" W
Distance from Dam: 1 mile
Datum: NAD83
River: Snake
River Mile: 40.4
USGS-ID: 13352600
Owner: U.S. Army Corps of Engineers-NWW
Gauge Type: Hydrosonde
Data Transmission: GOES Satellite
Dates of Operation: Was seasonal prior to 2006, now year around.
Years of Operation: 1995 – Present
Water Conditions: Switches between mixed & spillway.
Location: On the southeastern shore of the Snake River.
This gage replaced: N/A
Reason for replacement: N/A
Comments: --

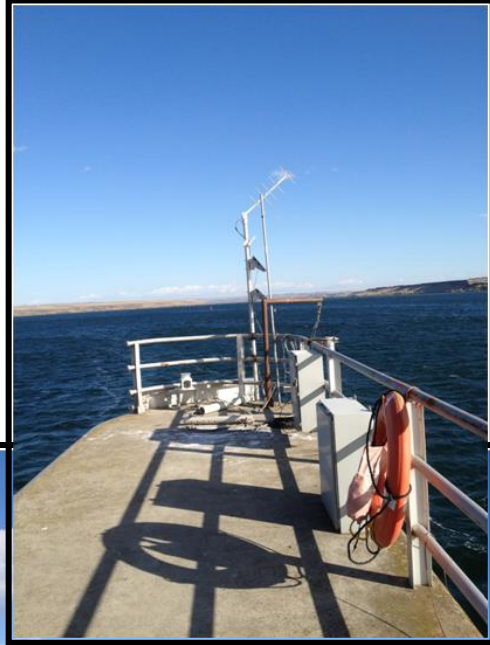
22. McNary Forebay TDG Monitoring Station (MCNA)

Location: At the end of the navigation lock guidewall near the Washington shoreline.

Reason for replacement: Moved due to thermal influences and lowered from 15 ft to 45 ft.

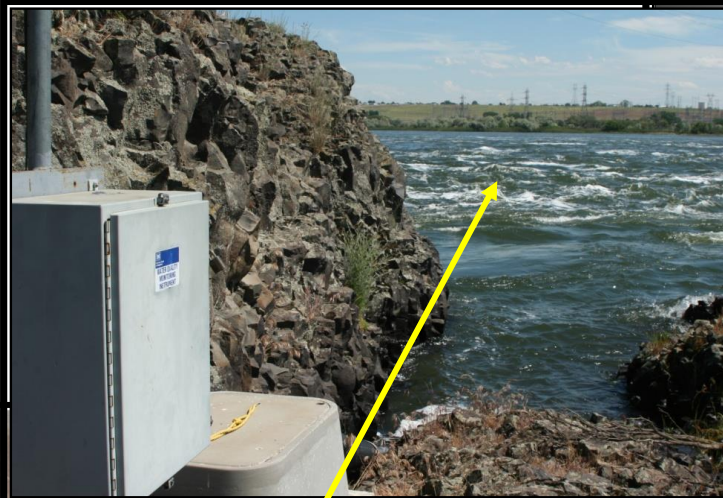
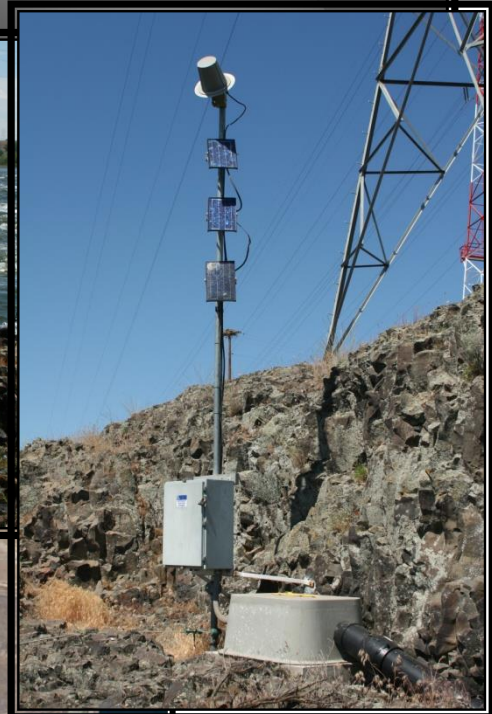
23. McNary Tailwater TDG Monitoring Station (MCPW)

Gage Elevation: Fixed
Latitude: 45° 56' 02.7775" N
Longitude: 119° 19' 35.4628" W
Distance from Dam: 1.3 miles
Datum: NAD83
River: Columbia
River Mile: 290.7
USGS-ID: 14019240
Owner: U.S. Army Corps of Engineers-NWW
Gauge Type: Hydrosonde
Data Transmission: GOES Satellite
Dates of Operation: Year around
Years of Operation: 1995 - Present
Water Conditions: Spillway
Location: On a rocky outcrop on the Washington shore and just upstream of the Highway 395 Bridge.
This gage replaced: N/A
Reason for replacement: N/A
Comments: --

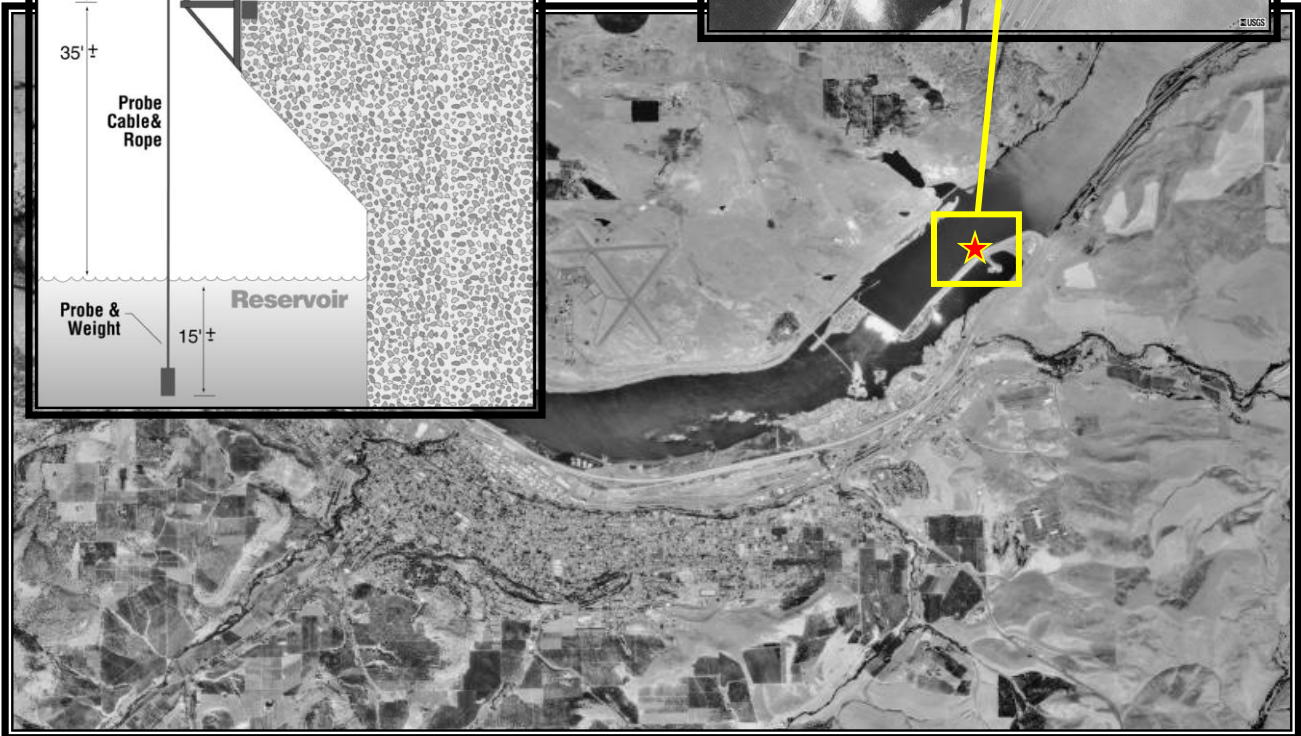
26. The Dalles Forebay TDG Monitoring Station (TDA)

Gage Elevation: Fixed
Latitude: 45° 37' 11.43618" N
Longitude: 121° 07' 16.25220" W
Distance from Dam: On part of dam
Datum: NAD83
River: Columbia
River Mile: 192.4
USGS-ID: 453712121071200
Owner: U.S. Army Corps of Engineers-NWP
Gauge Type: Hydrosonde
Data Transmission: GOES Satellite
Dates of Operation: April 1 – August 31*
Years of Operation: 1985 – Present
Water Conditions: Mixed
Location: In forebay of dam near the end of Powerhouse Unit 22.
This gage replaced: N/A
Reason for replacement: N/A
Comments: * The seasonal gauges may go in several days before April 1 and remain in operation several days after August 31.

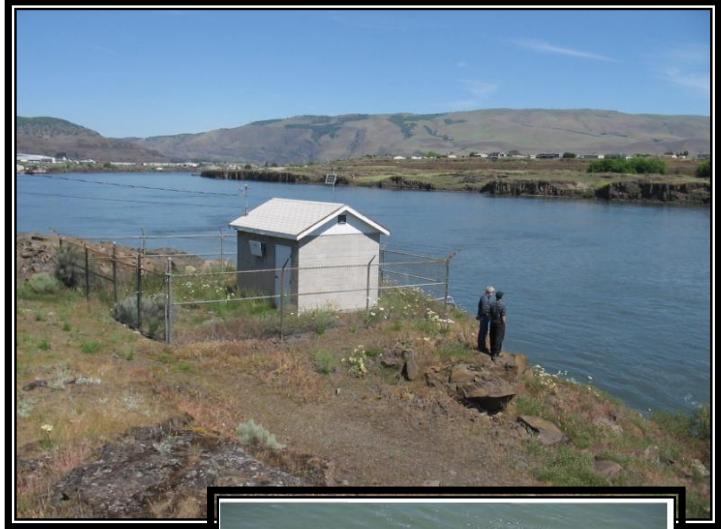
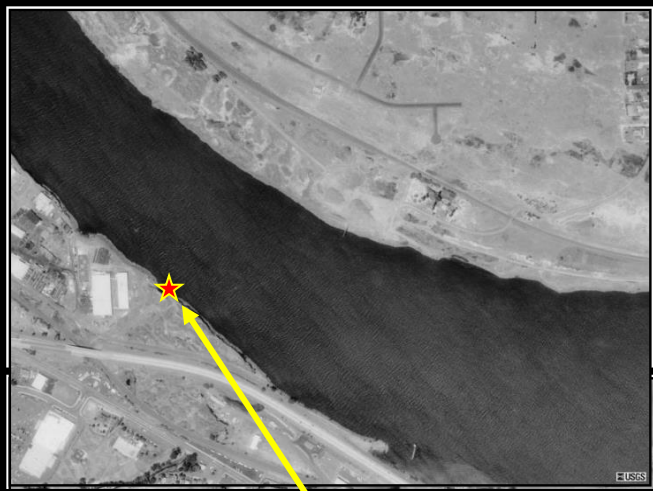
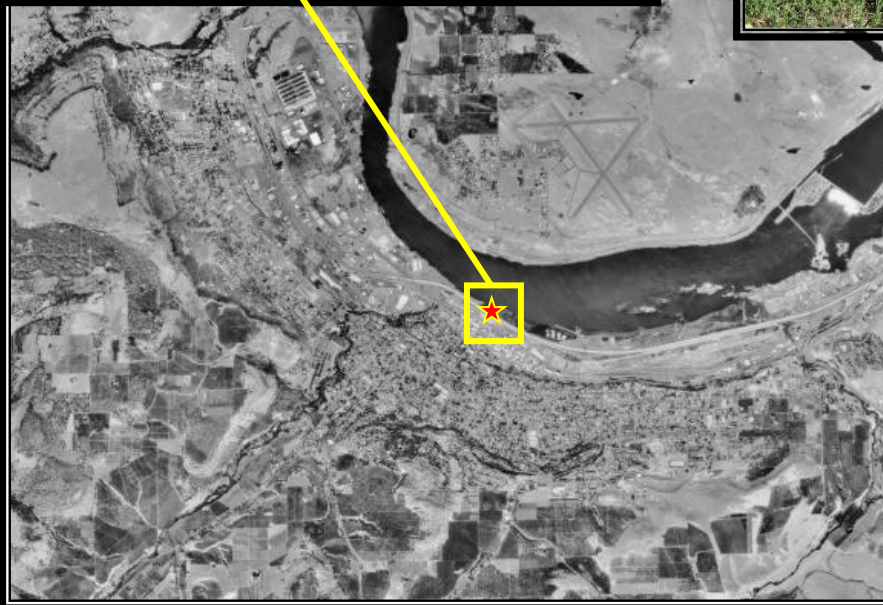
27. The Dalles Tailwater TDG Monitoring Station (TDDO)

Gage Elevation: Fixed (107.6 ft)
Latitude: 45° 36' 26.43330" N
Longitude: 121° 10' 24.25569" W
Distance from Dam: 2.5 miles
Datum: NAD83
River: Columbia
River Mile: 189.1
USGS-ID: 14105700
Owner: U.S. Army Corps of Engineers-NWP
Gauge Type: Hydrosonde
Data Transmission: GOES Satellite
Dates of Operation: Was seasonal prior to 2006, now year around
Years of Operation: 1996 – Present
Water Conditions: Mixed
Location: Off Bargeway Road from Webber Street, near industrial complex.
This gage replaced: N/A
Reason for replacement: N/A
Comments: --

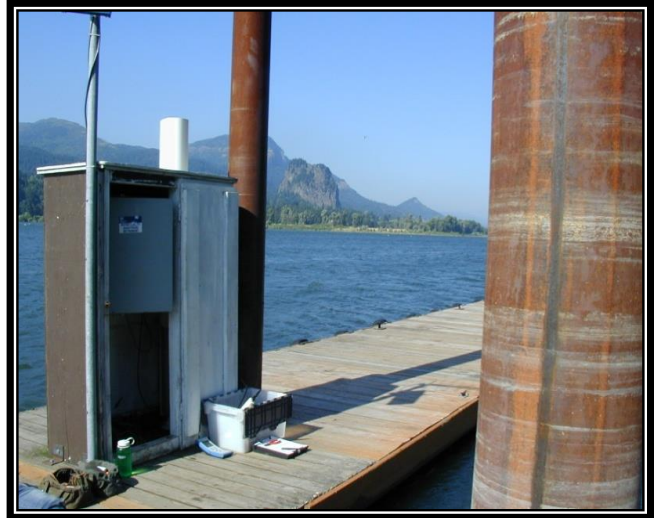
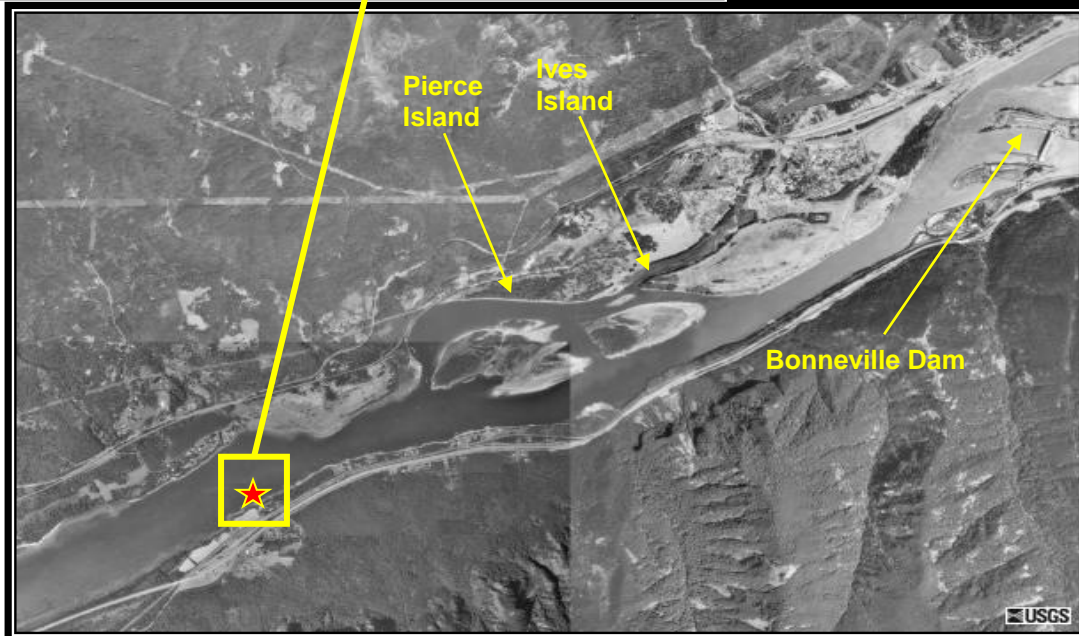
28. Warrendale TDG Monitoring Station (WRNO)

Gage Elevation: Variable
Latitude: 45° 36' 29.42299" N
Longitude: 122° 02' 18.30278" W
Distance from Dam: Approximately 6 miles downstream of dam
Datum: NAD83
River: Columbia
River Mile: 140.3
USGS-ID: 453630122021400
Owner: U.S. Army Corps of Engineers-NWP
Gauge Type: Hydrosonde
Data Transmission: GOES Satellite
Dates of Operation: Year around
Years of Operation: 1985 – Present
Water Conditions: Mixed
Location: This gauge is fixed to the boat dock at “The Fishery” off NE Enquist Pl in Dodson, Oregon (Near Warrendale) approximately 6 miles downstream of Bonneville Dam.
This gage replaced: N/A
Reason for replacement: N/A
Comment: Up until the 2004 spill season, this gauge was used as the BON tailwater gauge for spill management and was operated year around. Currently, this gauge is being used as a fall, winter, and spring TDG monitor for Chum spawning.
